Sebastian GRONEK, Paweł SZCZEPANIAK, Grzegorz JASTRZĘBSKI,
 Urszula WINIARSKA, Maciej KAMIŃSKI, Marek KRUKOWSKI
Air Force Institute of Technology (Instytut Techniczny Wojsk Lotniczych)

STUDYING THE WEAR OF TITANIUM THREAD OF AIRCRAFT FUEL FILTER

During the operation of aircraft, failure of aircraft engine occurred, due to which it was damaged. One of the hypotheses on the reasons for this can be a failure of the fuel filter. According to this hypothesis, the filter was unsealed due to the thread on the titanium shank being sheared. The above-mentioned thread was a structural element of the filter. Tests that were conducted to examine analogous filters revealed increased wear of threads, which developed due to shearing. It is estimated that this wear reduces the thread's shear strength, which can result in it being sheared due to loads directed along the shank's axis and as a consequence, total damage of the filter.

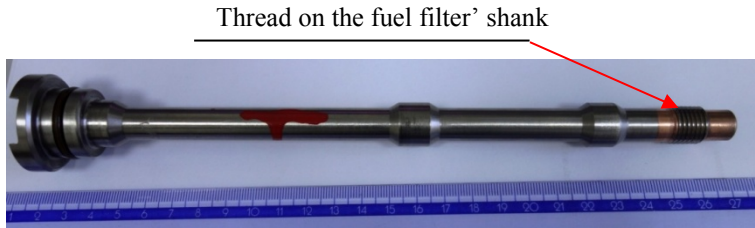
Fig. 1. Decommissioned shank of the fuel filter. The thread is covered with a visible galvanic coating, which is aimed at improving the tribological properties

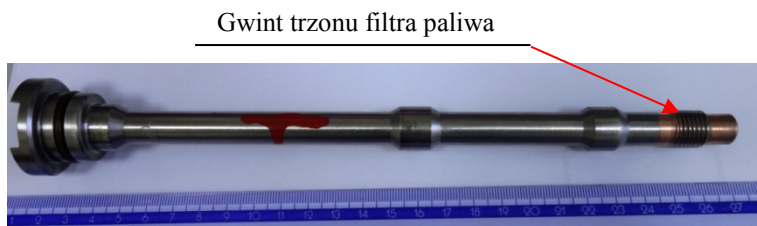
Rys. 1. Wycofany z eksploatacji trzon z filtra paliwa. Na gwincie widoczna powłoka galwaniczna, mająca poprawić własności trybologiczne
