CONSTRUCTION DISASTER HAZARD CAUSED BY A DEFECTIVE BUILDING STRUCTURAL SURVEY

Leopold KRUSZKA, Alicja OSTROWSKA¹

Faculty of Civil Engineering and Geodesy, Military University of Technology, Warsaw, Poland

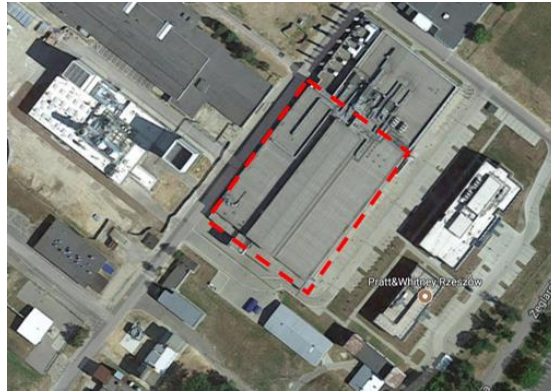
The reinforced concrete roof load-bearing structure of the F20 building was built in the 1950s. In study [11], the safety of the building roof load-bearing structure in question, rebuilt and extended between 2010 and 2011, was verified. The load-bearing capacity verification concerned the rebuilt part – Figure 1, not the extension, i.e. a three-aisle building with a footprint of approximately 4,200 m². The building features a three-aisle layout, with two side aisles approximately 9 m high and an approximately 14 m high central aisle.

Fig. 1. Location of building F20. The part rebuilt between 2009 and 2011 is marked in red [11]
