## INVESTIGATION INTO FATIGUE BEHAVIOUR OF METAL-COMPOSITE GLUE CONNECTION

**Mirosław Rodzewicz**

*Warsaw University of Technology, Poland*

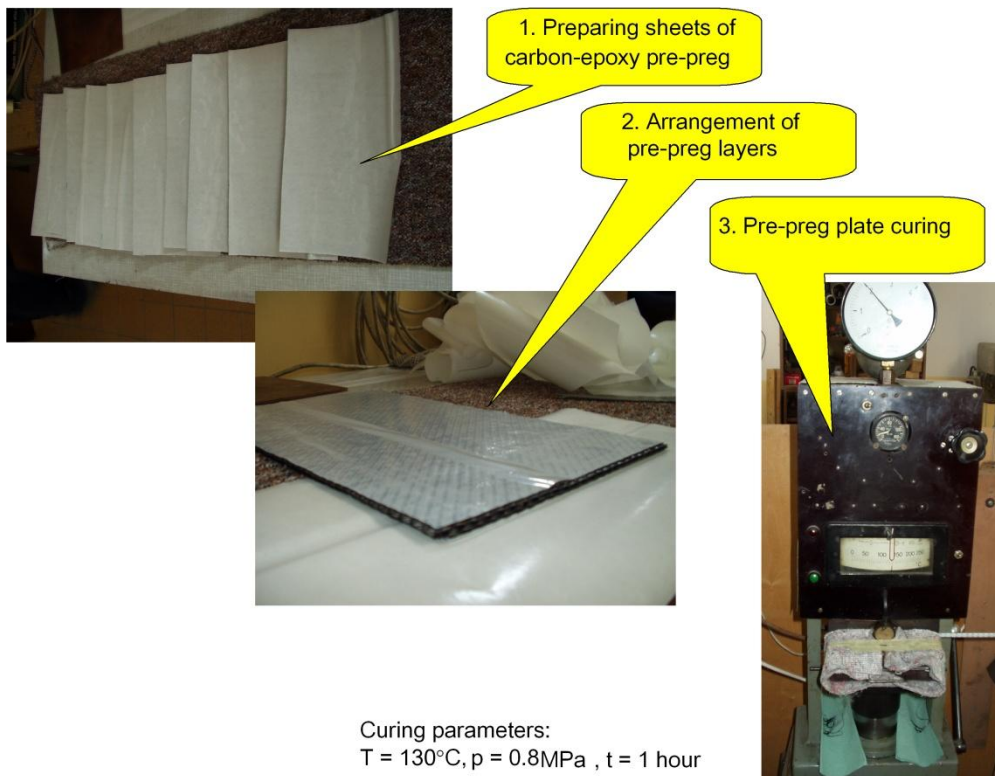
Figure 2 presents a the manufacturing process of the CFRP plate. The following key steps of the process are enumerated:

- preparing sheets of carbon-epoxy pre-pregs
- arranging the pre-preg layers
- curing on the press warmed up to 130°C and applying the pressure of 8 bars for 1 hour.

**Fig. 2. CFRP pre-preg plate manufacturing process**

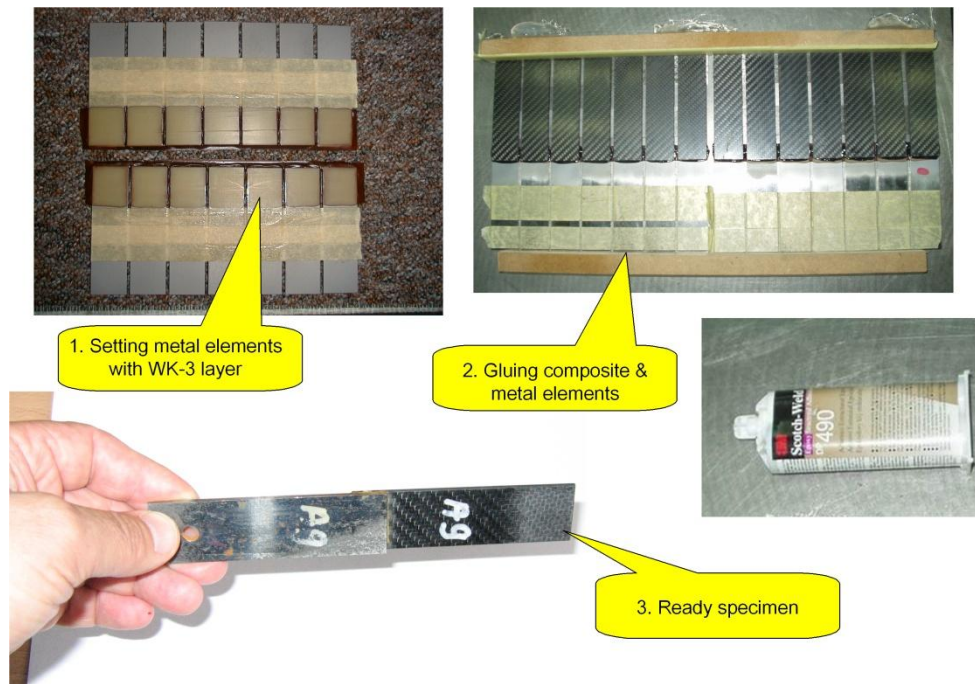
**Fig. 4. Manufacturing of the specimens –part 2/2**

The WK-3 adhesive needs more than 160 deg C for hardening so it is impossible to glue metal and composite at the same time as this temperature is critical for epoxy polymer. Therefore the process was divided into two stages: gluing and hardening the WK-3 adhesive on the metal sheets, and then gluing the composite sheets by means of an additional layer of liquid epoxy adhesive DP-490. Figure 3 presents the process of gluing WK-3 adhesive on the surface of metal sheets. The parameters of this process were:  $T=165\text{ deg C}$ , and pressure 10 bars for 1 hour. The process of integration of metal and epoxy sheets by use of DP-490 adhesive is illustrated by Fig. 4.

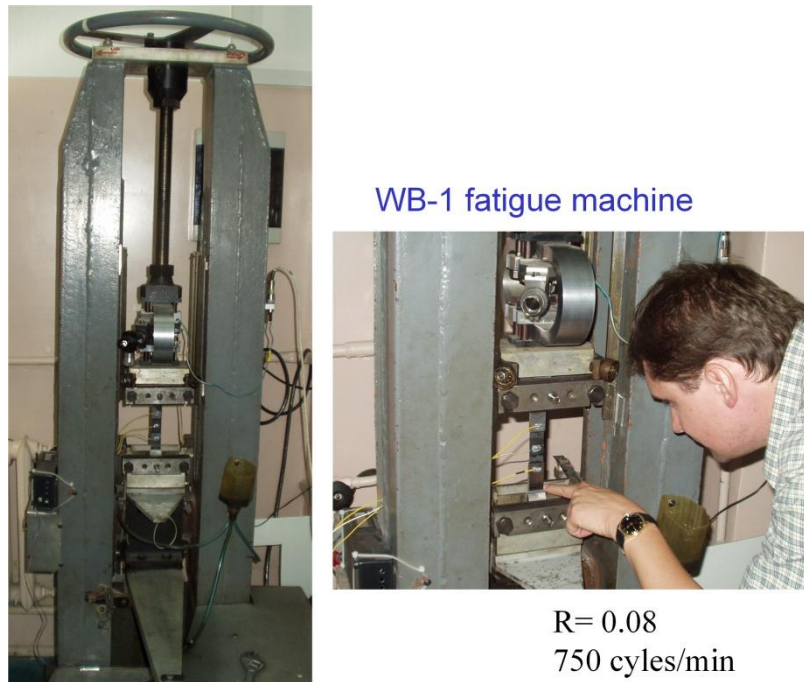
Fig. 5. Testing devices – part 1/2

Figures 5 and 6 present the fatigue devices. There were used two fatigue machines constructed at the Warsaw University of Technology. Both of them had the kinematical loading system, based on the adjustable eccentric mechanism with loading frequency of 750 cycles per minute. Normally, such loading frequency is too high for polymer composites (especially for GFRP composites), but it was checked before the tests that due to high thermal conductivity of carbon-epoxy composite - the increase in specimen temperature during the fatigue test was at the acceptable level. The bigger machine was the WB-1 fatigue machine, which was applied for double lap specimens. The smaller one was WB-2, which was applied for single lap specimens.

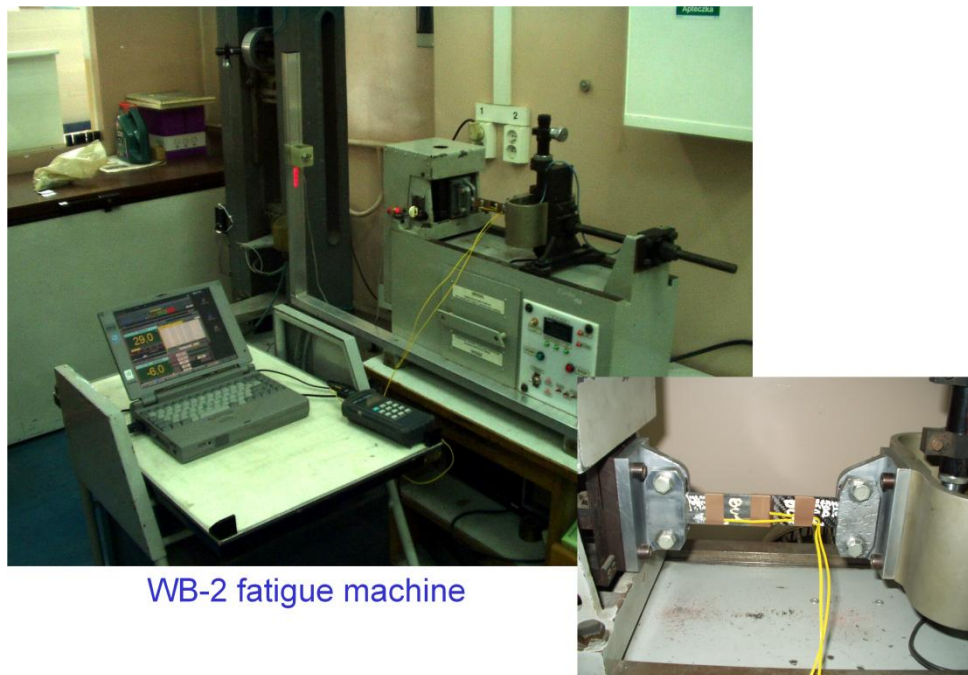
Fig. 6. Testing devices – part 2/2

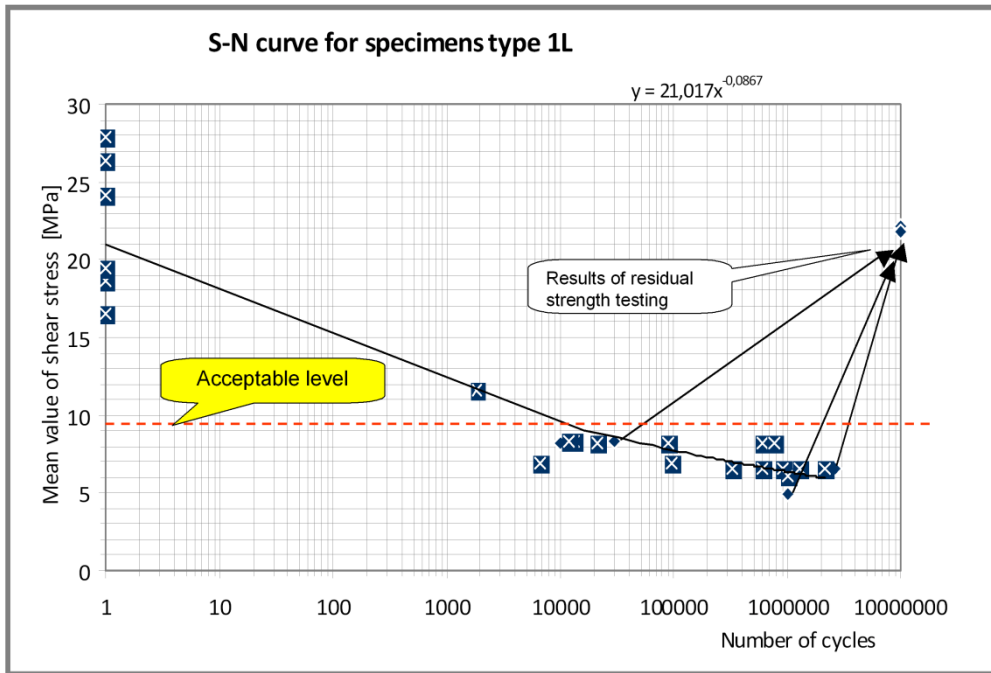
Fig. 7. S-N curve for single lap adhesive connection of metal and composite

Figures 7 and 8 present the S-N curves as the main result of the fatigue investigations. On the left edges of the charts there are presented the results of the static strength tests. On the right edges there are presented the results of the residual strength tests after the fatigue tests, which were performed for some specimens. The dotted line marks the acceptable level of glue connection strength (which was derived on the basis of catalog data for some different structural adhesives). As it can be seen - in the case of the single lap glue connection we have a significant number of results under this red line. When it comes to the double lap glue connection, the status quo looks different. The reason for this is symmetrical loading, which produces only shear stress in the glue, while in the case of the single lap glue connection there are existing also forces tearing off the glued elements.

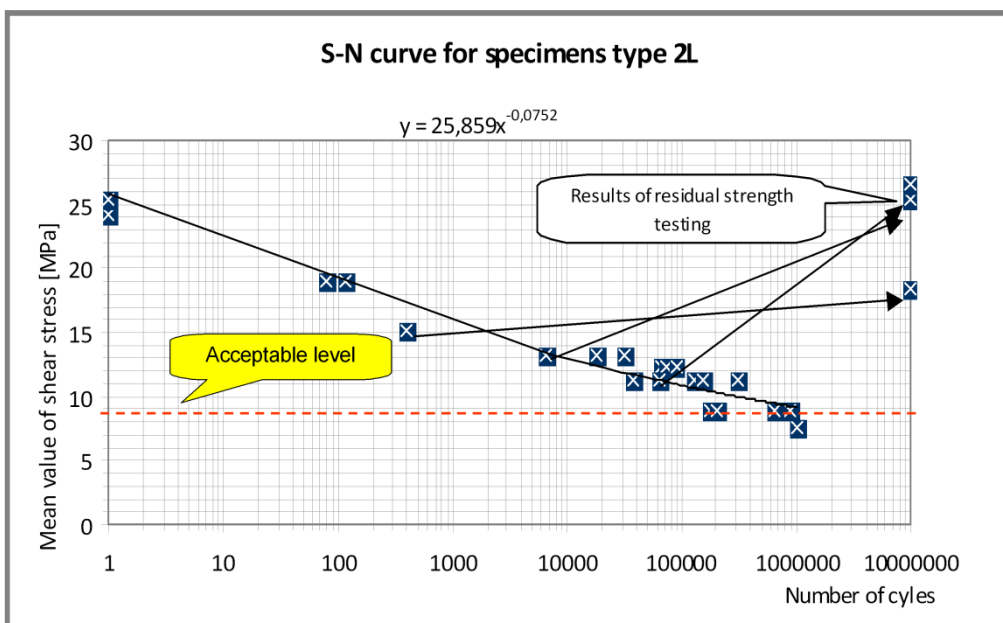
Fig. 8. S-N curve for double lap adhesive connection of metal and composite

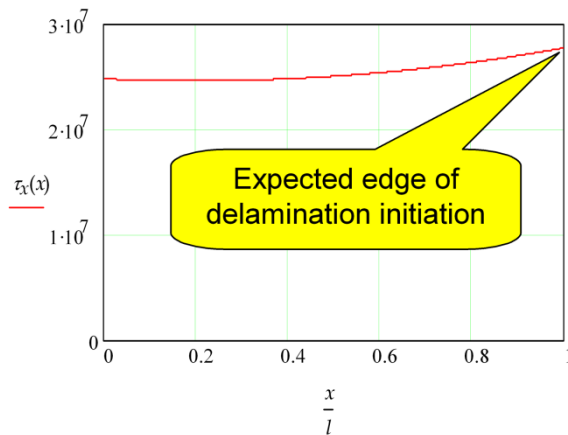
**Fig. 10. Shear stress distribution in the adhesive layer**

The second goal of the investigations was to observe the destruction process in the glued joints. For this purpose, there was made a theoretical analysis of the stresses in the glue connection (Fig.9). As the stiffness of metal and composite elements are different here, the edge of the glue-connection from the composite side is more loaded (Fig. 10), so one can expect that during the fatigue process the first damage will be observed exactly there.

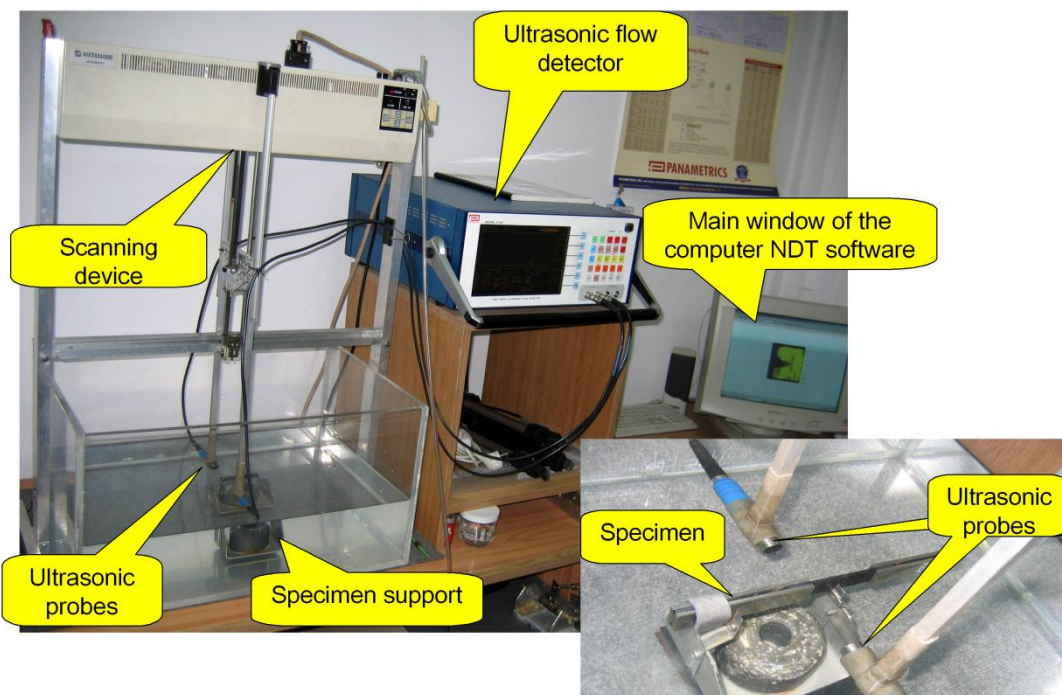
**Fig. 11. NDT testing facilities**

As a tool for this observation, there was prepared an ultrasonic scanner with a stand for immersion testing (Fig.11). The method applied was the “trough transmission” ultrasonic NDT-method.

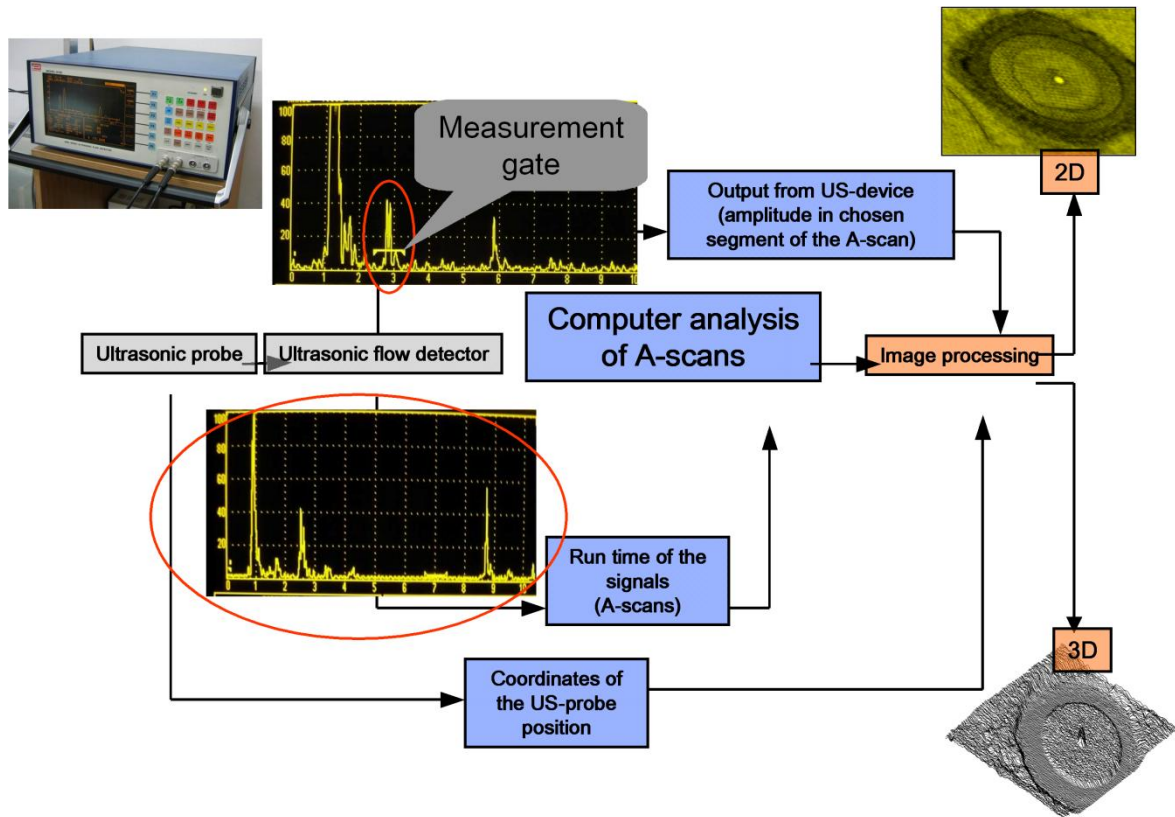
Fig. 12. Idea of images processing of ultrasonic inspection results

For the graphic presentation of the scanning results, the original software was used developed at the WUT [2]. The idea of the algorithm is explained in Fig. 12. As it is well known, the basic output from an ultrasonic flow detector is an A-scan obtained at a current point of tested specimen. It is possible to set the so-called “measurement gate” and to observe the amplitude of the signal in a chosen part of the A-scan, and to produce on this basis the 2-dimensional C-scans. It is the simplest way of generating the C-scan bitmaps. However, a much more effective method is to compare the whole scans by means of correlation function. This method is illustrated in Figure 13. In this case, A-scans made at the following scanned points of the specimen are compared with the template scan, which can be obtained from a specially chosen point of the same specimen. The maximum values of correlation function at the following scanned points are used in the software for making color C-scan bitmaps.

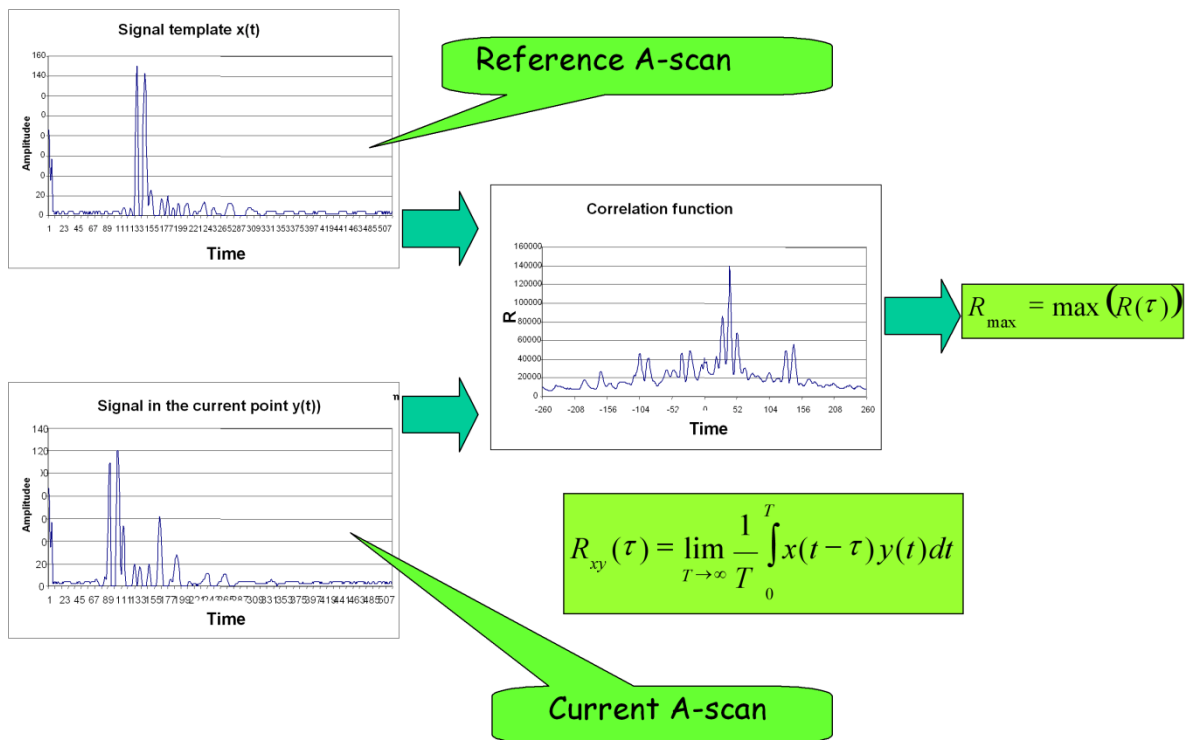
Fig. 13. Correlation function of A-scans and application values of correlation coefficients for processing the C-scan bitmaps

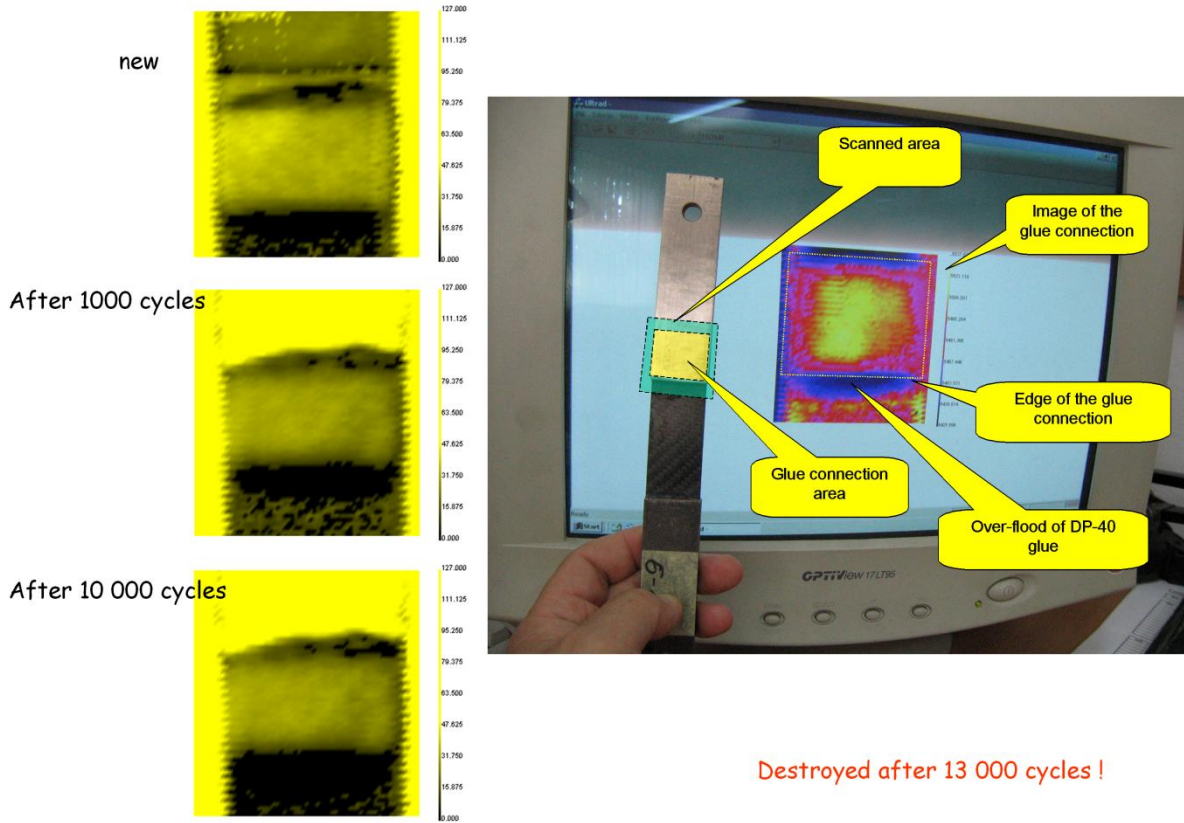
*Fig. 14. C-scans based on amplitude in the measurement gate*

Figure 14 presents an example of typical scans of the single lap specimen made at different stages of the fatigue test. All images in this figure are based on the amplitude in the measurement gate. What is very important at first glance: any delamination is visible on the edge of the glue-connection from the composite side, even at the advanced stage of the fatigue process.

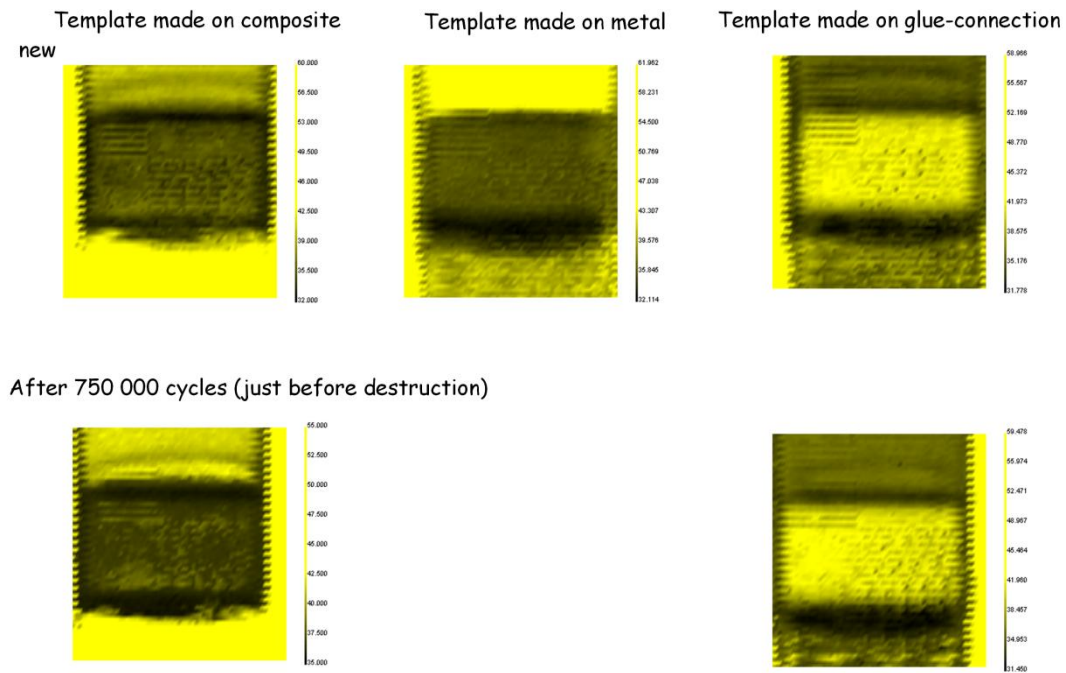
Destroyed after 753 000 cycles !

Fig. 16. Images obtained from correlation method

In the case of Figure 16, the specimen was destroyed after 753 thousand cycles, while the last scanning was done after 750 thousand load cycles. Again, no delamination on the edge of the glue-connection from the composite side appears. Such a behavior was typical of the majority of tested specimens.

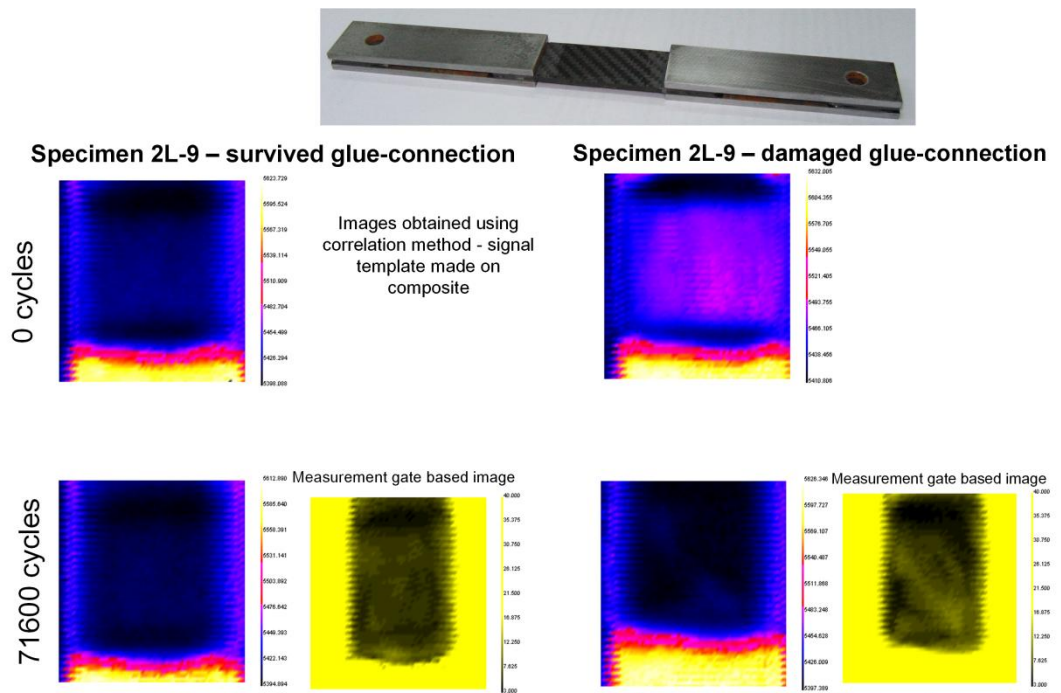
Glue connection just before destroying !!!

Fig. 17. Visible delamination zones just before specimen destruction

Figure 17 presents very interesting case as the fatigue process of the specimen was stopped just before destruction. Only in this particular case, on the C-scans there are visible the delamination zones in the two opposite corners of the glue lap.

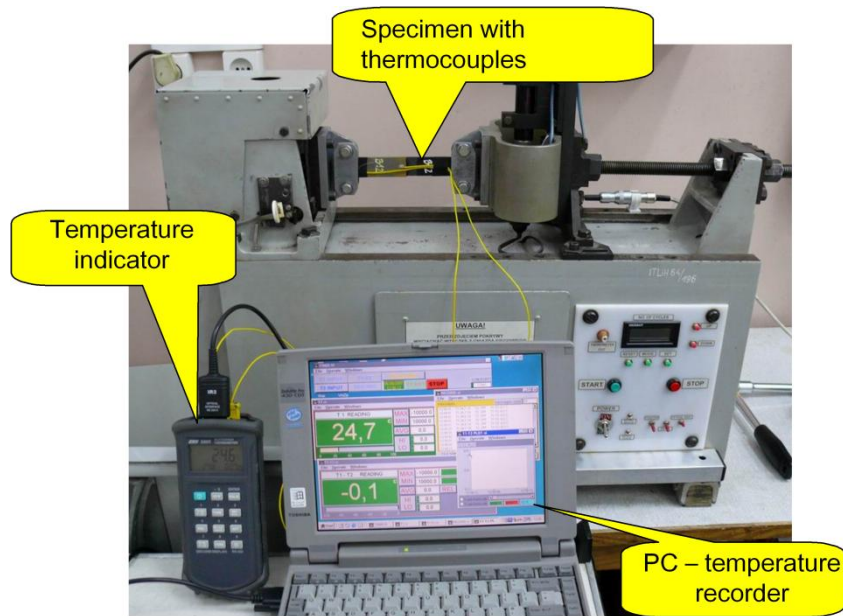
*Fig. 18. Instrumentation for heat effect investigation*

One can ask how to detect that the fatigue life of a specimen is approaching an end? This question refers to another interesting finding of those investigations. It is a heat effect, caused by energy dissipation in the glued joint during cycle loading. To be able to observe this effect, small thermocouples were glued to some chosen points of the tested specimens. During the first test - the thermocouples were glued mainly to the top surfaces of the specimen, but for better accuracy of temperature measurement in the layer of the glue, the thermocouples were glued on the side-edge of the specimens in remaining tests (Fig. 19).

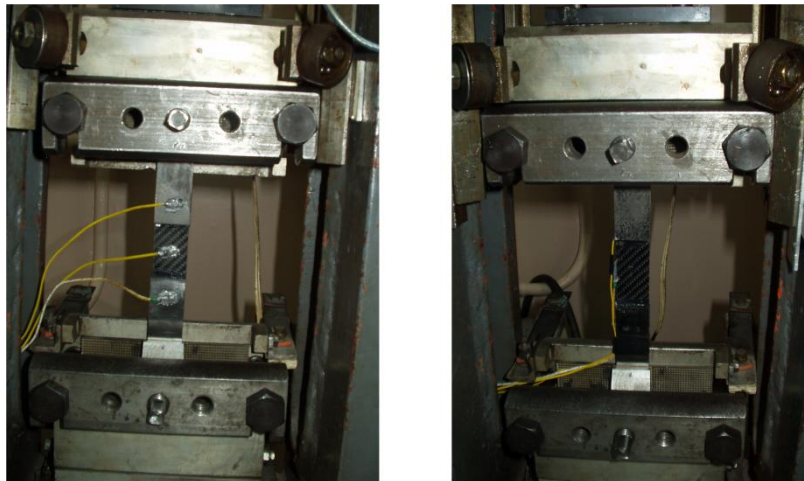
*Fig. 19. Location of thermocouples in the double-lap joints*

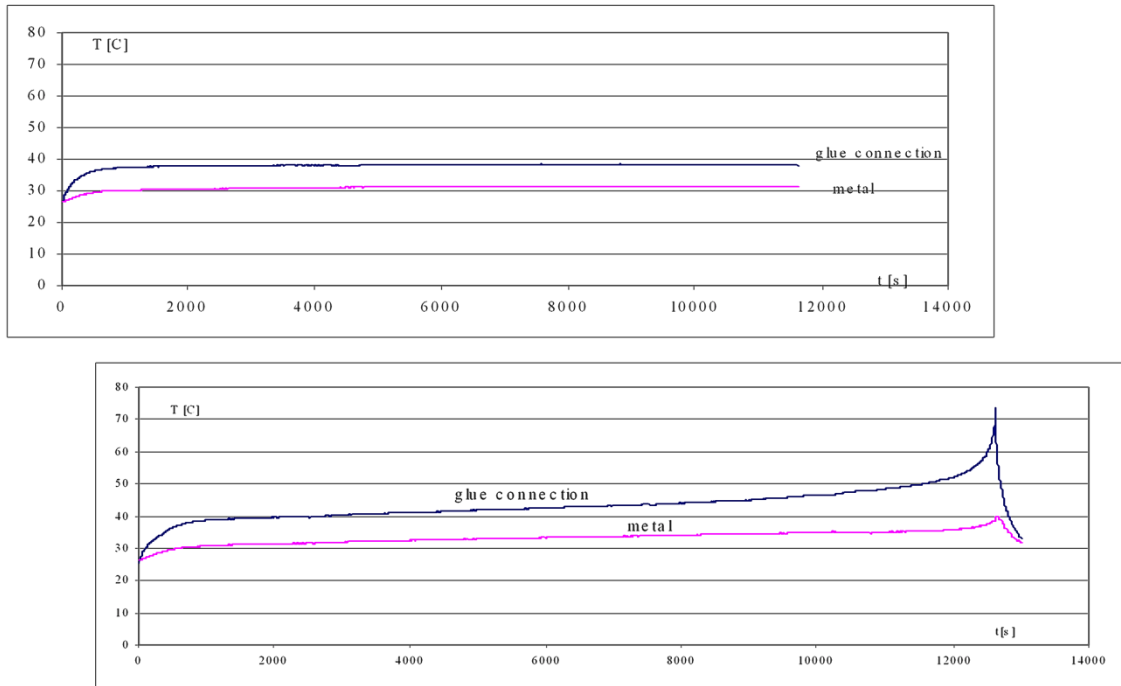
Fig. 20. Difference of temperature gradients for early and final phases of fatigue process of a single-lap specimen

Figure 20 presents the temperature versus time charts for a chosen single-lap specimen. The upper chart was made at the early stage of fatigue testing while the lower chart was made at the final stage. Analysis of those charts reveals an interesting feature of the temperature gradient, which slowly increases when the glued joint is more fatigued. But just close to the moment of destruction of the glued joint - the temperature gradient rises very rapidly. This symptom was used for the prediction that the fatigue life of the specimen is close to an end. The same behavior was observed also during testing the double-lap joints. The temperature chart for a double-lap

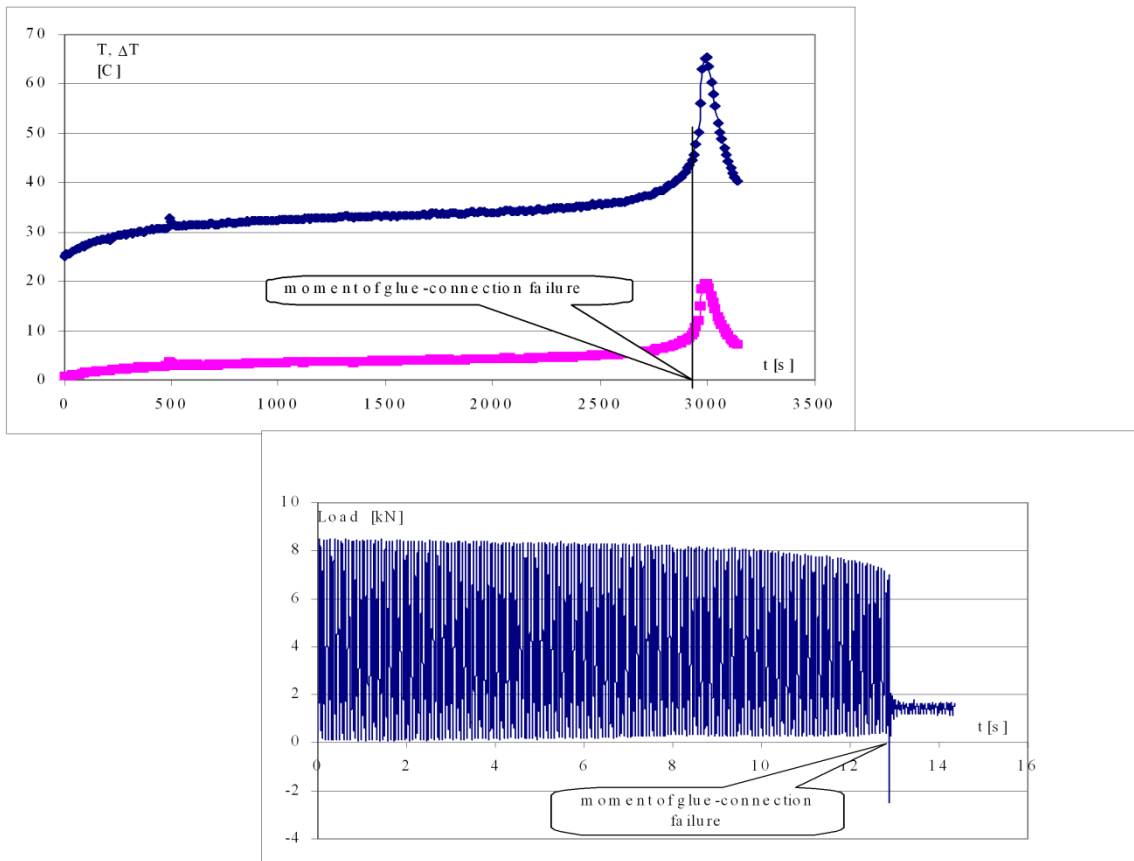
Fig. 21. Heat effect investigation for a double-lap specimen

specimen is presented in Fig. 21. As it can be seen from the chart, the maximum temperature was obtained not before the destruction, but several cycles later. It was due to the inertia of the fatigue machine, which cannot be stopped rapidly, so some cycles are made on the damaged specimen, producing huge friction.

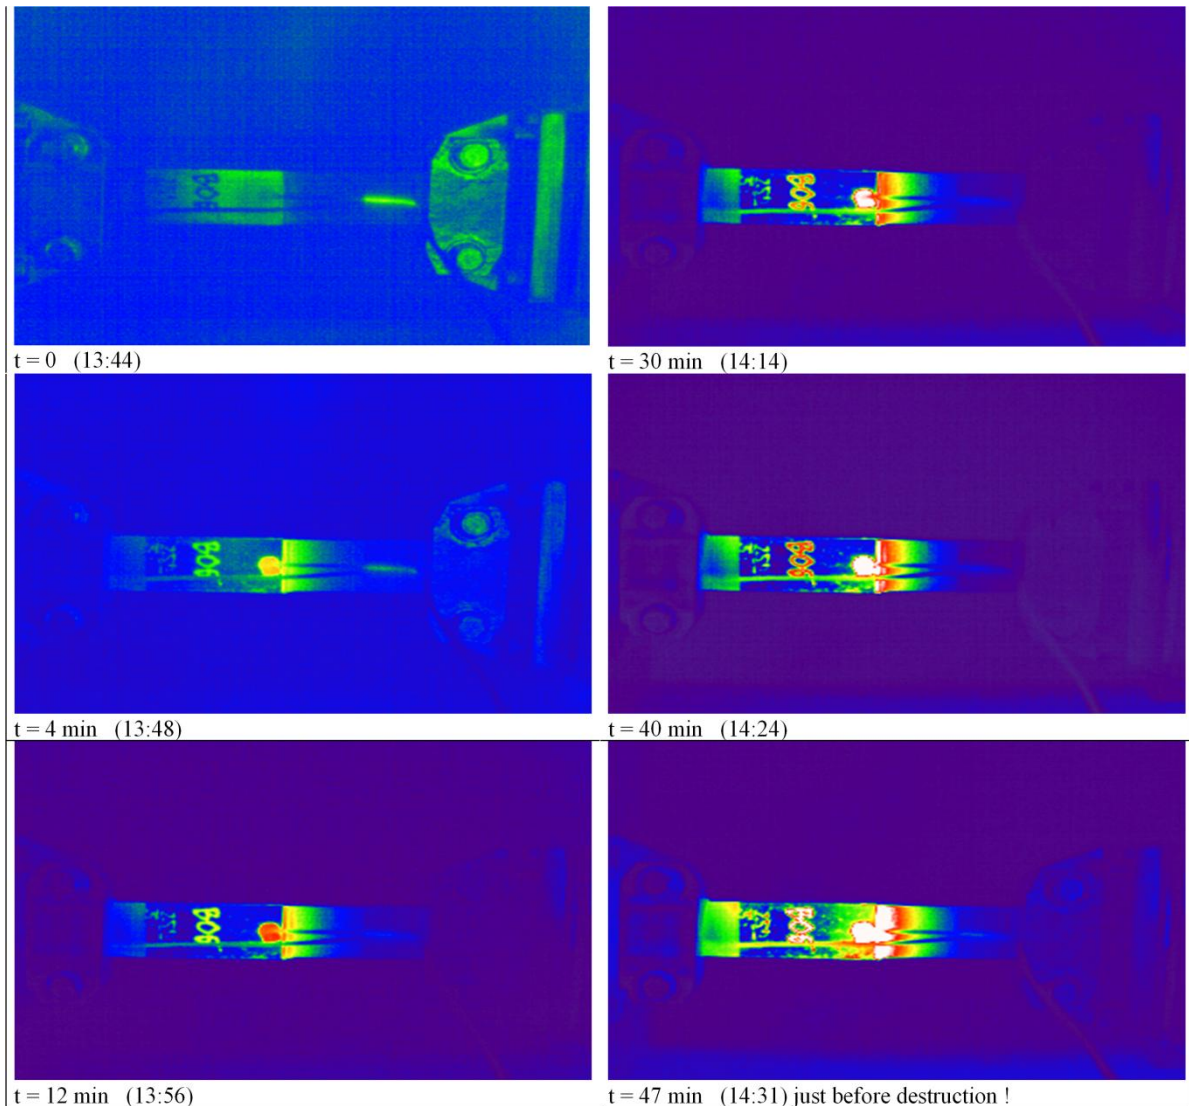
*Fig. 22. Thermo-vision images taken during the fatigue tests*

Figure 22 contains some images of the specimen made by an infra-red camera, which confirm that the temperature in the glue-lap is increasing very significantly before the specimen destruction. It was an extra test, and for speeding up the fatigue effect - the R value was changed to  $-1$  for this particular specimen.

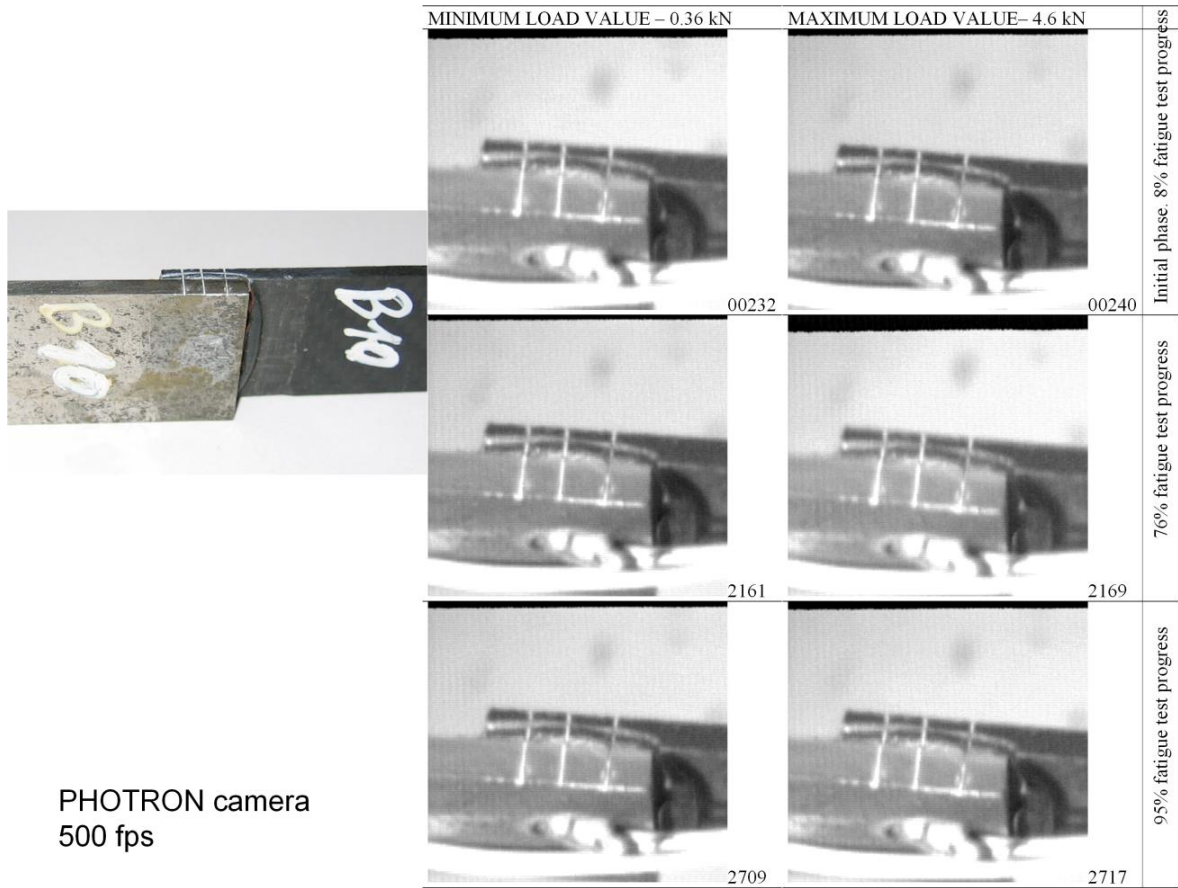
Fig. 23. Early phase of fatigue test

The process of stiffness deterioration just before specimen destruction - was observed also by means of a fast camera. For this purpose, 3 white line segments were marked on the side edge of the specimen. Fig. 23 shows the set of image couples made for minimum load and for maximum load. The index in the bottom of each picture indicates the sequence number of the picture.

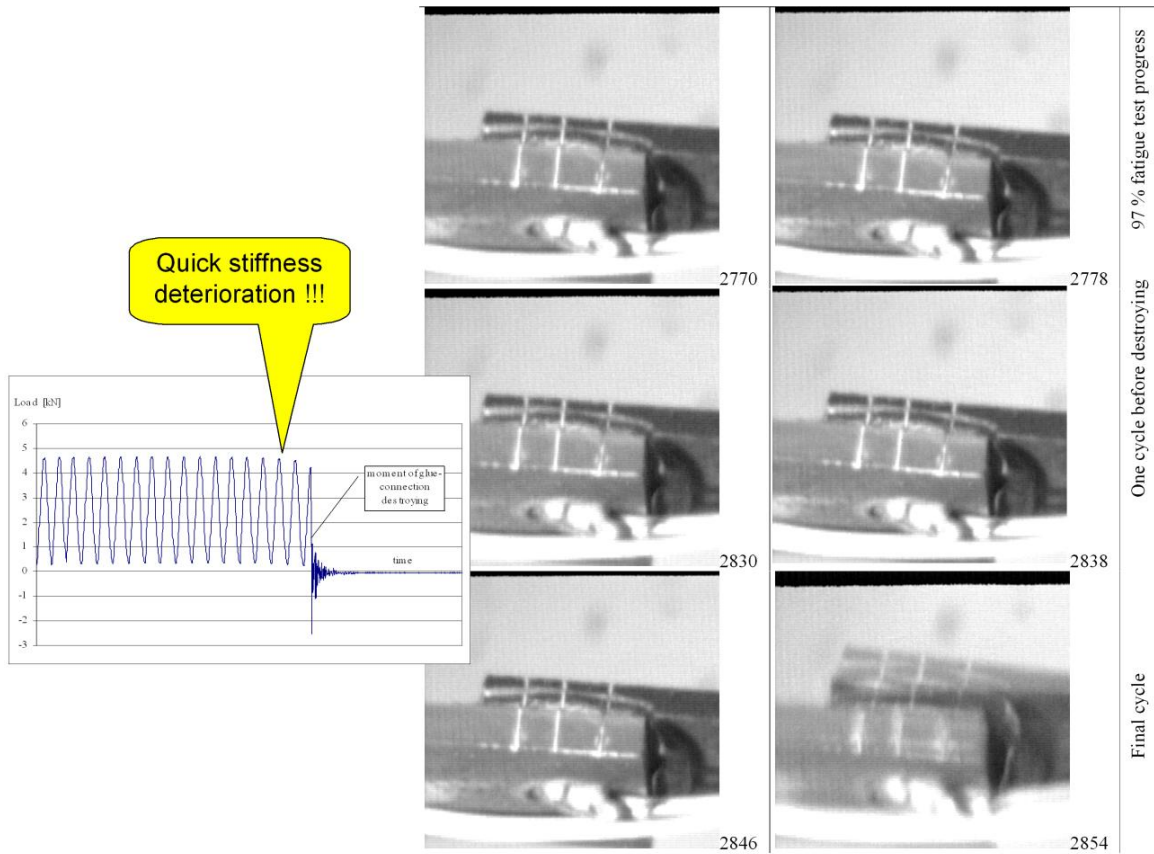
Fig. 24. Final phase of fatigue test

At the beginning of the fatigue test the displacement of glued elements was insignificant and difficult to detect. But near the end of fatigue life the displacement was very visible. The last picture is made exactly at the moment of specimen destruction. Figure 24 contains the chart with load history recorded in the last phase of fatigue. The effect of stiffness deterioration is clearly visible there.

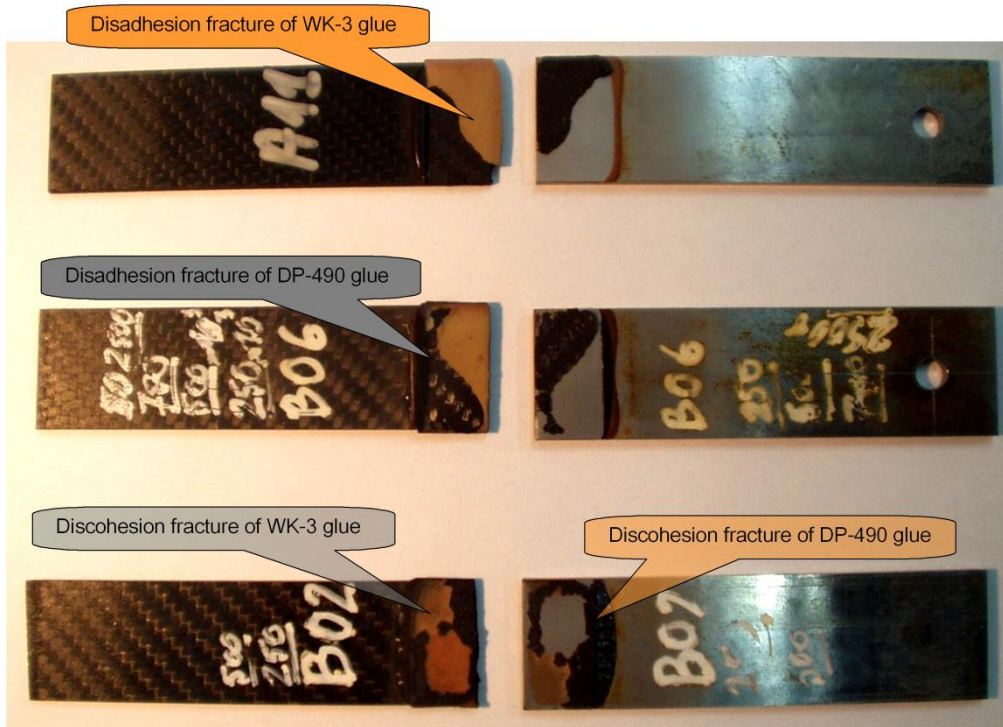
**Fig. 25. Fracture modes of the single-lap specimens**

Two fracture modes were observed during the tests for both adhesives WK-3 and DP-490: disadhesion and discohesion (Fig. 25).

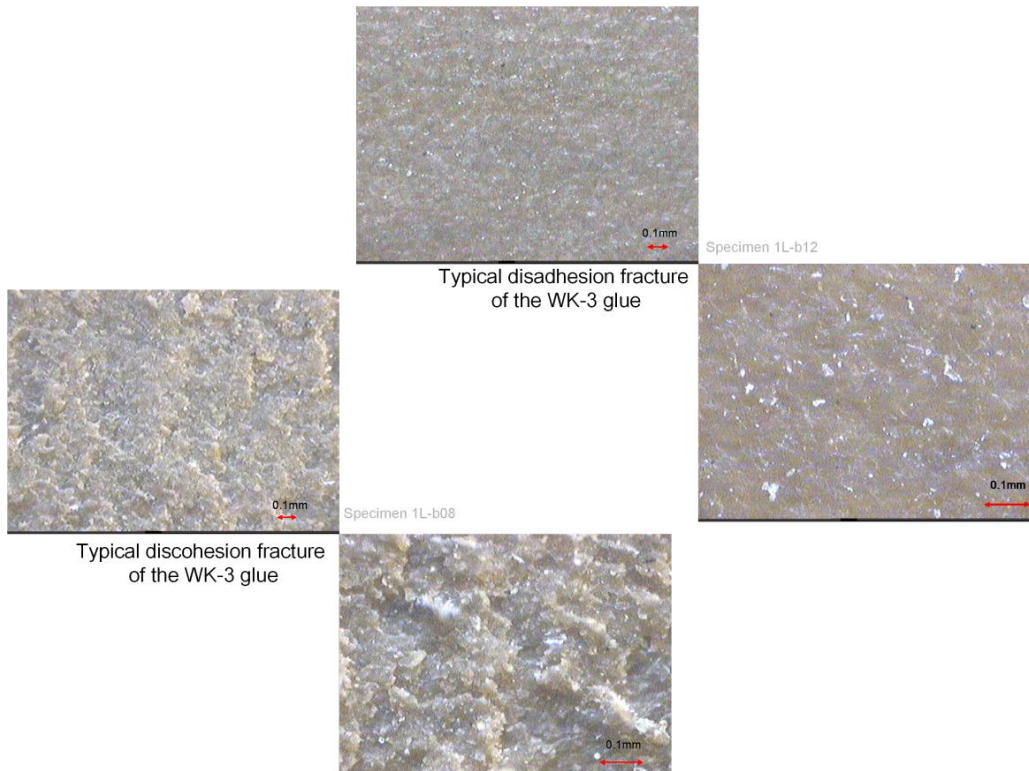
**Fig. 26. Microscopic pictures of the WK-3 glue fracture**

Figures 26 presents microscopic images of typical disadhesion fracture, and typical discohesion fracture of the WK-3 glue.
