WIESŁAW OSTACHOWICZ,<sup>1</sup> TOMASZ WANDOWSKI, PAWEŁ MALINOWSKI

## Principles of piezo-based machinery health monitoring

*The Szewalski Institute of Fluid-Flow Machinery of the Polish Academy of Sciences, Mechanics of Intelligent Structures Department, Fiszerza 14, 80-231 Gdańsk, Poland*

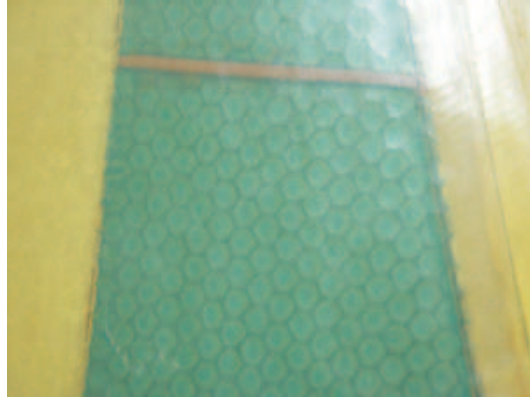
Figure 7: Visible internal structure of helicopter main rotor blade.

Next step was related to the analysis of elastic wave propagation in composite panel of real engineering structure. In this research a fragment of a helicopter main rotor blade was used. This blade had a complex internal structure which consists of GFRP skin, GFRP I-section, honeycomb core and stiffeners (Fig. 7). The considered blade before measurements was covered by retro-reflective tape in order to enhance reflected laser signal of vibrometer. The wave signals were collected for two excitation frequencies 16 kHz and 50 kHz. Based on these signals RMS energy maps were created (Fig. 8). Analysing results for excitation frequency 16 kHz it can be seen that details of internal structure of the composite blade are accurately visualized. Due to elastic wave interaction with honeycomb core its cells can be clearly recognized. Elastic wave has been generated near the lower edge of blade on the left hand side. This place can be clearly visible on RMS maps because there is a maximum amplitude of the energy distribution. In the considered area composite profile is located that creating leading edge of the blade. The main part of wave energy is distributed in the leading edge profile. It means that waves propagate mainly along this part. The smaller part of energy distribution is related to the propagation outside
