## FIRES OF PASSENGER CARS IN POLAND

The main causes of fires of passengers car in Poland were presented in this paper. The paper depicts results of tests of the development of passenger car fires. Temperature measurements were taken with the use of thermocouples, an infrared pyrometer and a thermal camera.

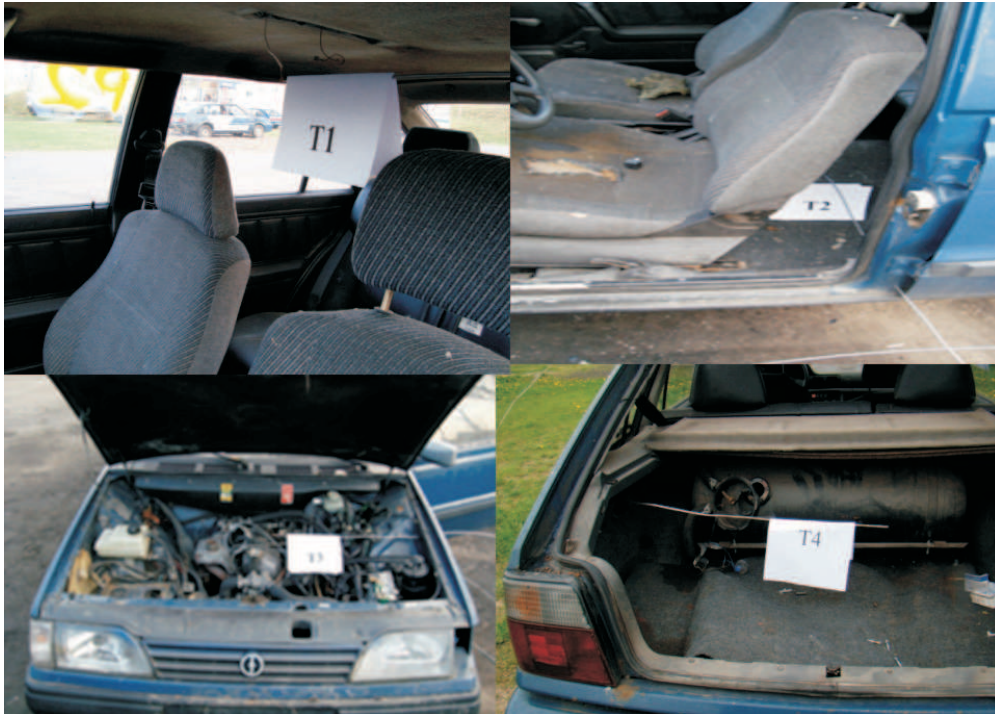
*Fig. 2. Location of the thermocouple in a car*

The tests are carried out to determine the development of a passenger car fire, using a thermal camera and an infrared pyrometer for temperature measurements. Temperatures are also measured by means of thermocouples (Fig. 2). In the first experiment, the fires of three passenger cars were simulated. The experiment was carried out at a parking lot in the windless and rainless weather conditions, at an ambient temperature of about 20°C. The temperature was continuously measured by means of K type thermocouples, the infrared pyrometer Raytek PM50 and the thermal camera VIGOCam V50. Two thermocouples were placed inside the car at the highest and lowest points of its interior, one was situated inside the engine chamber in the middle, about 2 cm over the valve cover, and another in the boot (Fig. 2). The pyrometer was used to measure the temperature of the external surface of the car door, under the window pane. The tests were carried out at the Sub-officer School of the State Fire Service in Bydgoszcz. In the course of the experiment, three FSO Polonez cars with complete equipment were burned.

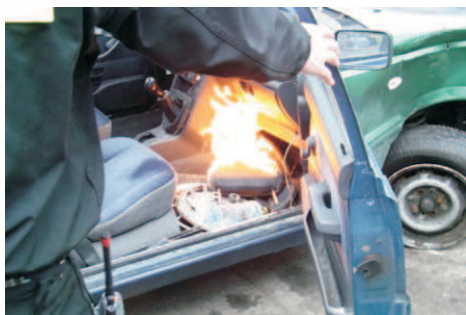
Car A

*Fig. 3. The seat of the fire*

A fire was started inside car A, by lighting a petrol-saturated sponge placed on the floor under the dashboard, in front of the passenger seat (Fig. 3). After five minutes the rear doors were opened, since the fire diminished. At car B, a fire was started near the engine, by lighting a tray with a fuel on a cushion pool, placed on the road under the engine. At car C, a fire was started inside the car, just as in the case of car A, and its course was observed with closed windows.

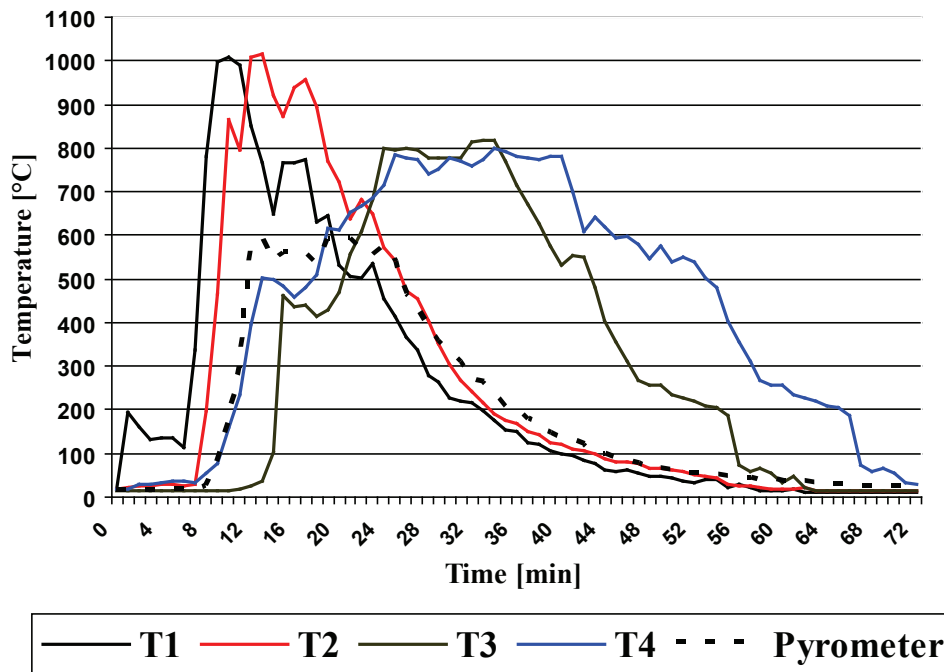
Fig. 5. The temperature dependence on the fire duration for car A, measured by thermocouples: T1 (top), T2 (bottom), T3 (engine), T4 (boot) and the infrared pyrometer

The figure shows a very fast temperature increase in the car cabin up to about 1000°C. After this temperature had been reached, in a matter of several minutes the fire almost to the whole car. The dynamics of the fire and temperature were higher inside the cabin than in the engine chamber and the boot. Probably, it was so because in a short time the window panes were damaged and there was a good air supply. The course of the fire in the engine chamber and the boot was less dynamic and reached a lower temperature, of about 800°C, which persisted for about 20 minutes.

Fig. 5 shows the temperature dependence on the fire duration, measured by thermocouples placed as in Fig. 1: T1 (top), T2 (bottom), T3 (engine) and T4 (boot), and the infrared pyrometer (the front door under the window pane) for car A.

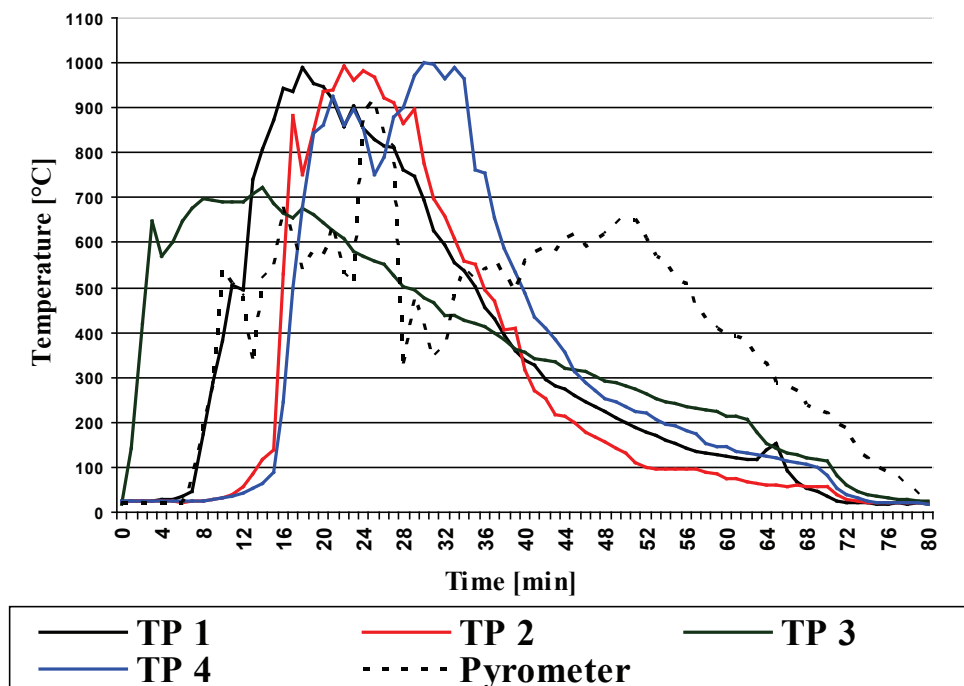
Fig. 6. The temperature dependence on the fire duration for car B, measured by thermocouples: T1 (top), T2 (bottom), T3 (engine), T4 (boot) and the infrared pyrometer

The fire in car B was initiated in the engine chamber. At the beginning the fire developed under the hood, then spread into the car interior and at the end to the boot. Values of the fire temperature were similar as for the fire of car A.

Fig. 6 shows the temperature dependence on the fire duration, measured by thermocouples placed as in Fig. 2: T1 (top), T2 (bottom), T3 (engine) and T4 (boot), and the infrared pyrometer (the front door under the window pane) for car B.

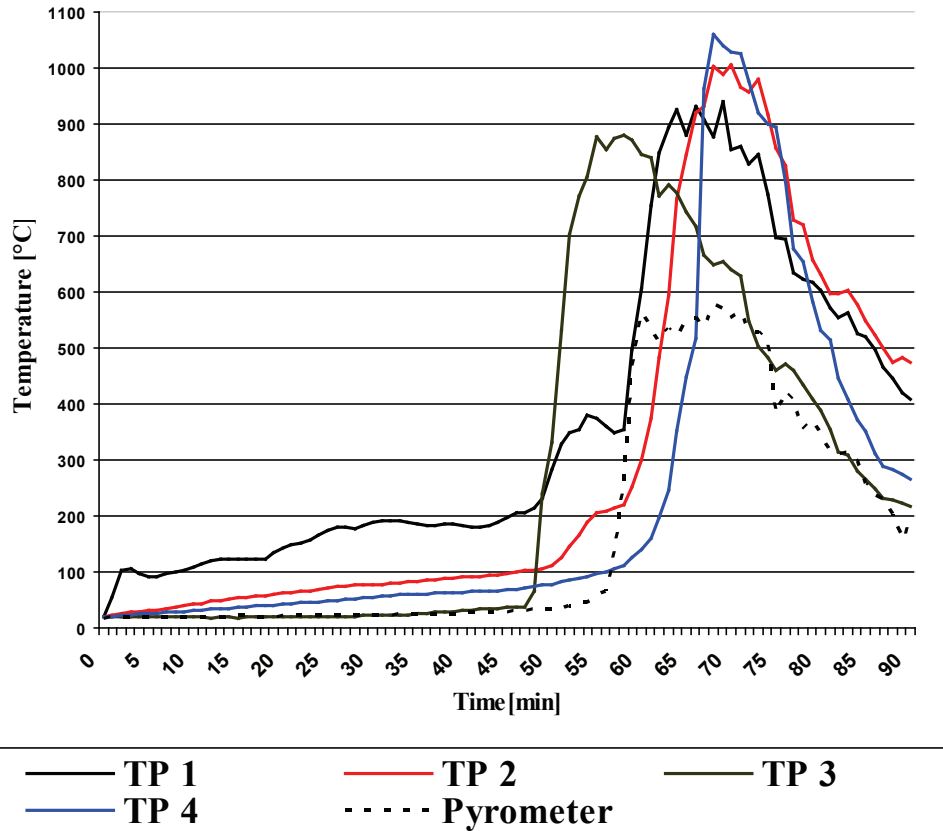
Fig. 7. The temperature dependence on the fire duration for car C, measured by thermocouples: T1 (top), T2 (bottom), T3 (engine), T4 (boot) and the infrared pyrometer

Fig. 7 shows the temperature dependence on the fire duration, measured by thermocouples placed as in Fig. 2: T1 (top), T2 (bottom), T3 (engine) and T4 (boot), and the infrared pyrometer (the front door under the window pane) for car C. The temperature inside grows very slowly. Only after ca. 50 minutes, once the temperature grew above 200°C, the window panes became unsealed which led to a dynamic temperature growth.

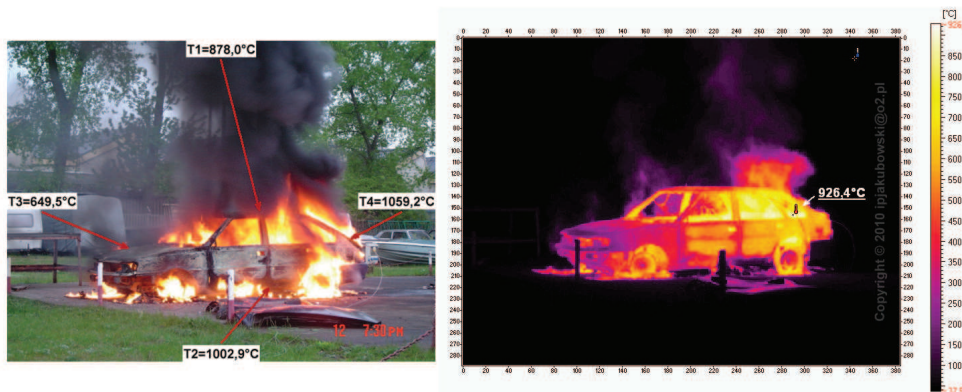
*Fig. 8. The photo and the thermagram of burning car*

The figure 8 presents a photo and thermagram of burning car C in the 68<sup>th</sup> minute from the fire beginning.
