## Safety Management on Ro-Ro Passenger Ships

**ABSTRACT:** To define the safety management on Ro-Ro passenger ship, the wide spectrum of captain's responsibilities should be taken into consideration. One of the important responsibilities is the ship's stability examination. The other measures as the ship's condition, wind on ship with large windage area, rolling characteristics, severe seas etc., are important for ensuring the safe operating of ship, to minimize the risk to the ship, to the personnel and passengers on board, and to the environment. The international convention for the Safety Of Life At Sea – (SOLAS 90) make into fact the continual development of safety standards in the 111 years since the sinking of the Titanic. Important enhancement stability, operational requirements and damage stability requirements were made as a consequence of several disasters at sea: "Torrey Canyon" in 1967, "Herald of Free Enterprise" in 1987 (183 dead), "Exon Valdez" in 1989, "Braer" in 1993, "Estonia" in 1994 (892 dead).

The presented paper describes the results of practical use of the stability calculations and damage stability calculations for the RO-RO/Passenger vessel M/F "Polonia"

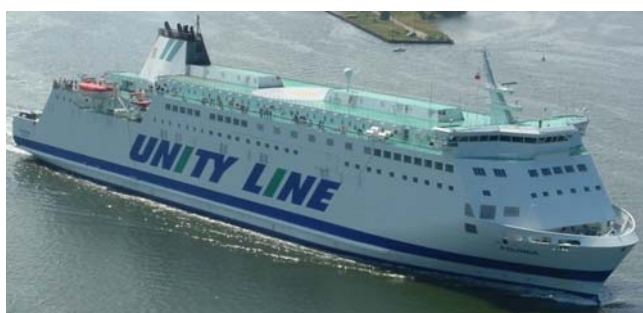
The said vessel is shown in Fig.1 .

Figure 1 M/F "Polonia" (by UNITY LINE)

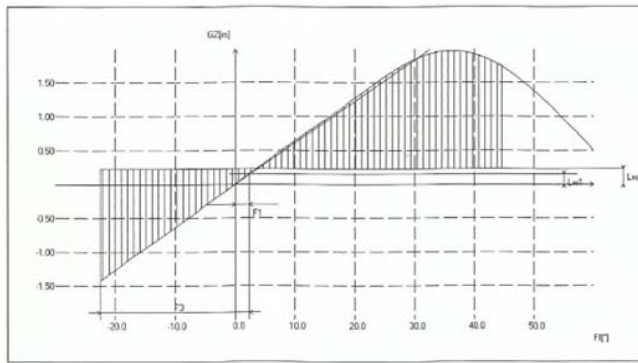
Fi 5 10 20 30 40 50 60 70  
 GZ 0.318 0.637 1.264 1.844 1.926 1.378 0.491 -0.598  
 Figure 3. The righting levers curve.

Stability Criteria	Actual	Required
GZmax value	GZmax = 1.97 m	0.20 m
GZmax angle	Fi = 36.25°	30.00°
Metacentric height corr.	GMc = 3.51 m	2.98 m
Area under GZ up to 30°	A30° = 0.493 mrad	0.055mrad
Area under GZ up to 40°	A40° = 0.835 mrad	0.090mrad
Area between 30°-40°	A30°-40°=0.342mrad	0.030mrad
Angle of heel due to crowding of passengers	Ap = 0.93°	10.00°
Angle of heel due to turning	At = 3.17°	10.00°
IMO Weather Criterion	K = 2.198	1.00
Heeling lever of lateral wind force	Lw1 = 0.148 m	
Angle of roll to windward due to wind action	F1 = 24.74°	
Angle of downflooding	FiD = 44.6°	
List	Fi = 0.1°
