## TESTING OF COMPOSITE PANELS USED AS COMPONENTS OF A FREIGHT WAGON BY THERMOVISION

**Key words:** Thermovision, Components, Testing, Panels, Imaging Method

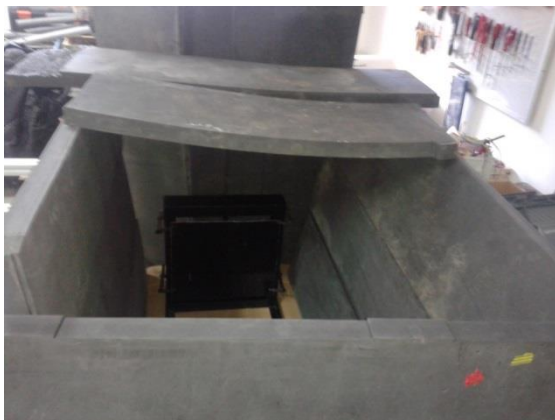
The tested samples were inserted to the black chamber made of an open cell polyurethane foam, length of 1 meter and a width of 0.5 meter, presented in Fig. 1.

**Fig. 1.** The laboratory stand with tested sample placed in the black chamber

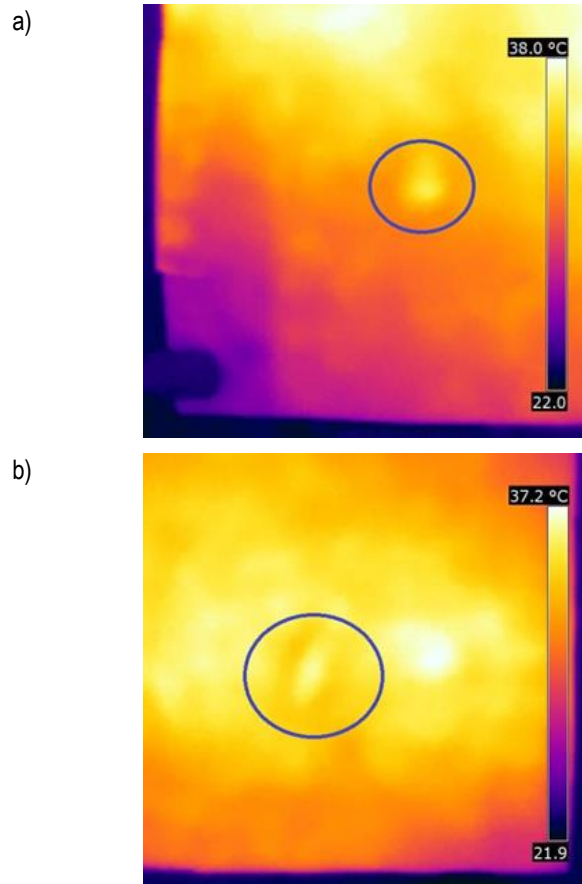
In case of studies with the division of laminate for parts (Fig. 2a,b.), it may be noticed more damages. Basic damage that thermography method detects is a delamination. They are visible in the case of heating from both, the front and back side, but the manner of their representation is different. If you set the lamp on the same side as the camera, delamination is seen as spots of higher temperature than the area around the damage. When the back of the laminate is heated, the thermograms show that delamination of a surface part of lower temperature. The thermogram (Fig.2) shows them as places with higher temperatures, but in addition it is surrounded by surface with lower temperature. The photos do not show the large transverse crack. It is too shallow.

**Fig. 2.** The thermograms obtained while panel's testing 1: a) III quarter heated from the front, b) IV quarter heated from the front

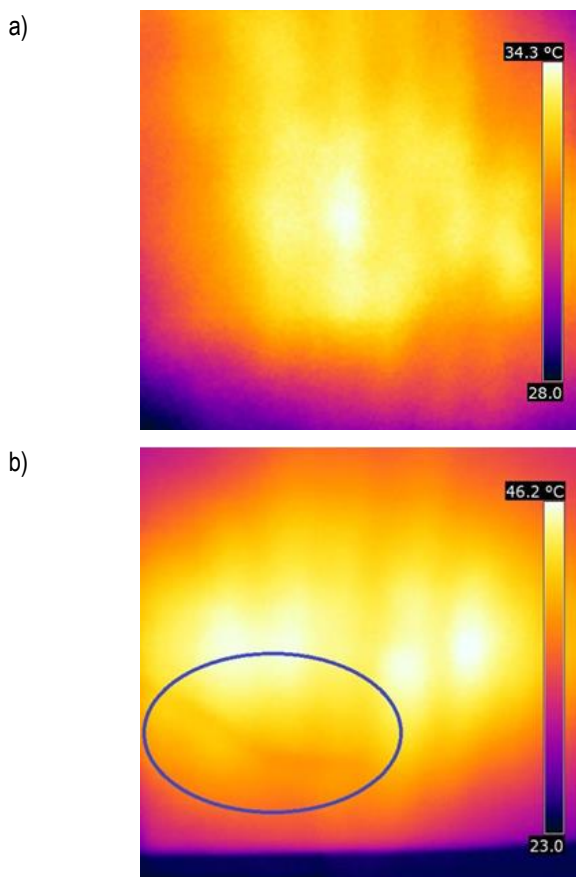
**Fig. 3.** The thermograms obtained through the test of panel no 2:  
a) III quarter heated from back, b) IV quarter heated from back side

The thermograms shown in Fig. 3, describing a case of studies of the panel no. 2, similarly as in the case of the laminate no 1, the defects cannot be located by using photos of the entire panels. Defects are visible only in the case of the panel heating, divided into four parts. On the thermograms vertical stripes of lower temperature are visible. These are the effects of applying a gel coat with a brush. On the side edges of the paintbrush, band of the higher thickness of the gel coat were formed, which afterward were heated less. Furthermore, the thermogram presented on Fig. 3 b) shows a small delamination, but the cracks are already noticeable around it. In addition to these defects, the infrared method gives the feasibility of a change in a number of layers. An example of this is the thermogram of Fig. 3b) where it is clearly visible thin band running across the panel. This is part of the fiber that had to imitate change in the number of layers. Panel no. 2 was of much better quality than panel no 1 and for this reason, there is much less damage visible through the thermal camera.

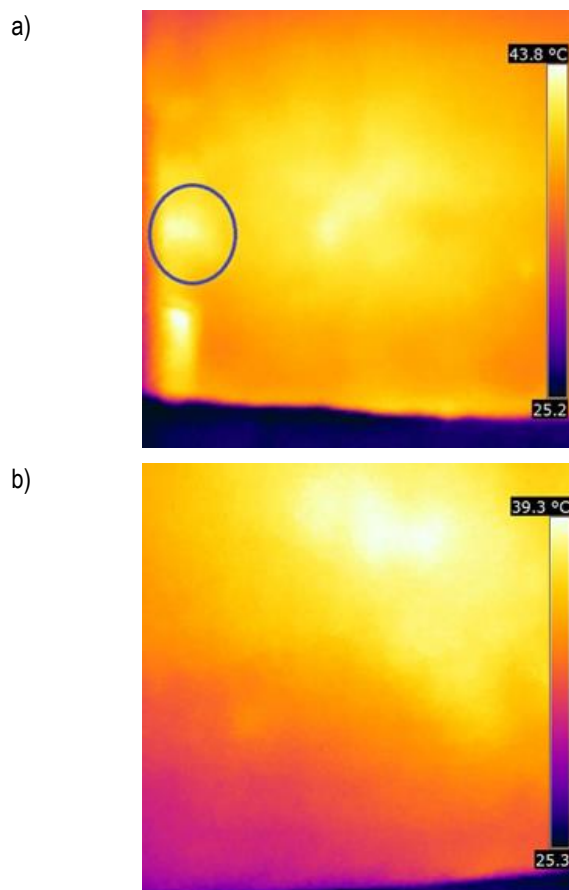
On the thermograms obtained from testing of panel no 3, contrary to appearances, and previous studies, most can be identified on the basis of photos of sub-paragraph 3. b). It can be observed on it the band of lower temperature running on the bottom. This is an area where the amount of resin was correct. However above this place, it was too much of resin. Furthermore, the laminate no 3 contained defects in the form of the local, too small saturation of resin and it is also shown on thermographs depicting the entire panels. Apart from these defects, images obtained in the case of heating from the back side, show some minor delamination. Panel damage of this panel was much more, but low emission of plate made it impossible to obtain accurate results.

**Fig. 4.** The thermograms obtained with the test panel no 3: a) III quarter heated from back, b) IV quarter heated from back side

The thermograms obtained while heating the front side differ from those heated from the back. This is due to the difference in emissivity of the surface, because the front was shinier (smooth) than the back. The measurement results are reproducible. During the heating and cooling plates, temperature measurement error in all the samples of the same batch does not exceed 8%.
