MIROSLAW JURDZIŃSKI
Gdynia Maritime University, Poland

CAUSES OF SHIPS GROUNDINGS IN TERMS OF INTEGRATED NAVIGATION MODEL

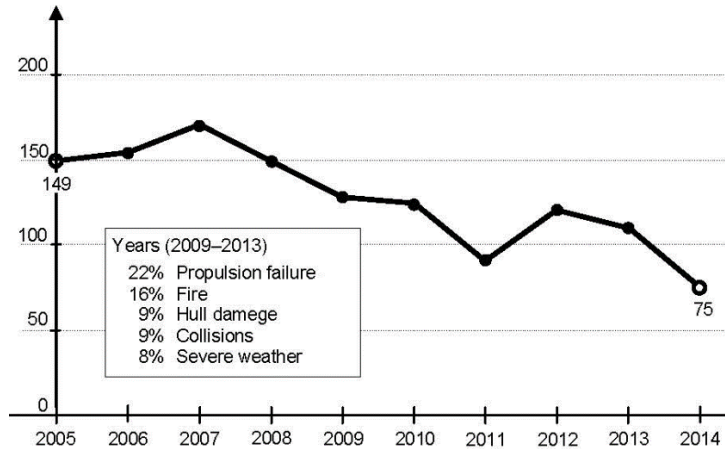
Fig. 1. Total losses of large vessels from 2009 to 2013 [Bužančić-Primorac, Parunov, 2016]

The number of total ships losses is getting smaller. Figure 1 shows the graph presenting the losses of large vessels from 2005 to 2014 [Bužańczyć-Primorac, Parunov, 2016].

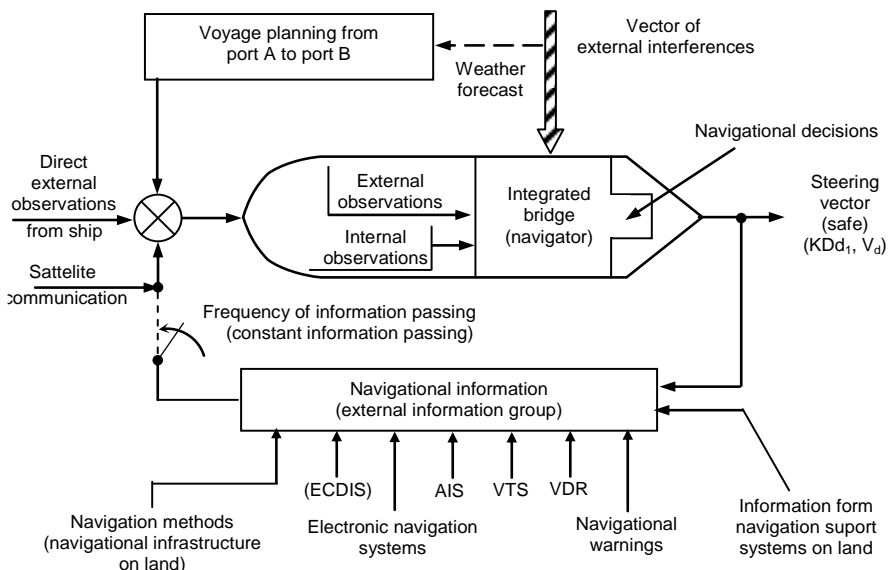
Fig. 2. Simplified modern integrated navigation model

The contemporary model of integrated navigation has changed the decision making processes on the bridge while navigating the ship. Figure 2. shows a simplified modern integrated navigation model.
