ANALYSIS OF THE POSSIBILITY TO ASSESS THE OCCURRENCE OF HIDDEN CORROSION IN LAP JOINTS USING ACTIVE THERMOGRAPHY

**Lukasz Kornas
Krzysztof Dragan**

*Air Force Institute of Technology,
Warsaw, Poland*

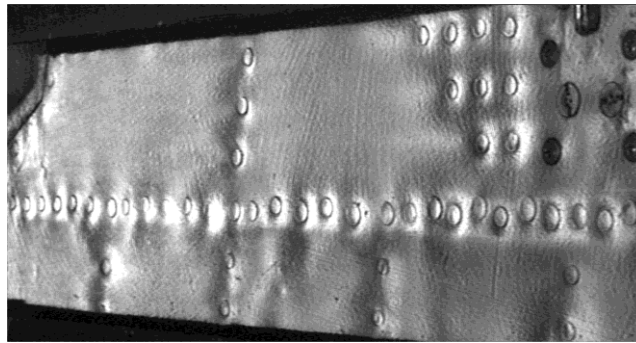
Fig. 1. Hidden corrosion (pillowing), the result of test with the use of DAIS system[1]

Corrosivity is a very important phenomenon unfavourably affecting materials used in aviation. Corrosivity necessitates continuous aircraft surveillance during operation. The effect of corrosion processes is the damage of the material observed mainly on the surface of the material in the form of an accumulation of solid compounds such as oxides, rust and scale resulting from chemical reactions. These chemical reactions are caused by changing weather conditions, increased humidity and the working environment such as contact with sea water. In many cases, the aircraft structural component exposed to corrosion is the plated area of the lap riveted joints. As a result of the difference in potential at the interface between two materials, oxidation of the material occurs creating corrosion products in the form of metal oxides. In the case of aircraft structures made of light alloys (usually aluminium alloys), these are mostly aluminium oxides $Al_2O_3 \cdot 3H_2O$, whose molar volume is greater than that of pure aluminium. They accumulate between adjacent materials, causing local surface deformations. Continuous process of creating metal oxide contributes to fatigue. Ignoring this phenomenon may lead to deterioration in strength properties of joined materials as well as damage of the rivet connecting them. It is a kind of hidden corrosion called pillowing.

The DAIS system measures the degree of surface deformation caused by the presence of solid metal compounds at the boundary between two materials. Using a number of different test techniques enables better verification of the research results. The authors used a pulsed thermography technique, which allows the registration of changes in infrared radiation emitted by the material. Based on the fundamental thermal coefficients (table. 1) for specific materials, the authors conducted preliminary tests to confirm the presented thesis.

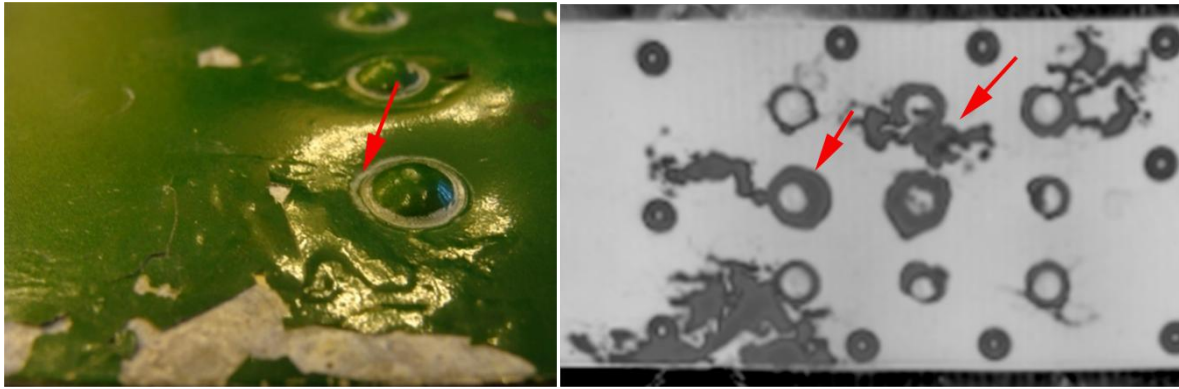
Fig.2. a) damaged anti-corrosion paint coating, b) thermograph of damaged anti-corrosion paint coating

While performing preliminary tests, samples with the damaged anti-corrosion coating from the wing flap of Su-22 aircraft were used (Fig.2). The tests were carried out with pulsed thermography using EchoTherm. Hidden corrosion can manifest itself through the paint coating damage such as cracks, blowholes, etc. This causes the varnish layer flaking due to lack of adhesion to the surface. Anti-corrosion coating damage is caused by adverse external factors such as humidity, exposure to sea water or by contaminants introduced during the production stage. Thermographic results of the damaged paint coating are shown on the thermograph below (Fig. 2).

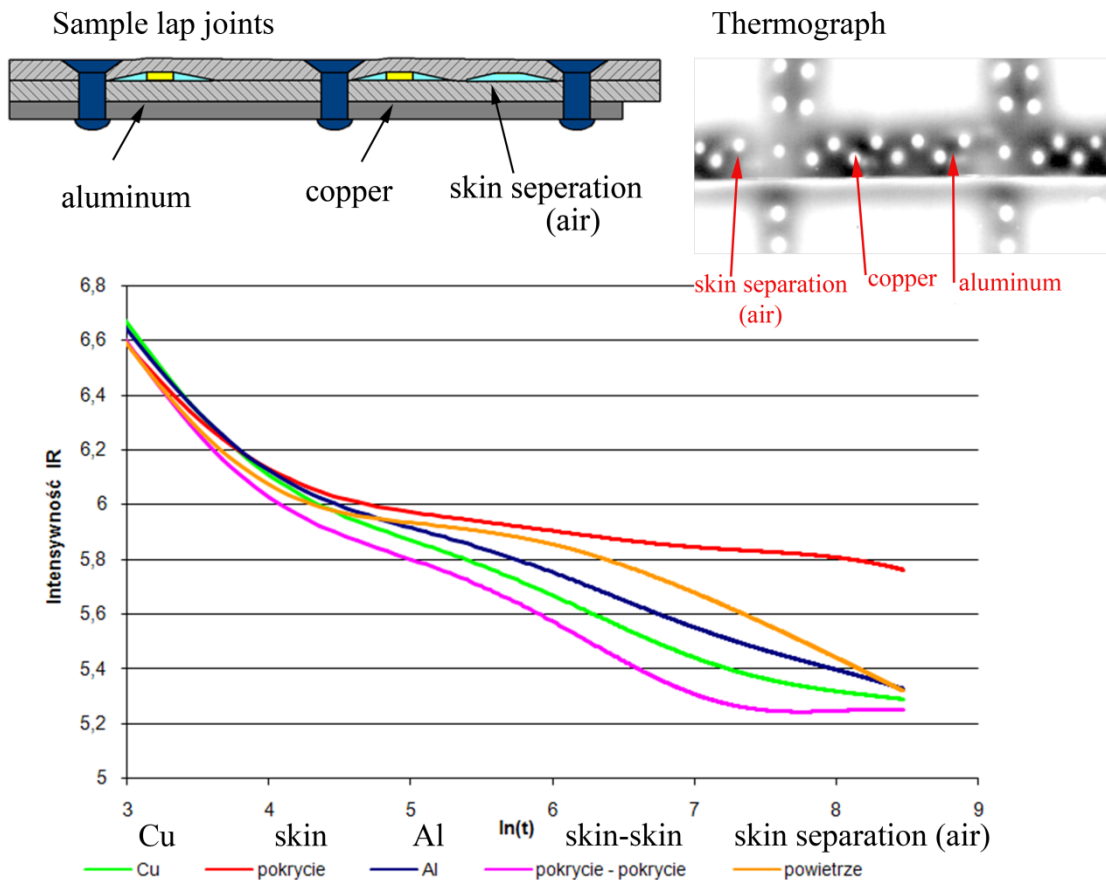
Fig.3. Thermograph of the sample tested and the diagram illustrating the surface intensity

Hidden corrosion manifests itself mostly as a result of the material oxidation creating solid oxide compounds. In aircraft structures, because of the materials used in the plating, corrosion products are aluminium oxides. The resulting compounds are characterized by other thermal properties allowing their detection with thermographic methods. Preliminary tests were carried out on the object with riveted joints. Solids with other thermal parameters in relation to the base material (aluminium alloy) were introduced to lap joints. They cause disruption in homogenous intensity of infrared radiation emission on the surface of the tested object. The thermograph of the sample tested and the diagram illustrating the surface intensity of infrared radiation during cooling of the material are presented below (Fig.3).

Preliminary results with the pulsed thermography method show the capabilities of the selected technique for hidden corrosion evaluation in aircraft structures. With the method used we can easily and quickly check the quality and correctness of paint coating at the stage of application, as well as its status during operation (Fig. 2). The infrared technique offers opportunities for detecting material inclusions due to differences in thermal properties. With this technique a different infrared radiation wavelength is detected in the area where material compounds of different thermal parameters are present (Fig. 3).
