Analysis and Modeling the Streambed Evolution after the Check Dam Restoration: the Case of Krzczonówka Stream

Marta Łapuszek¹

¹ Institute of Water Engineering and Water Management, Cracow University of Technology, ul. Warszawska 24, 31-155 Kraków, Poland, e-mail: mlapusze@iigw.pl

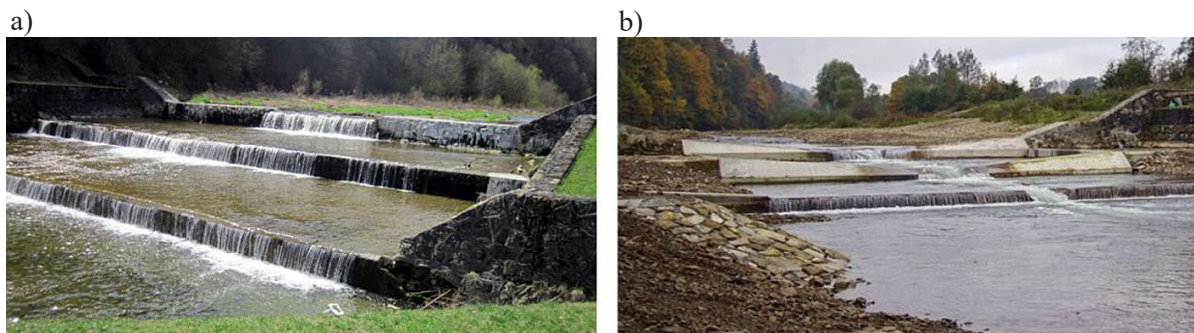
Photo 1. Check dam on the Krzczonówka stream: a) before restoration (Photo: M. Łapuszek, May 2013), b) after restoration (Photo: tarliskagornejraby.pl)

The Krzczonówka Stream, a tributary of the Raba River, drains a 92.2 km² catchment in the southern region of Poland (Figure 1). In 1879, the Krzczonówka river channel was wide and alluvial along the entire researched, downstream reach. The construction of a check dam was started in 1935 at kilometer 2+440 of river course. The hydraulic structure was made of concrete with a stone front, and the height of the dam was approximately 7 m (Project No. 46/43/1473). The check dam had interrupted the natural continuity of the fluvial system, thus limiting the supply of sediment from the upstream section of the river. The average width, in the reach downstream from the check dam, decreased from 41 m to 24 m, and the average width in the reach upstream from the dam decreased from 105 m to 23 m (Lenar-Matyas et al., 2015). At present, the stream channel width within the entire 5-kilometer long reach of the channel is about the same and very small. Preliminary work on the lowering of an existing check dam on the Krzczonówka Stream was begun in 2013. Finally, in 2014, the check dam on the Krzczonówka Stream was lowered, redesigned, and rebuilt as a cascade (Photo 1b). Downstream

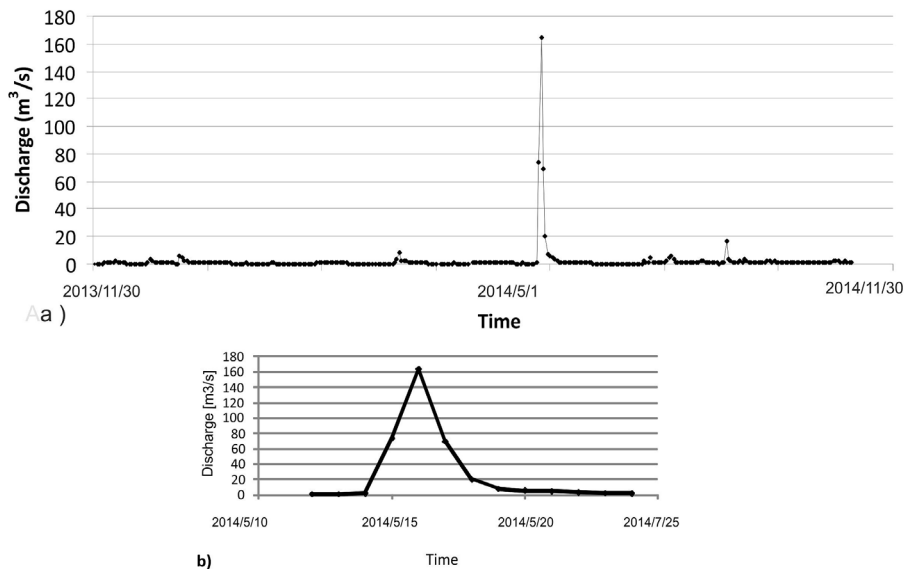
Figure 2. a) Hydrograph of The Krzczonówka stream registered at Krzczonów gauging station for 2014; b) Recorded daily discharge of the flood event at Krzczonów gauging station (according to Poland's Institute of Meteorology and Water Management)

Daily discharge at the Krzczonów gauging station in 2014 year is provided in Fig. 2a). Before the check dam lowering and restoring, the highest discharge was $8.47 \text{ m}^3\text{s}^{-1}$ (according to Poland’s Institute of Meteorology and Water Management). Only a single flood event occurred after the dam restoration. Figure 2 illustrates the hydrograph of that event. The maximum recorded discharge was $164 \text{ m}^3\text{s}^{-1}$ (according to Poland’s Institute of Meteorology and Water Management). The subsequent discharges in 2015 and 2016 were lower than $23 \text{ m}^3\text{s}^{-1}$. The maximum stream power of the Krzczonówka stream at the gauging station and at the cross-sections as located in the Figure 1 (PP19, PP22, PP32, PP34) were estimated to be 59076, 96, 78833, 18437 $\text{kg}\cdot\text{m}/\text{s}^3$, respectively during the flood.

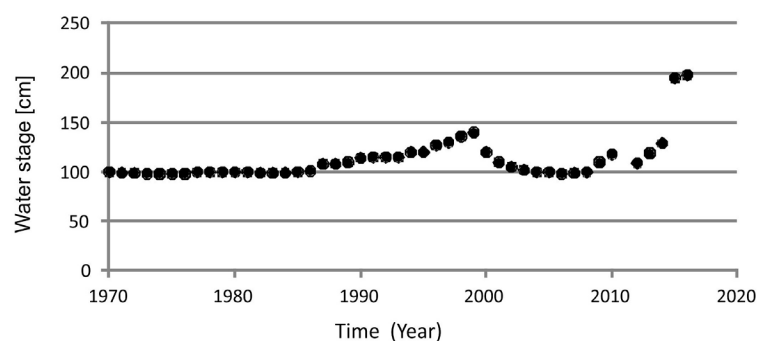
Figure 3. Lowest annual water stages at the Krzczonów gauging station in years: 1970–2016 (according to Poland's Institute of Meteorology and Water Management)

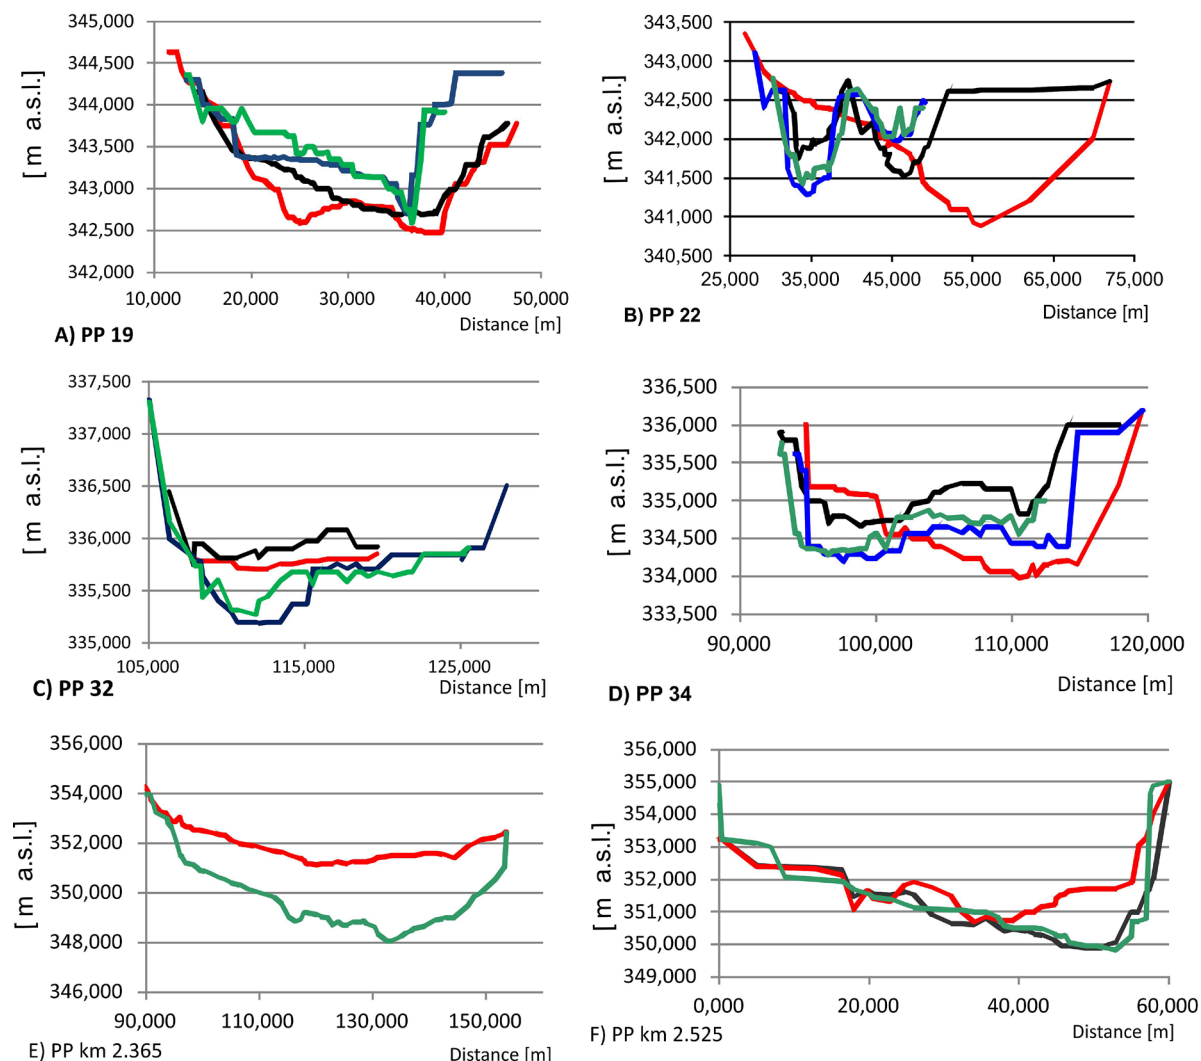
Figure 4. Representative cross-sectional elevation changes over time on Krzczonówka Stream downstream the lowered check dam (a-d) and upstream the dam (e-f), red line: 2013, black: line 2014, blue line: 2015, green line: 2016 year

upstream of the check dam (as a result of its lowering) and from the side cuts due to lateral erosion of the banks (Figure 4e,f). In some channel reaches, the bank was moved back several tens of centimeters, while some bank reinforcements became substantially damaged. The structure of most new riffles was not visible. A small bump in the down slope of the channel is found where the riffles used to be.

On the basis of the obtained results, it may be stated that the stream channel, within long sections of it, was filled with the material released from the sedimentation reservoir of the dam (Figure 4e,f), and also with additional material from the right bank, where strong lateral erosion had occurred.

up to that time within the dam reservoir and above it, became eroded and transported to the channel reach downstream of the dam (Fig. 4e,f).

2016 show no significant effects on the change in the channel geometry. The subsequent discharges in 2015 and 2016 were lower than $23 \text{ m}^3\text{s}^{-1}$. The maximum stream power of the Krzczonówka stream at the gauging station and at the cross-sections, as located in the Figure 1, were estimated to be 8285, 13, 11055, 2585 $\text{kg}\cdot\text{m}/\text{s}^3$ respectively for lower discharge. Therefore, in 2015, the changes of the channel geometry were visible, but not high. In 2016, the changes were very slight comparing to 2015 (Fig. 4a,d).

Looking at the longitudinal profile of the studied stream channel (Fig. 6), it can be noticed that the stream bed elevation has increased along the entire reach. The thickness of deposited sediment ranged from 0.20 up to 0.91 m at 1.5 km of the reach. The layer thickness deposited from 2.1 to 1.75 km of the reach, is rather thin; subsequently, the layer thickness increases and the highest values are reached at the area of 1.35–1.7 km (Fig. 4: PP22). The local erosion is observed in 1.1 km of the reach (Fig. 6).

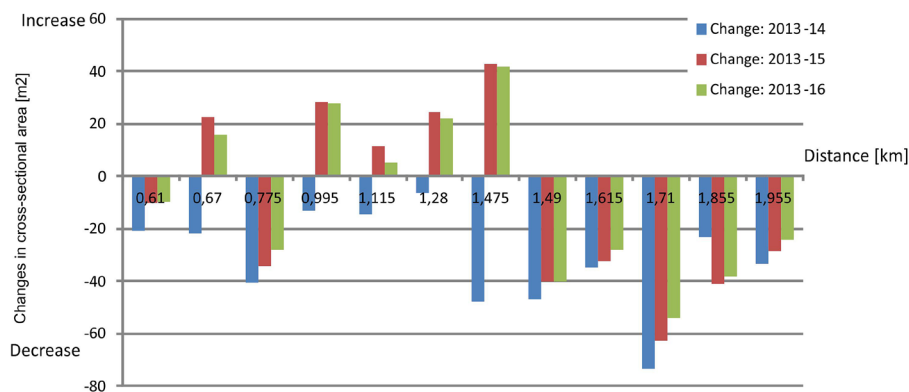
Figure 5. Changes in cross-sectional area in years 2013–2016

Analyzing the changes in the cross-sectional area at the level of $Q_{50\%}$, in years 2013–2016, it can be clearly noticed that the cross-sectional areas drastically decreased in 2013–2014 over the whole section below the check dam (Fig. 5). In subsequent years, the cross-sectional areas were increased due to the sediment movement, especially in the km 1.475–0.995. Along a subsequent reach of the stream channel, the cross-sectional area keeps decreasing within the range from 47% to 2.54%, which is the minimum value that occurs at cross section 34 (Fig. 5)

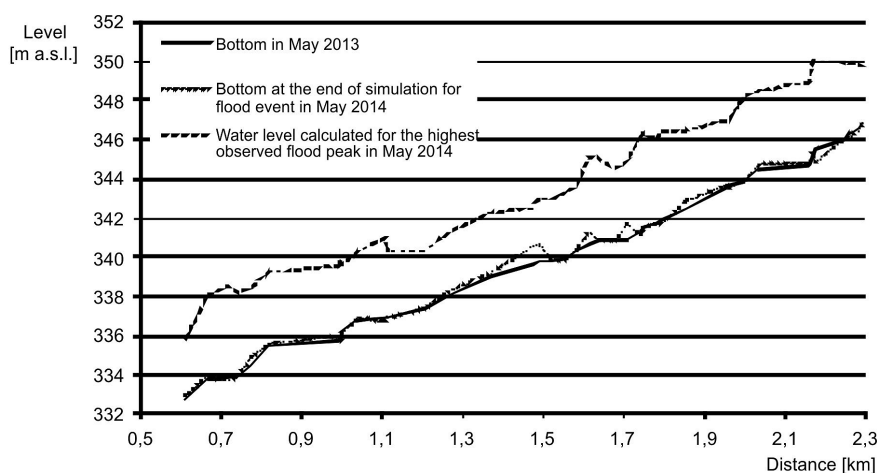
Figure 6. Numerical simulation of stream channel evolution after flood event in 2014

The process of intensive erosion on the area located directly below the check dam (km from 2.2 to 2.0) is observed (Fig.6). This process observed just after the check dam lowering is difficult to interpret. This area is directly affected by the works related to the reconstruction of the

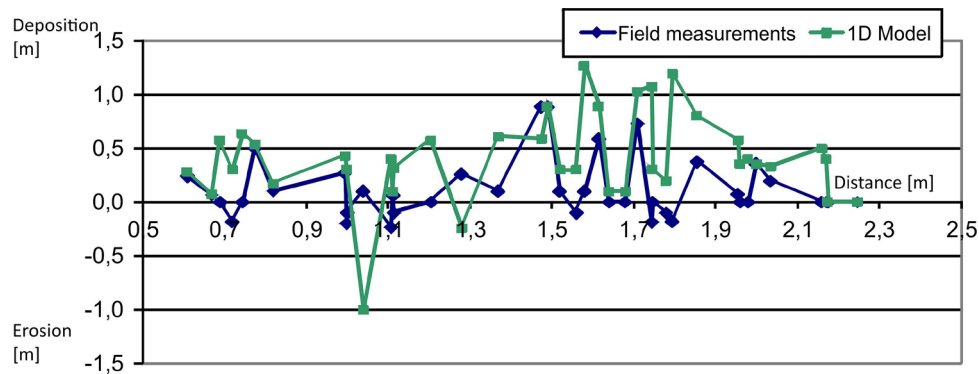
Figure 7. Bottom level changes at the studied Krzczonówka stream course after flood event in 2014

The calculation results summarizing the lowest value of riverbed elevation, both those measured in 2014 and the values based on model cal-

culations, are plotted on a graph (Fig. 7), including the magnitude of erosion and accumulation of material at cross sections in the Krzczonówka Stream channel, both values measured in the field and the values calculated based on the studied model. Clear differences in the obtained values can be noticed on the graph. However, what is very important, is that the identified erosional and accumulation tendencies are the same at corresponding cross sections: measured values and values calculated based on the model. This also provides a practical form of model validation. The discrepancies between values may result from underestimating Strickler's coefficients or may be due to an inaccurate specification of active channel width in the model. An active channel width may assume slightly different values in the special case when large masses of bed load are transported during a flood event.
