SYNERGISTIC PERFORMANCE DEGRADATION OF MARINE STRUCTURAL ELEMENTS: CASE STUDY OF POLYMER-BASED COMPOSITE AND STEEL HYBRID DOUBLE LAP JOINTS

Keywords: Wet-dry cycle; Double lap joint; Polymer composite-steel joints; Surface roughness; Aging in marine environment

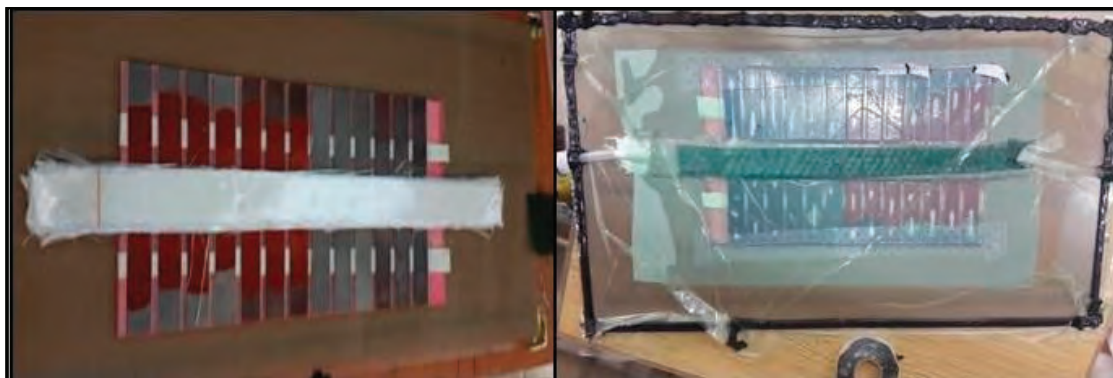
Fig. 3. Specimen fabrication with vacuum bagging technique

The steel layers were Grade A St37 marine steel manufactured by Erdemir Iron and Steel Mill Corp. of Turkey [29]. The specimens, consisting of the composite material and a steel layer, were vacuum-bagged in a serial manner using a system developed by the authors (Figure 3), since vacuum-assisted methods cause fewer manufacturing defects than conventional hand lay-up methods [30]. To ensure that the steel parts did not touch each other and were aligned correctly, strips of PVC foam material were placed between them. In this way, it was prevented that the epoxy fills the gap between the steel parts.
