Analysis of the Surface Topography of Fractures Caused by Static and Impact Bending of Polypropylene and Polyamide PA6 Reinforced with Continuous Glass Fibers

The work analyzes the fracture topography of composite specimens subjected to three-point bending – static and impact. Scanning electron microscopy was used for this purpose. The tests were performed for two different materials, namely polypropylene and polyamide PA6, each reinforced with unidirectional glass fibers. In one case, the fibers were distributed evenly, and in the other, there were areas more and less reinforced with fibers. It was observed that in all cases the tension and compression parts could be clearly distinguished. However, for different materials and with different methods of destruction, varying failure mechanisms were observed, noted based on the analysis of the fracture topography. It was observed that regardless of the loading method and material, in the tensile part there were visibly protruding fibers, and in the compressed part it was the matrix, rather than the fibers, that was destroyed. In the case of statically loaded samples, damage occurred at the macrostructural level, and in the case of dy

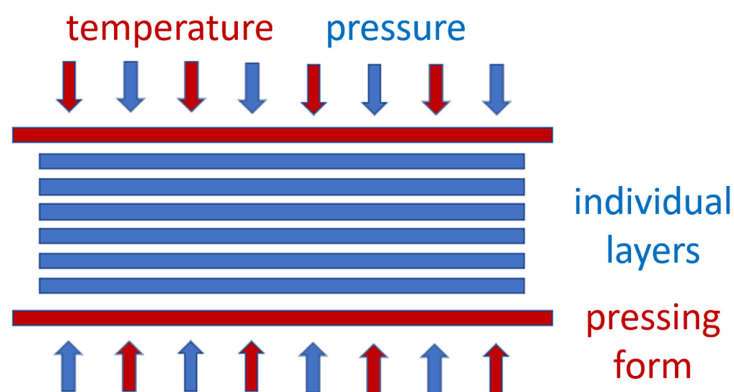
Figure 2. Material manufacturing scheme. Stage 2: producing laminate from separate layers

Then, the prepared tape was cut into parts of appropriate dimensions. In the next step, the layers were placed one on top of the other, and then, under the influence of temperature and pressure, ready-made plates with the desired layer arrangement were obtained. In the case of the produced specimens, in order to obtain not only unidirectional layers, but entire specimens with unidirectional reinforcement, the fibers in individual layers were arranged in the same direction. The diagram of the second stage is presented in Figure 2.

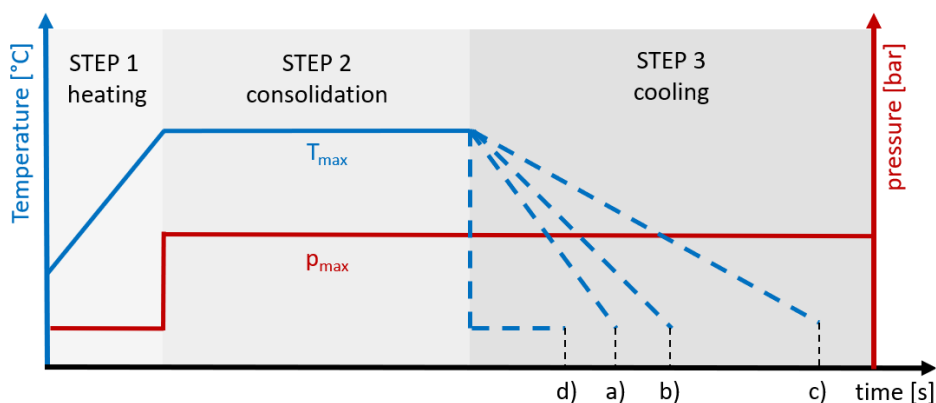
Figure 3. Temperature and pressure during the production of a GFRP laminate with a thermoplastic matrix in variants (a) fast (b) standard (c) slow (d) very fast

The course of temperature and pressure over time for composite materials depends on the thermoplastic material used. In the general case, this course is presented in Figure 3. The process

- Step 1: Heating and plasticizing the thermoplastic matrix at a temperature linearly increasing from 25 °C to 220 °C (PP) or 285 °C (PA6), within 10 minutes;
- Step 2: Consolidation of individual fiber-reinforced layers under a pressure of 30 bar, at a constant temperature of 220 °C (PP) or 285 °C (PA6), for 20 minutes;
- Step 3: Cooling and solidification of the obtained multilayer composite by linearly lowering the temperature to room temperature under a constant pressure of 30 bar. Finally, the applied pressure is reduced.
