COMPARISON OF PULSE THERMOGRAPHY (PT) AND STEP HEATING (SH) THERMOGRAPHY IN NON-DESTRUCTIVE TESTING OF UNIDIRECTIONAL GFRP COMPOSITES

This paper presents two techniques of active thermography i.e. the pulsed thermography technique and the step heating technique. The aim of this article is to compare these two techniques and present the possibilities, advantages and limitations of their use in the context of non-destructive testing of composite materials. The experimental section presents the results of tests carried out on samples of the polymer composites reinforced with glass fiber.

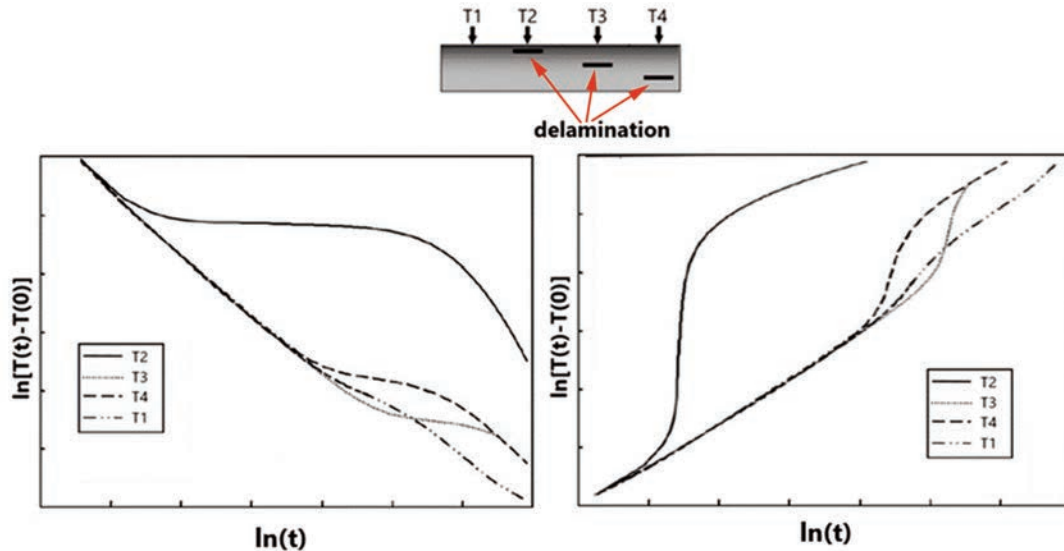
In both techniques, the presence of defects in the material locally changes the thermal diffusivity, causing differences in temperature between the area containing the defect and the area free of material discontinuities. Defects detected are inclusions and delaminations which can be assessed by plotting the relations $\ln[T(t)-T(0)] = f[\ln(t)]$ (Figure 1). For a homogeneous material without defects, the cooling / heating curve is

a straight line with an absolute slope of 1/2. The temperature distribution is determined based on the temperature value on the surface of the material in the area without damage (T1) and in areas with damage (T2, T3, T4) [5, 10].

Figure 1. Detection of delamination by pulse thermography and long pulse thermography.

Detection of damage is possible after the minimum time has elapsed when differences in temperature values appear. The range in which the temperature difference is visible on the diagram lasts until the temperature stabilizes in the test area. Deeper damages require more heat and longer recording time. The detection of damage depends on the size and depth of the damage deposition. Therefore, the results obtained may be affected by an error. Thermography is a surface method, that is why it may not be possible to accurately determine the extent of damages that are deep inside the material [5].

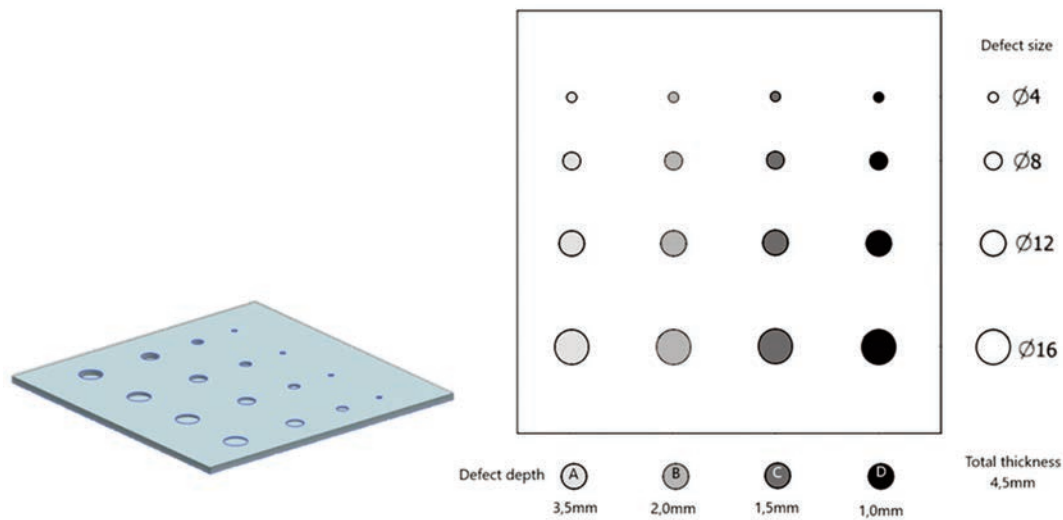
According to the scope of this research a specimen from GFRP was tested. The tested specimen with dimensions 205 x 205 x 4.5 mm was made of TC E720 pre-preg. Artificial damages were entered into the sample in the form of sixteen flat-bottomed round holes (Figure 2) with different diameters and at different depths. Such a system of discontinuities makes it possible to check how the depth variation and the size of defects affect the received indications. Damages are identified by the letters A, B, C or D indicating the depth of the hole and a number specifying the diameter of the hole.

Figure 2. Sample of a GFRP with 16 flat-bottomed holes.

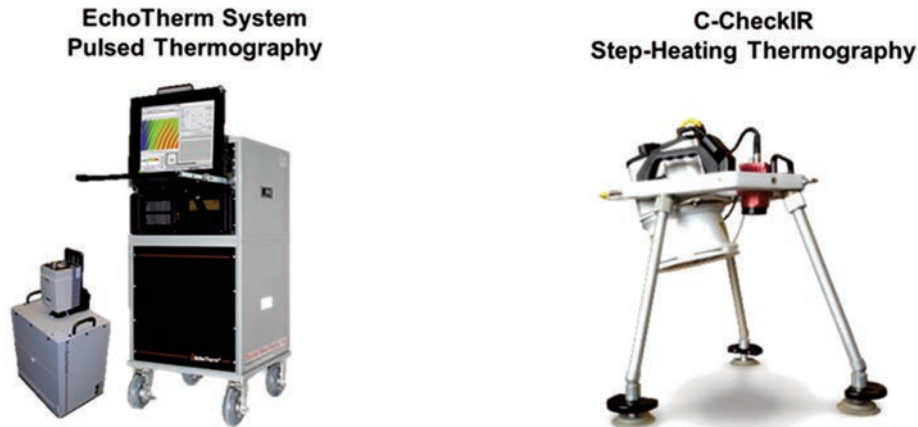
Pulse thermography was carried out using the Echo Therm System [10]. The apparatus creates a sequence of thermographic images, recording the temperature change of the tested surface within a specified time (in this case the time was 22s). The system is equipped with a FLIR SC7000 thermal imaging camera, two xenon (flash) lamps generating a total of 5kJ of thermal energy and software supporting the analysis that allows drawing temperature curves.

For step-heating thermography, the C-CheckIR system was used. The system is equipped with a halogen lamp with a much lower power than in the pulsed thermography system. The lamp power is 2kW @ 230V. Less energy supplied to the specimen surface during thermal excitation causes slower heating of the sample. Therefore, changes in the surface temperature distribution can be recorded both during the heating and during the cooling process. The time for heating and data collection was selected experimentally: 25s/10s, 30s/12s, 40s/16s (image recording time/sample heating time). The thermogram that gave the largest number of indications of damage was analyzed. The parameters of the cameras used for the particular techniques are presented in Table 1.

Figure 3. Pictures showing the measurement systems used.

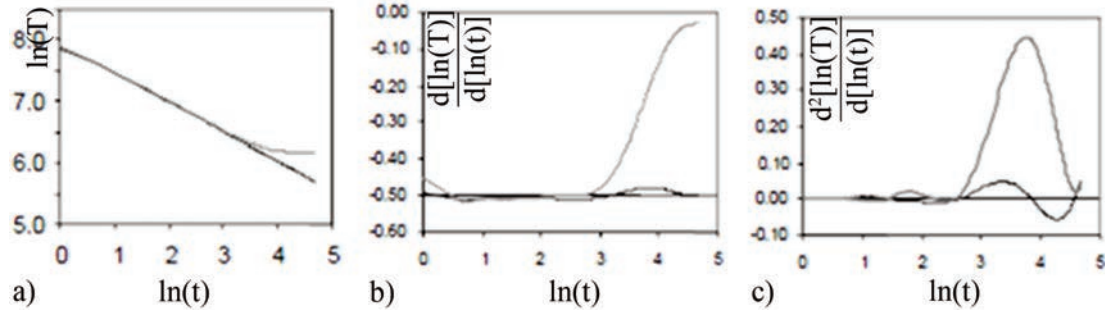
Figure 4. Change in surface temperature in TSR logarithmic coordinates [5]
a) Cooling process of the sample surface in logarithmic coordinates, b) Cooling process of the sample surface in logarithmic coordinates for the first derivative, c) Cooling process of the sample surface in logarithmic coordinates for the second derivative.

Derivatives of the temperature logarithm function are useful especially in distinguishing areas of a defective structure from an undamaged structure. Image recording in the pulsed thermography begins immediately after extinguishing an excitation pulse. The results of thermographic tests are presented at different times, in a way that the indications of damage at a given depth are most visible [11]. To select the most appropriate time, the diagram of the specimen's cooling surface was used. For each image of the sequence, the contrast

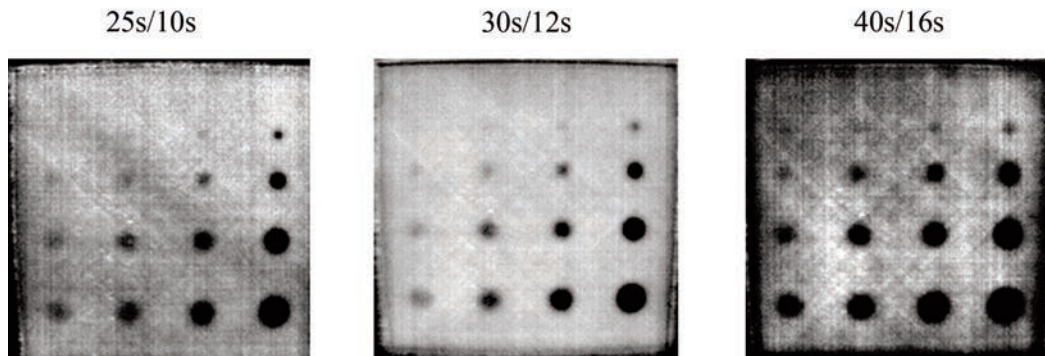
The system used in step-heating thermography did not allow for determining the temperature dependence on time. Therefore, the test parameters (total observation time / time of sample excitation) were selected experimentally in order to detect the largest number of damages. Three thermograms obtained using three different sets of parameters are presented below. As the observation of cooling curves was impossible only one thermogram that showed the largest number of indications of damages was selected out of each measurement. All thermograms were recorded during sample cooling.

Figure 6. The results of thermographic tests using the step-heating thermography for various measurement parameters (total image recording time / heating time).

Unlike in pulsed thermography, in step-heating thermography the recorded image of the cooling of the sample during the first seconds does not show high contrast. More time for sample observation allows detecting better quality indications of damages. In step-heating thermography, longer heating stabilizes the images (increasing the signal-to-noise ratio SNR) and enables finding more damages. But, even without differential image processing, it is possible to observe damages located deep in the material.

Analysis of the obtained thermograms shows that damages are best visible over the longest heating time of the sample. Indications of damages in this thermogram have similar sizes in all rows despite being at different depths from the test surface. Moreover, compared to the pulsed technique, the edges of the defects are not blurred. This makes it easier to determine where the damage is located in the sample and what size it is. A number of damage indications is the same for both techniques.

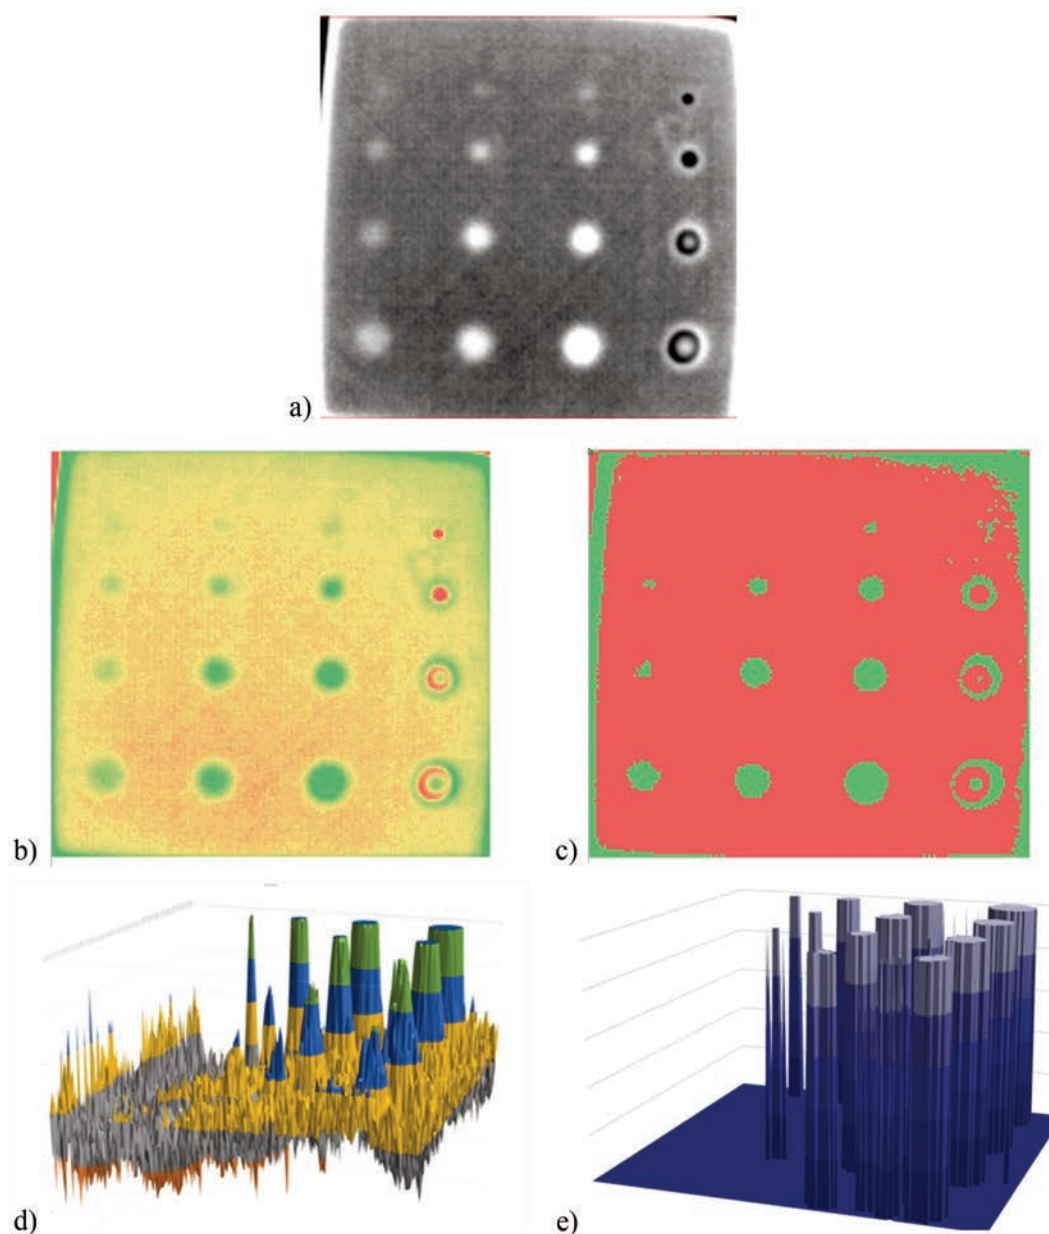
The next stage of the study was to carry out an analysis that allows a quantitative description of damages. All thermograms obtained during pulsed and step-heating thermography are greyscale images (Figure 7a) where each pixel is described with one

of 256 shades of grey. The value 0 indicates black and 255 indicates white. These values were decoded using Scilab and exported to Excel (Figure 7b). Then the average value and standard deviation were calculated from the obtained data. In the next step the image was binarized using the three-sigma rule (Figure 7c). In order to illustrate the results received well, for both the grayscale images and the images after binarization the matrixes values were presented using colors and three-dimensional charts (Figure 7d, e). It is obvious that binarization allows the unambiguous separation of undamaged areas from areas with defects.

Figure 7 a) Thermogram, b) matrix obtained using Scilab, c) three-dimensional representation of matrix values, d) matrix after binarization, e) three-dimensional representation of the matrix after binarization.

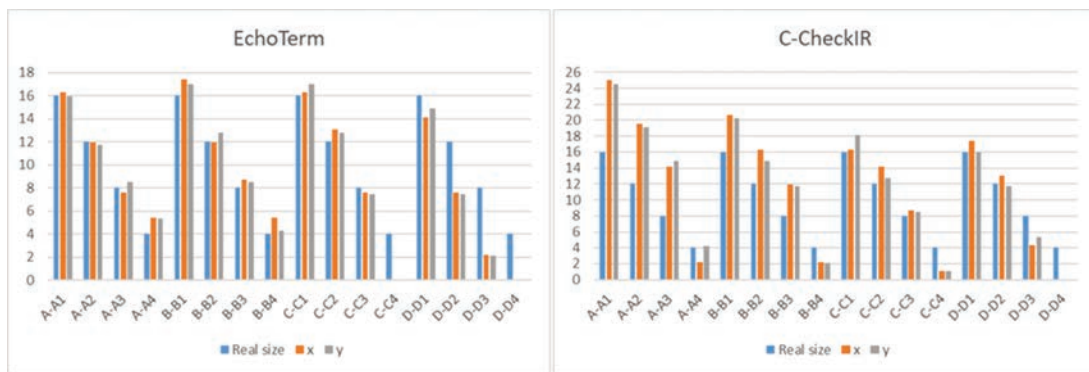
Figure 8. Diagrams showing the results of damage size measurement.

With pulsed thermography, image analysis allows a relatively accurate determination of the extent of damage compared to the actual size. The highest error values were recorded for the deepest defects. This difference is caused by the low contrast on the thermograms.

With step-heating thermography, the measured damages' sizes in most cases were much larger than the actual sizes. The total measurement error in this technique is almost three times greater than for pulsed thermography. However, it should be noted that this technique allows for finding more damages. In addition, the measurement was carried out on one thermogram and showed damage at various depths. For this reason heat diffusion around the damage had a greater impact.
