A Possibility to Improve Resistance of Cast-iron Hydraulic Valves to Cavitation Wear

A.W. Orłowicz, M. Tupaj^{*}, M. Mróz, B. Kupiec, M. Jacek, M. Radoń

Rzeszow University of Technology,

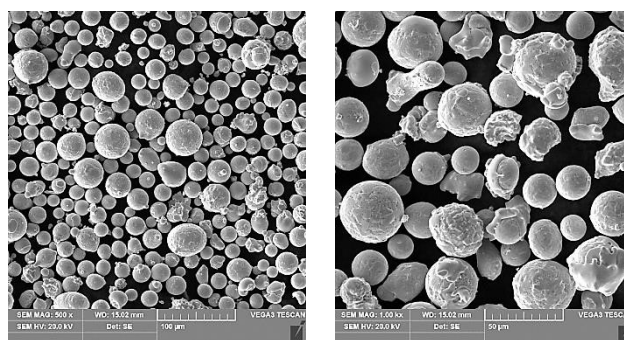
Shape	Size, μm	Share, %
Spherical	36–49	60
	10–36	20
Globular	26–60	20

Composition: 86.1% Cr, 7.2% Ni, 6.7% C

Fig. 1. A view of CRC-410 powder particles and their shapes, sizes, percentage share, and chemical composition

The material used for coating was CRC-410 powder (PRAXAIR). Results of examination of shape, size, percentage share, and chemical composition of powder particles are given in Figure 1.

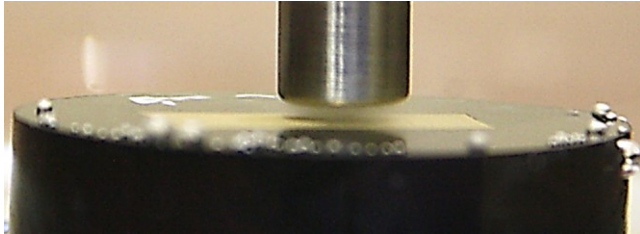
Fig. 2. A view of the cavitation mist area above specimen surface in the course of the cavitation wear test

The cavitation wear resistance tests were carried out with the use of Vibra-Cell Ultrasonic Liquid Processor (SONICS) equipped with a piezoelectric transducer probe. The used vibration frequency was 20 kHz. In the course of testing, the specimens were immersed in distilled water. The distance from ultrasonic probe face to specimen surface was 0.5 mm. The time of exposure to cavitation was 120 minutes.

A view of the cavitation mist area generated above specimen surface in the course of the cavitation wear test is shown in Figure 2.

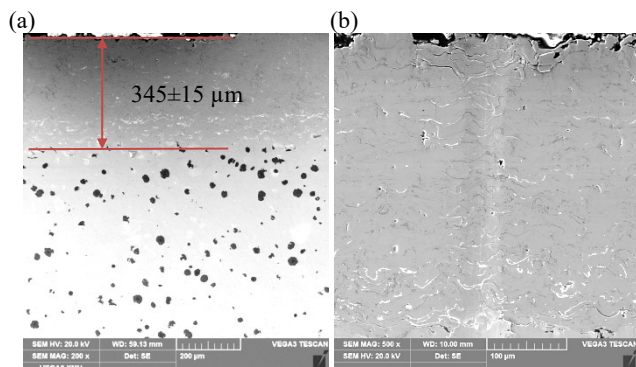
Fig. 3. (a) A view of coating made of powder containing 86.1% Cr, 7.2% Ni, and 6.7% C deposited on nodular cast iron substrate with the use of HVOF method and (b) a view of a test scratch made in direction from substrate to outer coating surface

Figure 3 shows a view of the deposited coating and a scratch made in direction from substrate to outer surface of coating.

The obtained results indicate good quality of the substrate-coating bonding. On the border line separating the materials, there are no signs of bonding discontinuities. The scratch test confirms good quality of the bonding and high compactness of the coating material which are evidenced by absence of exfoliation on surface and around the scratch path. Further, the scratch test results prove

that the substrate is much more susceptible to scratching than the coating material, as the scratch width is less on the latter.

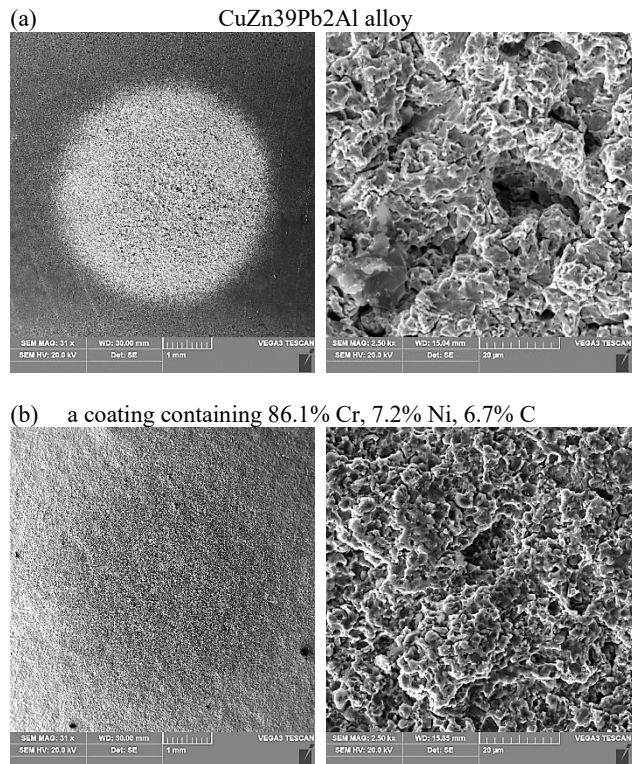
Fig. 4. Example views of cavitation craters and surfaces of the compared materials after exposure to cavitation in water

Figure 4 presents example views of cavitation craters and views of surfaces of the tested materials after exposure to cavitation.

The obtained results indicate that a crater with a distinctly defined outline was formed in the material of the tested valve seat sealing insert used typically to date. Observation of surface of the crater indicates that individual components of microstructure of CuZn39Pb2Al alloy are characterized with different susceptibility to cavitation damage which results in development of extensive local cavities.

On the surface of plasma-sprayed coating, a cavity without clearly defined edges was formed. Microscopic observation of the cavity surface reveals inhomogeneous susceptibility to cavitation damage. In case of the material used typically for valve seat inserts, dimensions and depths of tear-outs are much larger compared to those occurring on the coating surface.
