# THE INFLUENCE OF THE FASTENER HOLE PREPARATION METHOD ON THE FASTENER PULL-THROUGH PROCESS IN A CARBON COMPOSITE

MACIEJ KARNY

Composite Testing Laboratory, Centre for Composite Technologies,  
Institute of Aviation, al. Krakowska 110/114, 02-256 Warszawa  
[maciej.karny@ilot.edu.pl](mailto:maciej.karny@ilot.edu.pl)

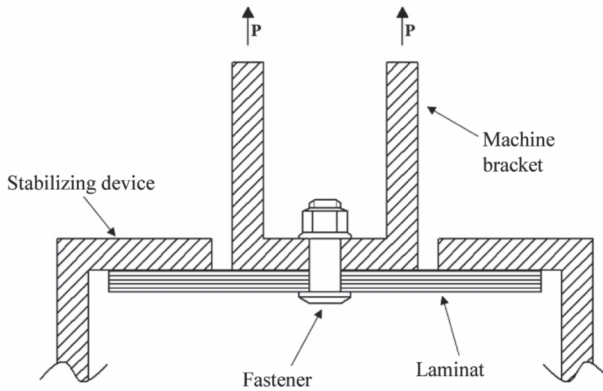
Fig. 1. Diagram of the D7332 method test [own elaboration]

The tests were conducted according to the standard ASTM D7332, procedure B (Fig. 1). In order to conduct the studies, 3 carbon fibre-epoxy resin composite plates made of uni-direction MTM44 prepregmate with area weight of  $268 \text{ g/m}^2$  and with a 32% weight content of epoxy were created. The reinforcement sequence was quasi-isotropic:  $[0/45/90/-45]_{2S}$ . The manufactured plates were cut into 9 coupons each, according to the dimensions presented in figure 4. The series differed in terms of hole preparation method: in the W series, the hole was drilled with a drill designed for making holes in composites, in the P series – it was milled on a CNC plotter, and in the K series – made during the plate manufacturing process (in the latter part of the paper, the P and W methods shall be called collectively as standard). Placing plates with ready holes forced another distribution of fibres than in the other cases, which is presented schematically by figure 4.

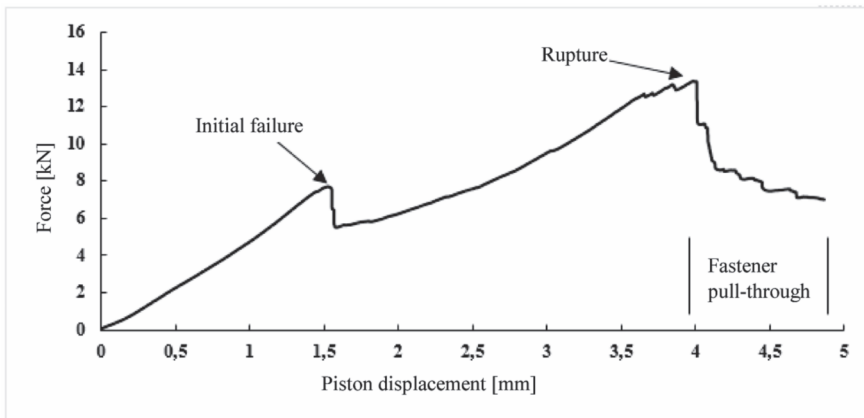
The joint failure process during fastener pull-through consists of several stages (Fig. 2). The first cracks inside the laminate layers appear quite early, even at 30% of the maximum load [2]. These cracks have no negative impact on the engine operation yet. The first visible sign of structural damage is a decrease of force by several percent, often combined with a change of the curve slope on the load – displacement graph, called the initial failure. This decrease is usually associated with the appearance of a first significant delamination in the material, however, it does not occur in all materials. In the course of further loading of the coupon, delaminations and cracks develop, which results in a significant decrease of force, defined according to the standard D7332 as joint failure [3, 4]. The crack development mechanism at this stage is compared to the mix-mode cracking with the dominating mode II (layer breaking) as a result of perpendicular load combined with mutual displacement over each other, resulting from inter-layer bending and shearing in the area next to the fastener) [1, 5]. Despite significant internal damage, a connection in such a condition is still able to carry loads. In the course of further loading, cracks spread over the entire non-stabilized area of the coupon, until condition of saturation is reached. When maximum force is reached, the laminate layer directly under the fastener head is destroyed, which leads to its deepening into the laminate and rupture.

Fig. 2. An exemplary load – displacement graph in the fastener pull-through test [own elaboration]

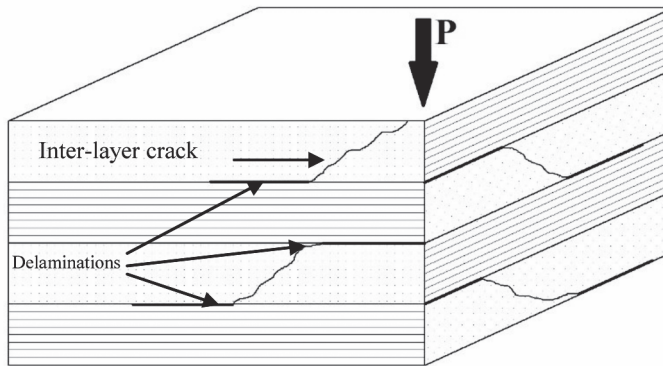
Laminate failures as a result of fastener pull-through are of, what the literature calls, the “staircase” character (Fig. 3). Staircase failure consists of two main components: intra-layer cracks of the structure and delamination (inter-layer cracks) [3, 6, 7]. The intra-layer cracks spread in the resin between fibres in the layer, usually at an angle of  $45^\circ$  in relation to its plane, which proves that they are induced by shearing pressures<sup>1</sup> (tangent). After going through the entire layer, a crack reaches a neighbouring layer, with a different direction of fibre arrangement, which stops it and begins delamination. The greatest delaminations occur between layers with the arrangement direction differing by  $90^\circ$  – such a fibre arrangement makes it completely impossible for a crack to move onto the next layer and intensifies the development of delamination [2]. The staircase failure type is very similar to the failures appearing in the composite as an effect of low velocity impact, which suggests that fastener pull-through may be treated as an extreme case of such an event [3, 5]. Apart from the fibre arrangement sequence, the main factors impacting the fastener pull-through process creation are, inter alia: the precision of hole preparation, type of fastener and the laminate’s bending resistance.

Fig. 3. Staircase failure diagram [own elaboration]

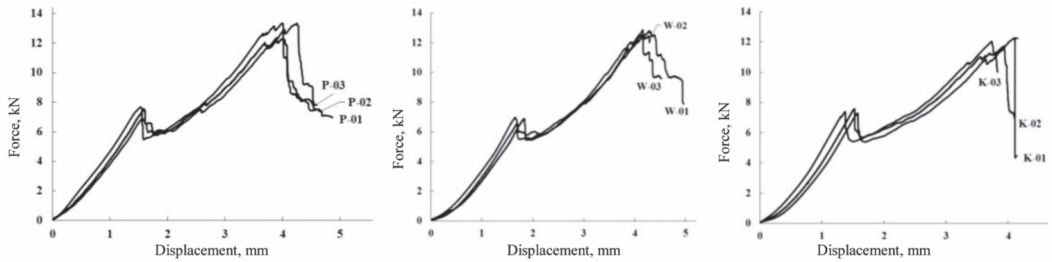
The sequence of a pull-through test was similar for all types of coupons (Fig. 5). After reaching the first maximum load ( $P_f$ ), a force decrease was noticed, followed by an increase of the load for fastener pull-through began ( $P_m$ ). Figure 5 shows, inter alia, the decrease of the force following the reaching of the maximum, associated with fastener pull-through and failure of successive laminate layers, which was the fastest for the K series coupons. It proves that at this stage of coupon loading, the laminate with continuous fibres, placed around the hole, resists the moving fastener to a lesser extent.

Fig. 5. Results of stretching until failure tests for coupons of the P, W, and K series [own elaboration]

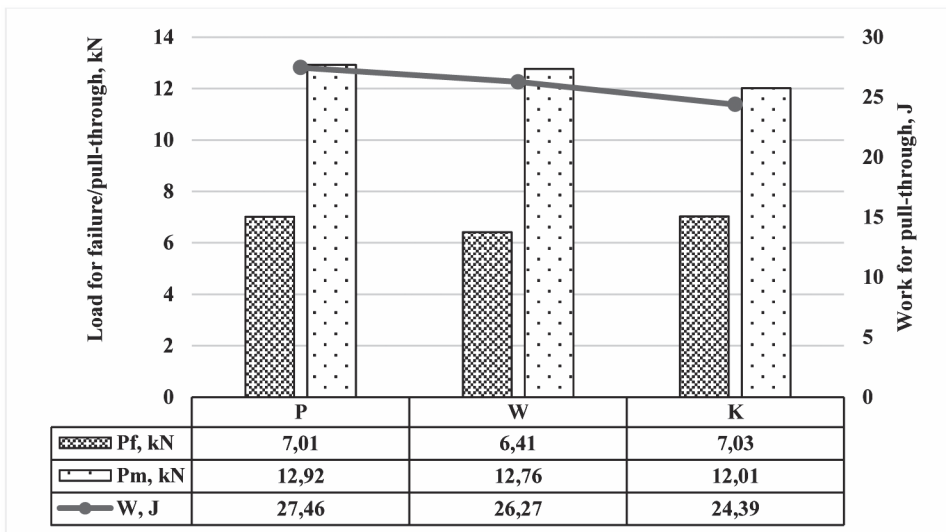
When comparing the average values of load for failure (Fig. 6), the lowest one was showed by the W series (6.41 kN), while in the case of the other two series, the  $P_f$  value was almost equal. During the comparison of loads for fastener pull-through, the K series showed a significantly lower fastener rupture force (12.01 kN) than the P and W series (respectively: 12.92 kN and 12.76 kN). It means that the damage propagation process in the laminate, after reaching load  $P_f$  are of greater intensity in coupons with holes made during plate application. Also, the work for fastener pull-through was significantly lower for the K series – in comparison to the P and W series, the work for pull-through in the K series was lower by, respectively, 11% and 7%.

Fig. 6. Average values of load for failure ( $P_f$ ), load for fastener pull-through ( $P_m$ ), and work for fastener pull-through ( $W$ ) [own elaboration]

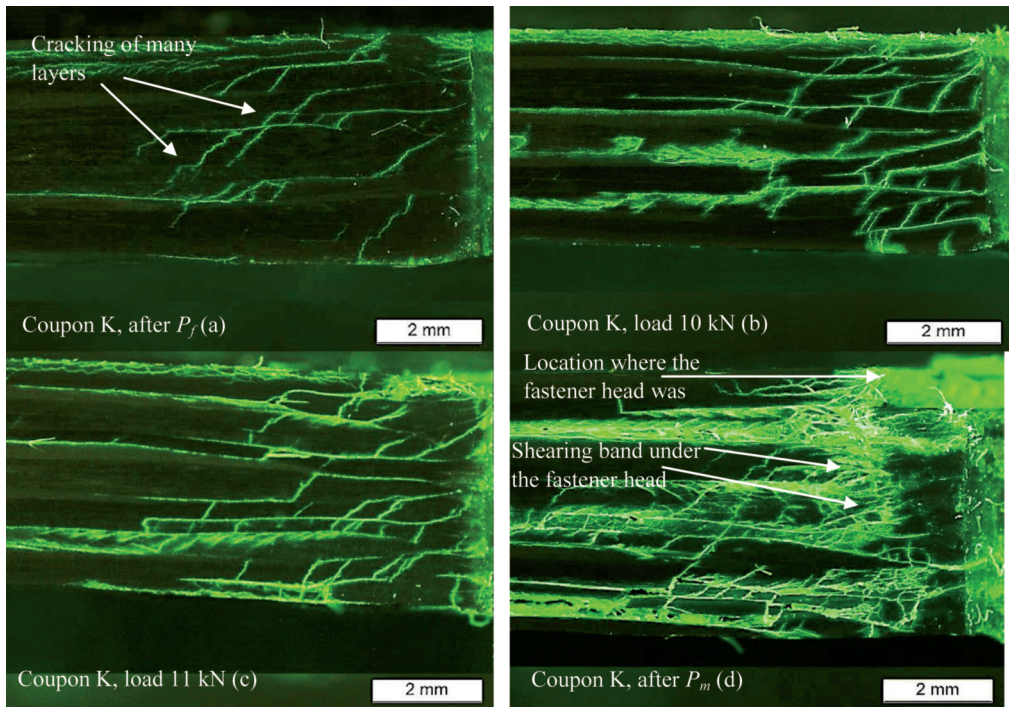
In the case of K coupons, already at the initial stage of crack development, differences arise in relation to P and W type coupons. The cracks in K type coupons are more branched and reach deeper than in the W coupon, loaded until such a similar moment during fastener pull-through. Moreover, intra-layer cracks seem to move in this case through all layers of the coupon, regardless of the direction of their arrangement (Fig. 8a). The reason for this condition is depicted in figure 9, which shows the arrangement of laminate layers in the immediate vicinity of the hole. As a result of the fibres “bypassing” the hole, the layers arranged in the  $0^\circ$  direction, most greatly resisting the intra-layer cracks, are not present in the immediate vicinity of the hole (an area of ca.  $2.5 \div 3$  mm from the edge of the hole). It makes all laminate layers in this area to be arranged in the  $90^\circ$  and  $\pm 45^\circ$  directions. Therefore, the cracks by the edge of the hole, shown in figure 8a, are resin cracks between carbon fibres. Further loading of the coupon results in the development of delaminations, which reach more than 7 mm (approximate length of the coupon in the image) deep, at a load of 10 kN and 11 kN (Fig. 8b and 8c). In this case, there are also more intra-layer cracks than in the case of P and

W coupons. Due to the reasons described above, it is impossible to observe laminate layers free of cracks in the case of the K coupon. The cracks in a coupon loaded to failure (Fig. 8d) also differ from the cracks in a destroyed W type coupon. In the case of a K coupon, we can observe a very well developed grid of intra-layer cracks, going through all the layers of the laminate. The main difference in this case is the different manner of laminate failure in the immediate vicinity of the hole. Similarly to the W type coupon, the layer directly under the fastener head is damaged in this case; however, directly underneath it, there are no clear cracks and delaminations. Instead, a shearing band is clearly visible, which begins at the edge of the fastener head and goes through all laminate layers. It means that in the case of the K coupon, the lack of fibres in the  $0^\circ$  direction, prevented effective seizure of laminate shearing in the direction perpendicular to its plane, which resulted in the fastener pull-through requiring less load than in the case of W and P coupons.

Fig. 8. Failure development in a laminate with a placed hole [own elaboration]

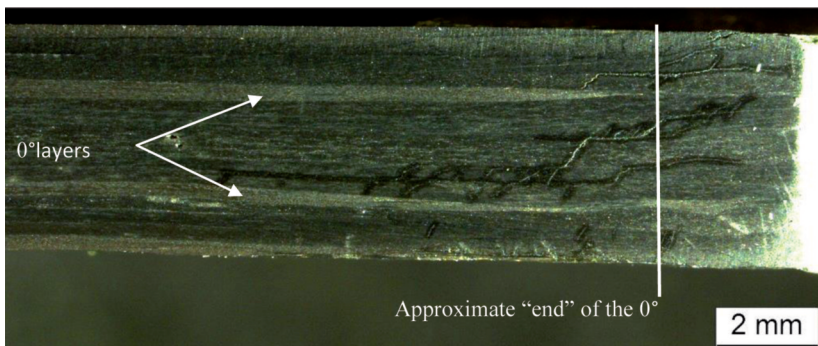
Fig. 9. Arrangement of composite layers in a K coupon near the hole [own elaboration]
