FATIGUE DAMAGE OF RIVET JOINTS IN THE CONDITION OF STABLE CYCLIC LOAD

Volodymyr Hutsaylyuk
Lucjan Śnieżek

Military University of Technology, Warsaw, Poland

Abstract

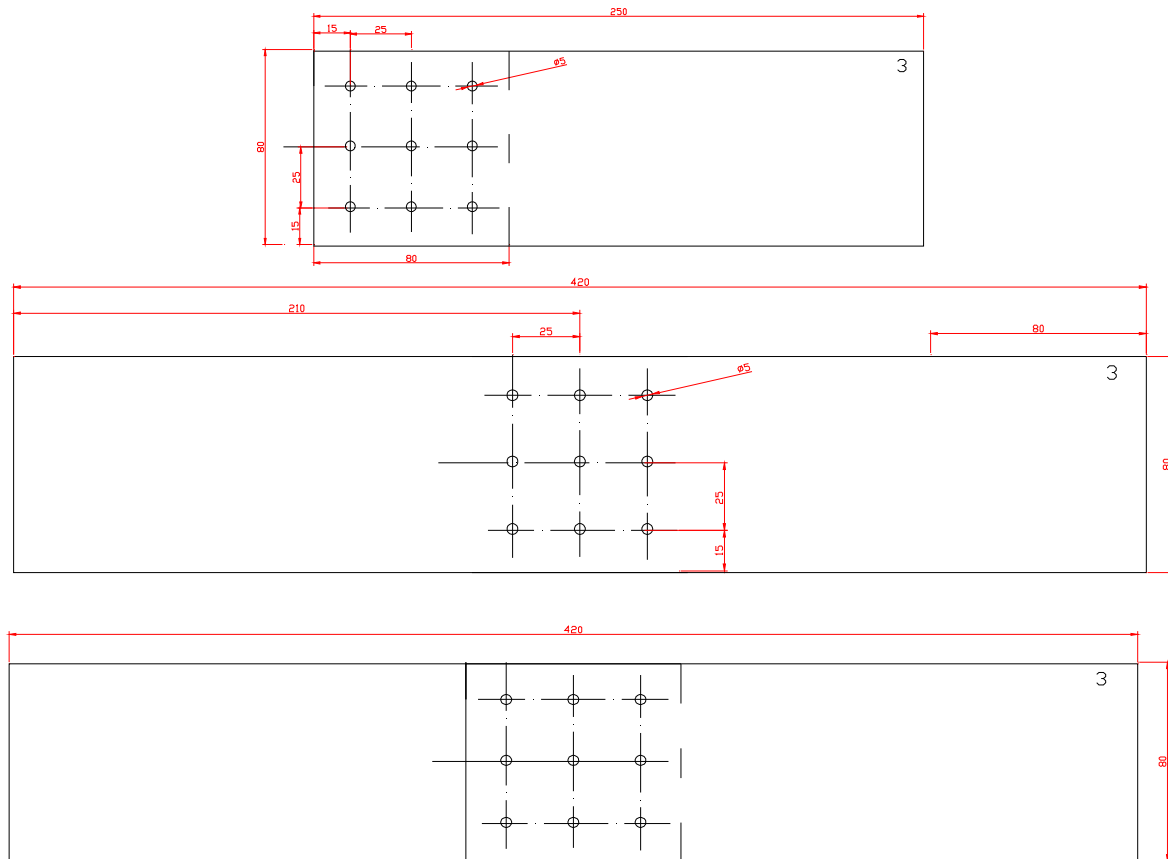
Fig. 2. Specimens for testing

The specimens for testing were made from sheet and were cut from double-sided lamellar aluminum in direction of rolling. For testing were used three types of unified specimens (Fig. 2): plates 80×250 mm, 80×420 mm and “oar shaped” specimens for tensile testing. The holes for rivets were manufactured in such way to ensure that heads of rivets would be with maximum fit to plane of the plate and crossing onto borders of head of plate was minimal. Shorter plates were joined by three rows of rivets, each row had three rivets. Riveting was realized by a press with forming a half a sphere closing head. Plates overlay estimated 40 mm. The longer plates were manufactured with holes for body of a rivet and also for the head. A part of them was joined by rivets in the central part, identically to previous specimens. Prior to testing rivets were removed

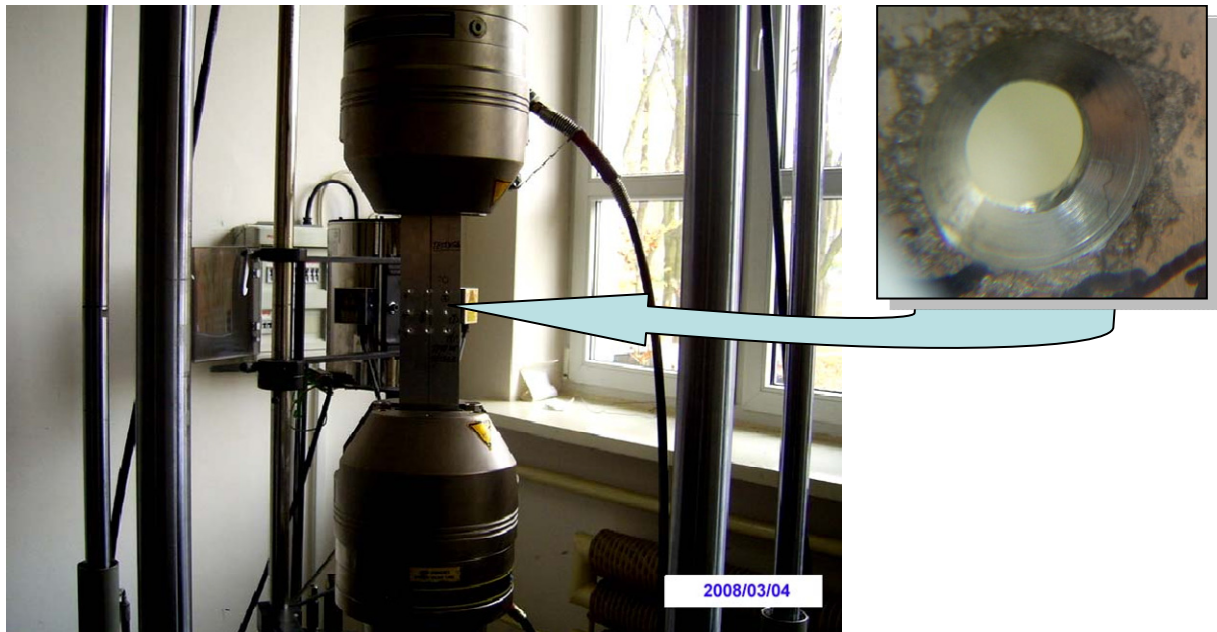
Fig. 3 Testing machine

Research was realized on testing machine «Instron» (Fig. 3) at cyclical load of stable amplitude $\Delta\sigma=100\text{MPa}$, at frequency of 15 Hz and coefficient of asymmetry $R=0.15, 0.3, 0.5$.

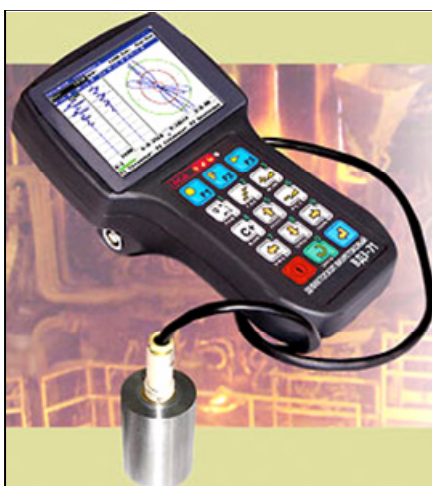
Major technical parameters:

Range of working frequencies	from 500 Hz to 2 MHz
Terminal volts generator	from 0,5 to 8 V
Range adjusting multiplication factor	52 Db
Range scaling signal	to 1:100
Frequency discretization (frequency selection)	to 3000 sel./s

SENSOR OF TYPE OF PN-12 MDF 01

Fig. 4 Vortex-current defectoscope BD 3-71

For the control of material damage was used vortex-current defectoscope BD 3-71 with a sensor of a converting type PN-12 MDF 01. The main parameters of the device are listed in Fig.4.

Prior calibration of a device was completed by use of master sample with depth from 0, 15 mm до 2 mm. Since sensor is being used in the protective shield, then amplifying coefficient was in

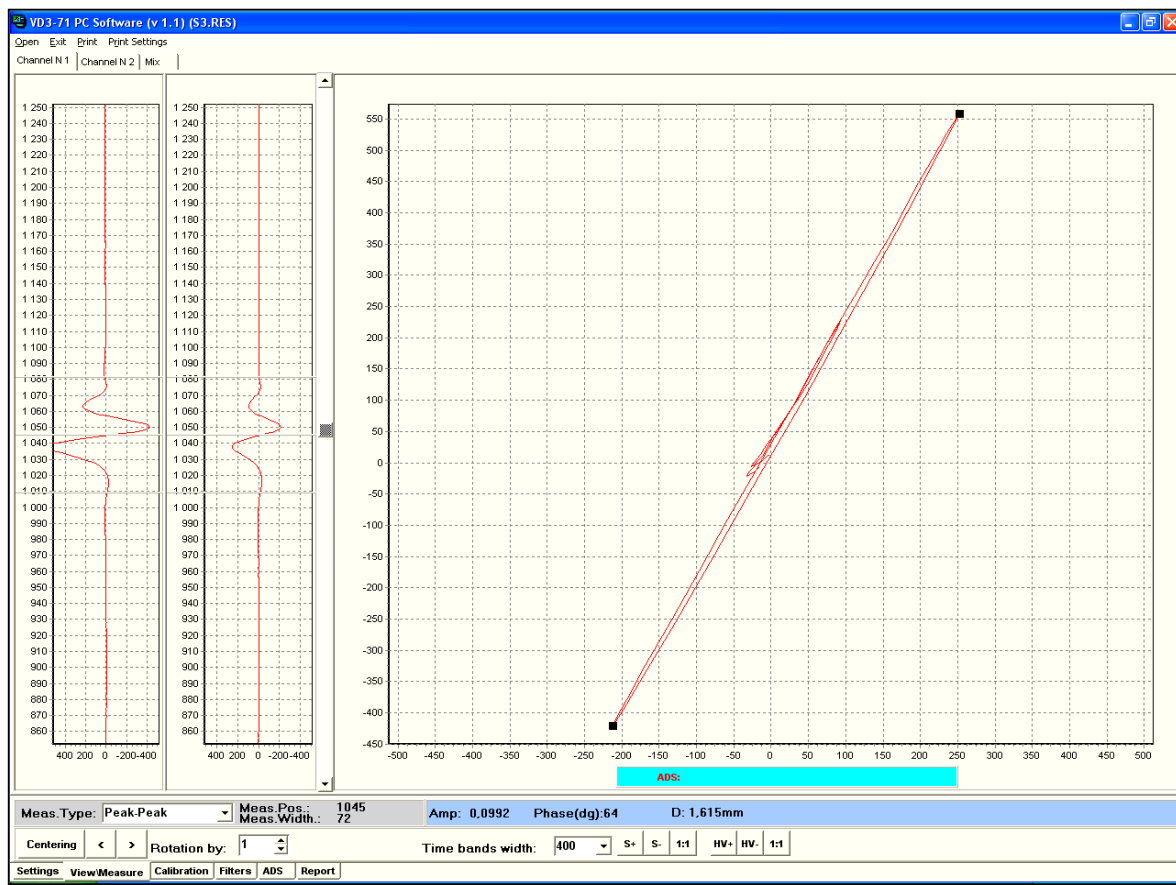
Fig. 5 Screen shot of BD371_1_11 program

Fig. 5 shows the screen shot of the program. The left side of the picture shows a signal in time over two channels and on the right side a complex plain. Hole is recreated in form of two peaks in time (crossing over beaches), and in the complex plane respectively as a loop.

Presence of damages causes deformation of a loop form in the complex plane and bending of the one of peaks on the graph of dependency signal from time.

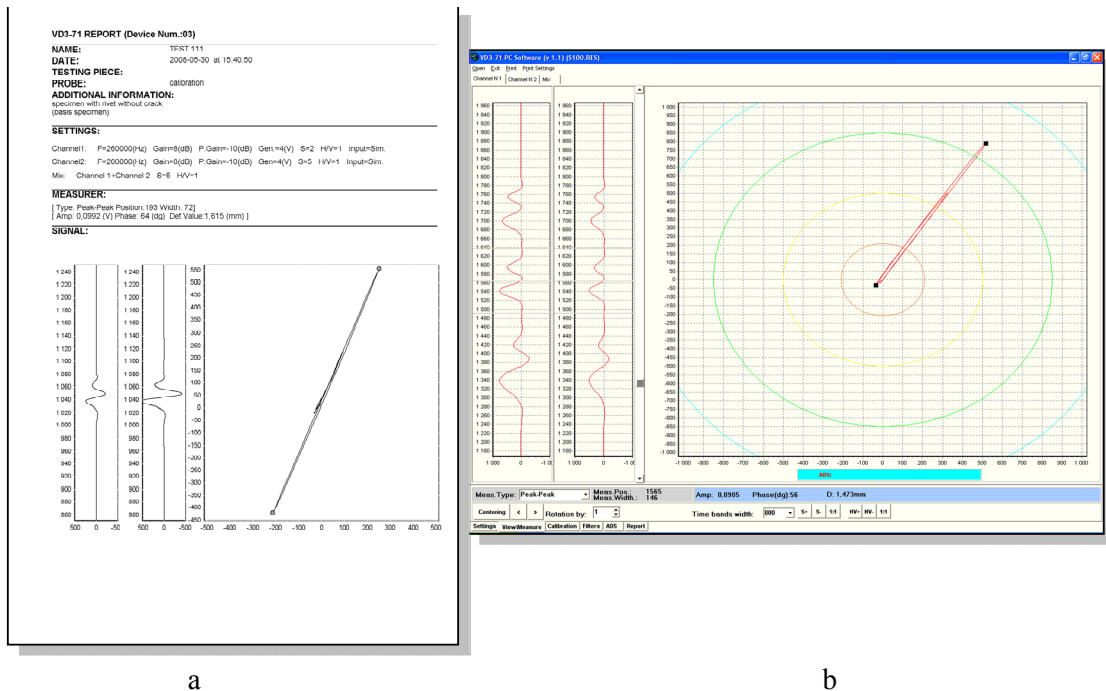
Fig. 6 Sample of a report in text document print out (a) and screen shot of a window with set limits (b)

The measurement of the value of a damage conducted by way of selecting of a peak on a graph by a cursor. Result of each measurement can be printed in the form of a text document (see Fig. 6). The document contain all numerical data and graphical reflection of a signal, however a set limits during measurement in complex plane on Fig. 6b on the print are not shown.

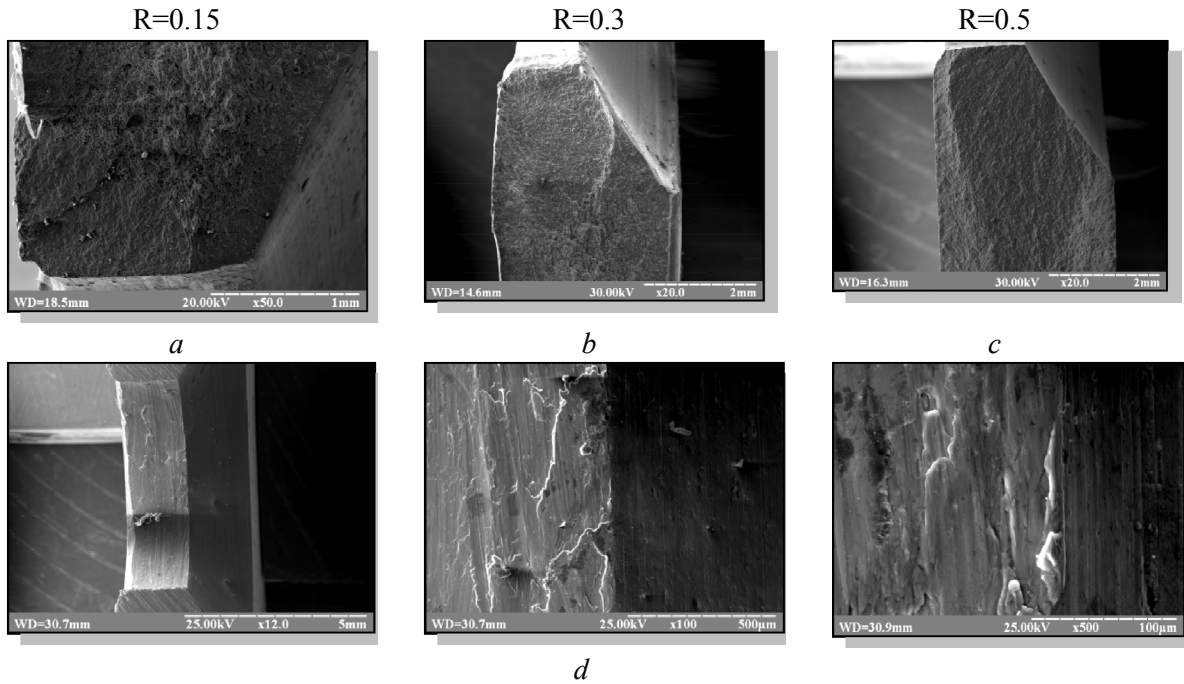
Fig.7 Source crack initiation on surface failure and area propagation crack in zone near source crack initiation (sem microscope picture)

Therefore, fractography analysis at first was conducted on broken surface of overlay. At that stage of research surface of a hole in underlay was analyzed only on surface for comparison of a mechanical state of damage on a surface after mechanical treatment(Fig. 7).

For a different asymmetry of a cycle characteristically is different front of a fatigue crack, short and wide in case of $R=0,15$ and more elongated, closely similar to half-elliptical in the next two (Fig. 7b,c). In the all cases fatigue propagation of a crack was happening in the thickness of a material, practically without surfacing. This illustrates importance of revealing of crack propagation prior to surfacing, because after appearance on the surface it becomes a case of finishing stage of failure and momentary propagation of a crack. On a Fig. 7a the front of a crack has a ripped form, more closely similar to elliptical quadrant. Typical pictures of a surface inside the hole after mechanical treatment are shown on a Fig. 7d. With magnification on the surface clearly are visible local mechanical damages which might be initiators for cracks. Especially vulnerable place is a transition between lamellar and base material. In the case of a hole additionally imposing deformation of a material on the border during riveting which leads to pressing out of metal, Fig. 8.

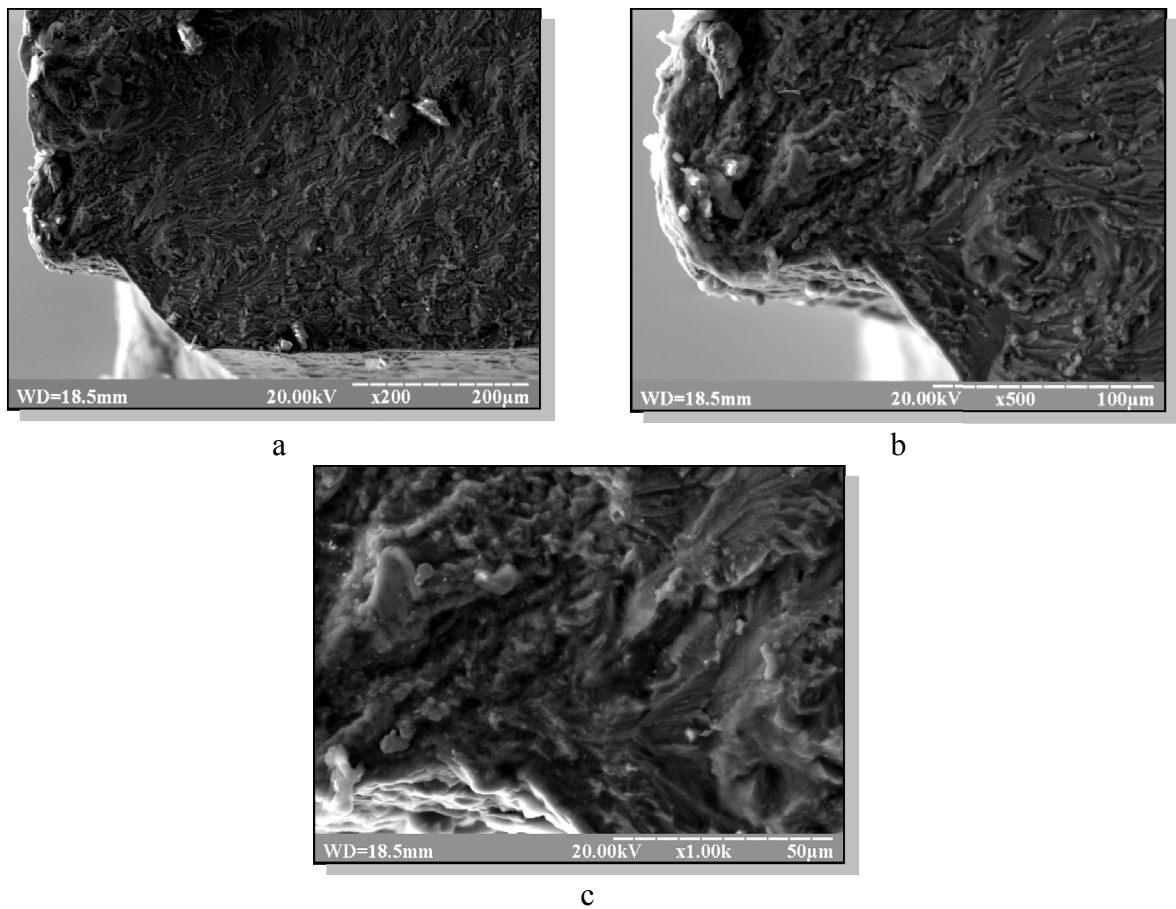
Fig.8 Fatigue mechanisms of crack propagation

On the surface of a fracture clearly visible deep valleys on the bottom of which secondary micro cracks are visible. Generally they are concentrated at the bottom of the pressed out material, facets are quite massive, and respond to size of structural composition, such as grains or sub-grains and created as a result of sliding on corresponding crystal- graphical planes, also visible pits that remain in subsequence to destruction of inter-metal inclusions. Direction of combs is parallel to direction of fatigue crack propagation. On Fig.8a it might be able to distinguish two different types of facets, more crumbled by the surface and a bit elongated towards center of the sheet, which assembly into brook pattern. Obviously this is explained by different level of hardness of surface layer of lamellar, which fails more brittle and base material. Separation of those layers acts as main source of crack initiation, inception of which is stimulated additionally by mechanical damages when making a hole and external loads. On some facets of main material fatigue furrows are observed, which appeared as a result of sliding of crystal-graphical planes. Already at this stage it can be noted the beginning arrangement of facets, that gives a basis to suppose that on this stage crack propagates towards surface of specimen, tunnelling lamellar and moving towards surface of the hole. Only in the next stage crack front would be formed which would define quadrant or half-elliptic macrocrack. General mechanism of fracture realized as consequences of beginning and propagation of cracks on planes of sliding by the way of movement under 45° angle in regards to axes of stress.

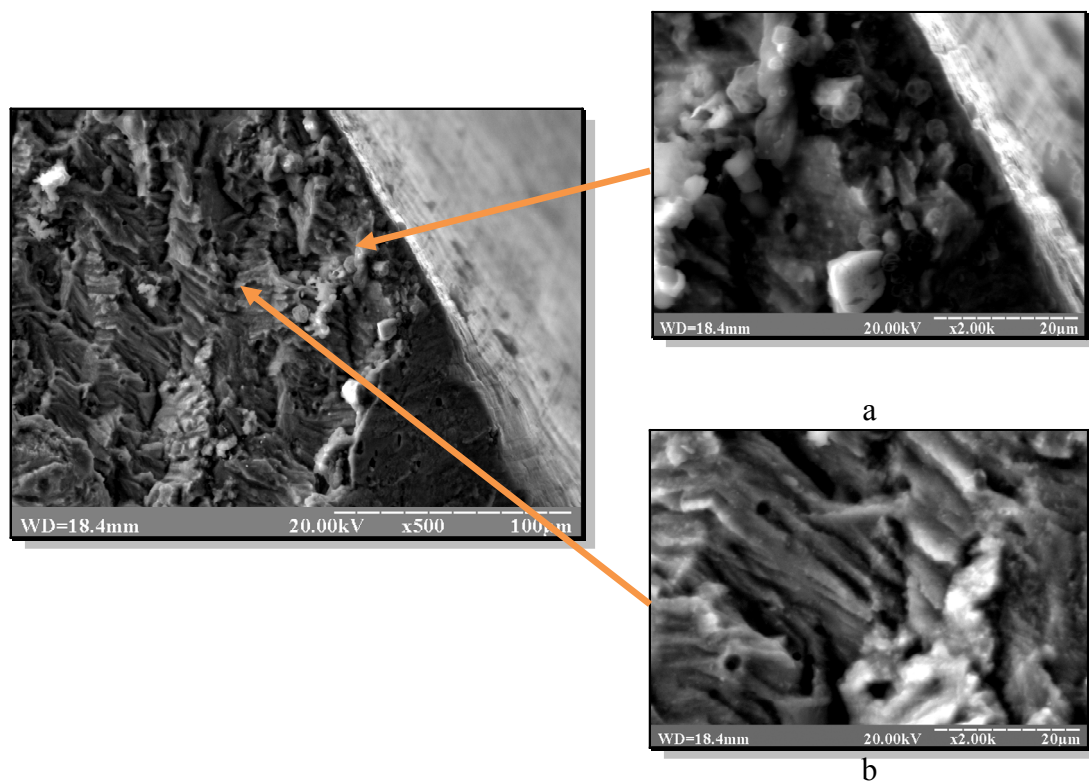
Fig.9 Fatigue mechanisms of crack propagation

Next character point was a field inside of propagation of fatigue macrocrack, with a certain distance from the layer of lamellar into depth of specimen (Fig. 9)

The state of surface of fracture was analyzed in two points: one of which is located on the surface of a base material and second on a surface of destruction of lamellar. Fracture of lamellar is characterized by great amount of small facets (Fig. 9a), which have rounded edges and remotely look like spherical objects, secondary cracks and in deepening small pits appear to be present. A general picture of damages in this layer is unclear and might be explained by additional failure of

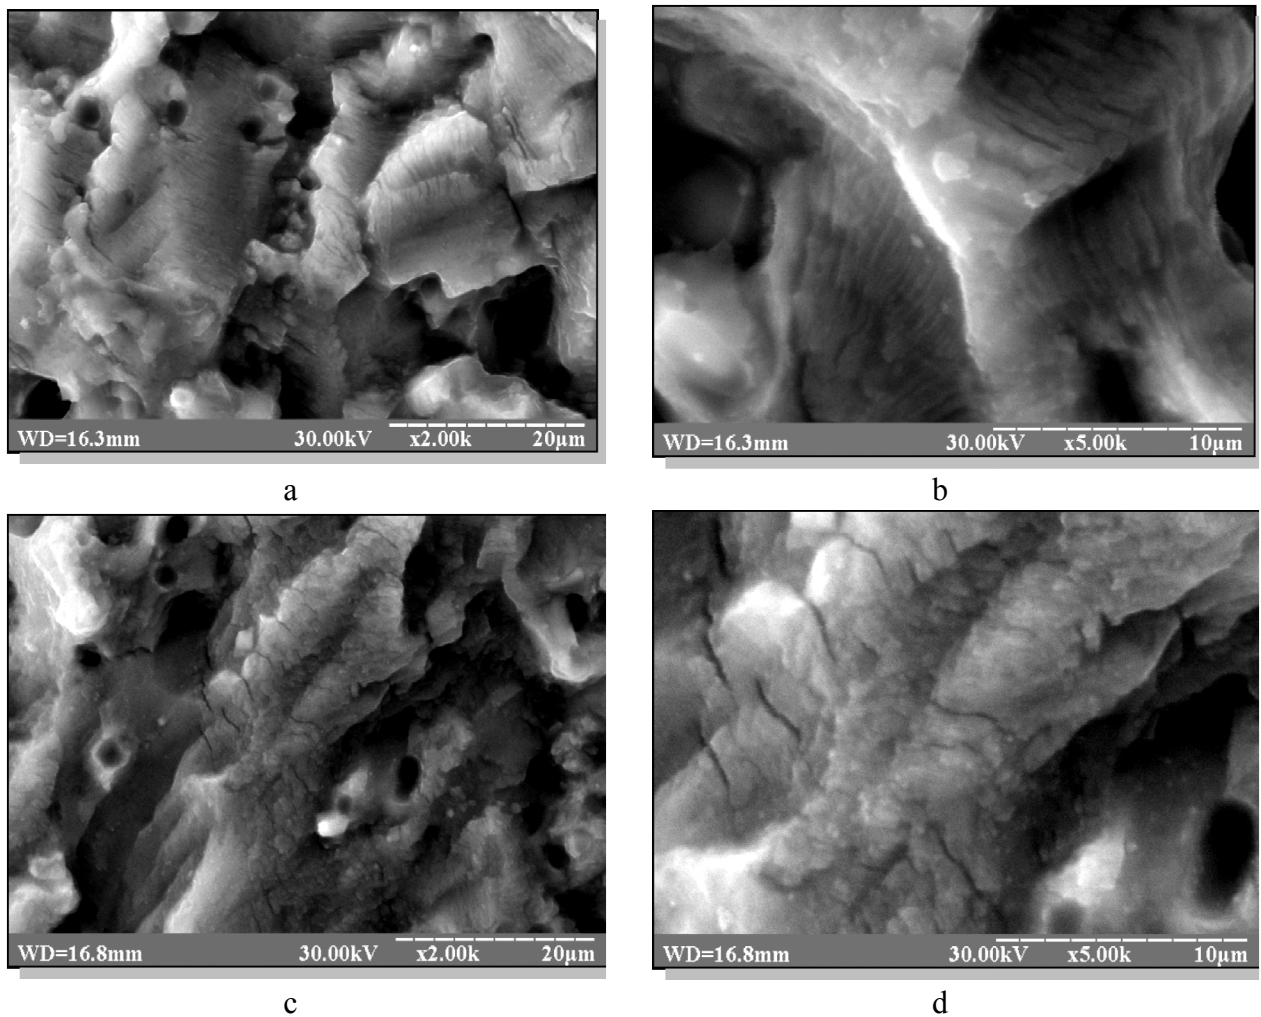
Fig.10 Fatigue mechanisms of crack propagation

On the stage of stable propagation of fatigue crack clearly defined fatigue furrows are formed, most character fragments of which are presented on Fig.10. Fatigue furrows located on facets, size of which corresponds to size of alloy structure elements. The orientation and levels of some facets changes from grain to grain. Presence of massive inclusions causes local ductile fracture due to mechanism of pores growth. By comparing small growth of fatigue crack a step of fatigue furrows is smaller (Fig. 10a,b). With an increase in speed of growing of a fatigue crack, step of a furrows increases and increases quantity of secondary cracks (Fig. 10c,d)

It is necessary to note that due to complex stress state in cyclical plastic zone prior to tip of a crack, the direction of lines of fatigue striations may be essentially differ in neighbouring grains, since fatigue crack locally propagates in a direction with minimal energy of fracture. (Fig. 10a,b)

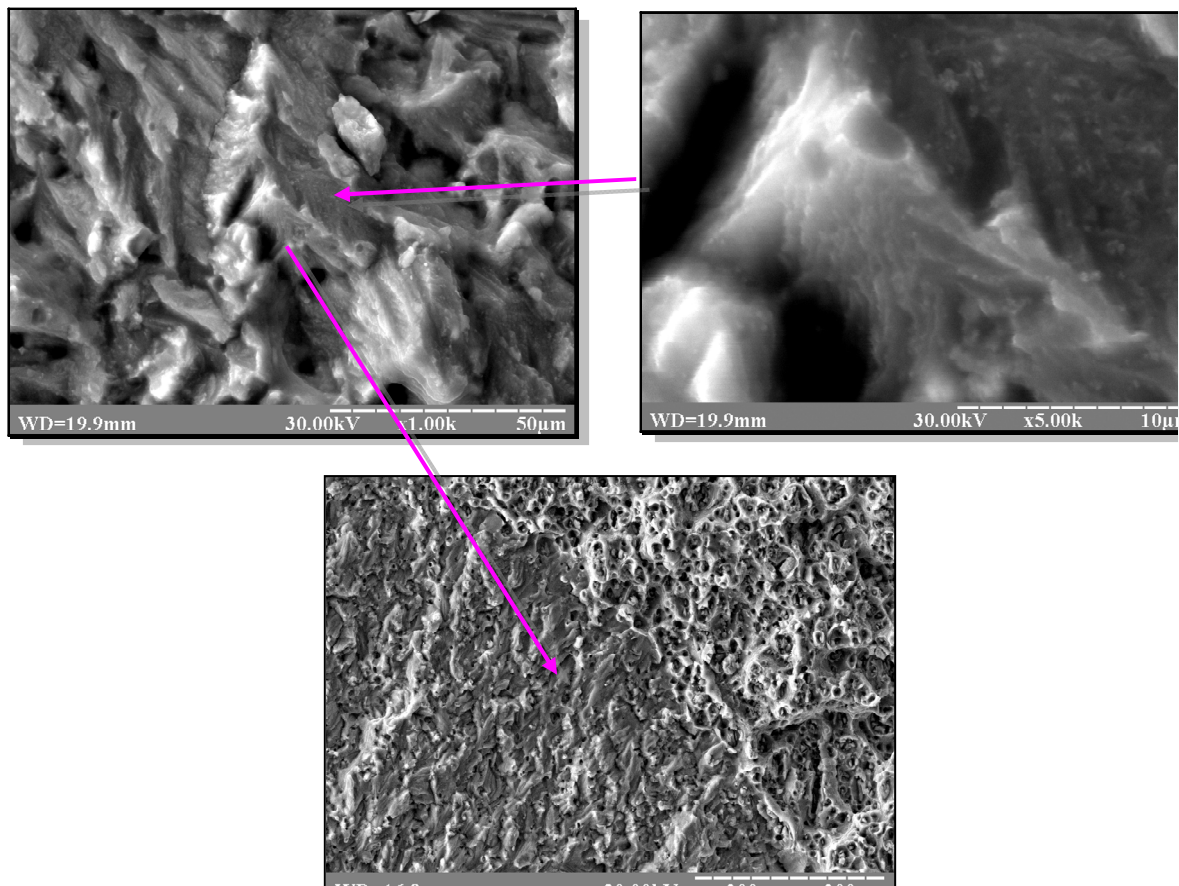
Fig.11 Fatigue mechanisms propagation crack

The last phase of macrocrack propagation is a zone of final stage of failure. On a Fig. 11, shown an area of a transition of fatigue growth of macrocrack into a ductile pit failure. However, a surface of fatigue failure is covered by facets, but they do not create brook patterns; but rather positioned chaotically. The surface of cavities and facets with clear boundaries (Fig. 11a) are well visible secondary microcracks which located in the area of cavities, on the edges of facets (Fig. 11b). Furthermore, it is possible to distinguish two types of microcracks, deep one, mentioned earlier and small one, which are located across facets edges, practically parallel one to another. Such positioning may suggest that failure is realized on inter-crystal planes by the method of breakage, practically brittle. Cracks that initiated in facets are a consequence of cyclical deformation of material during prior period.
