Influence of Laboratory Ageing on the Preservation of Anti-graffiti Properties for Paint Systems Used in Rolling Stock

Summary

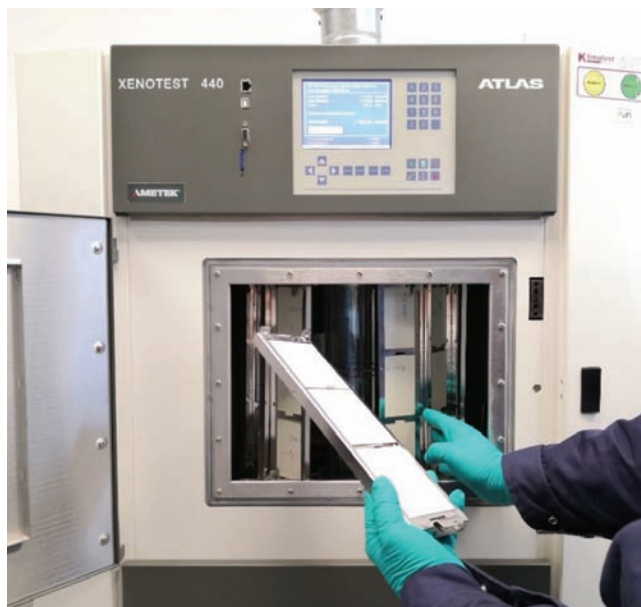
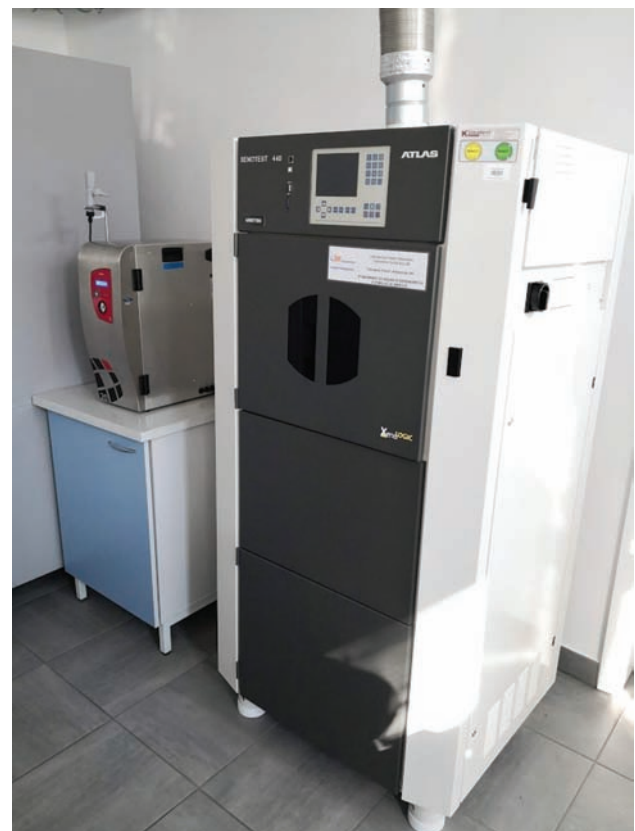
Fig. 1. Test stand for ageing samples according to ISO 16474-2 [7] (xenon weathering instrument, Atlas GmbH Xenotest 440) [Pic. M. Garbacz]

Pictures of the sample ageing test stands where the tests were carried out and an example of the graffiti painting are shown in Figures 1–4.

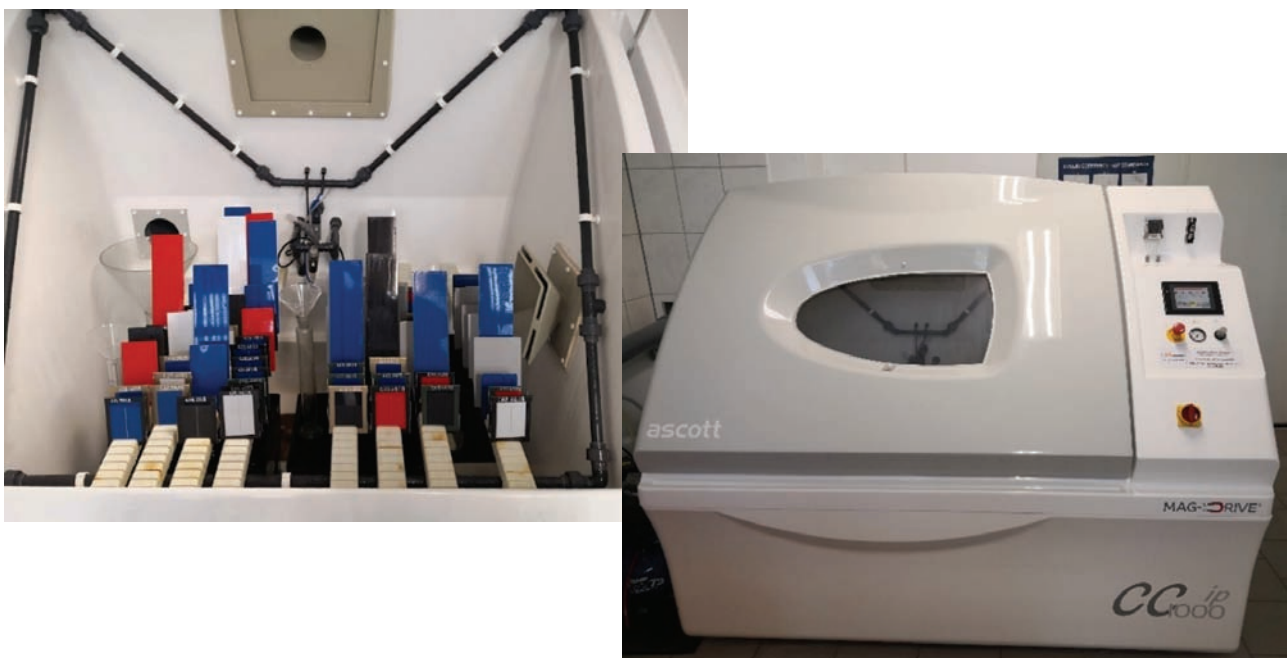
Fig. 3. Test stand for ageing samples according to PN-EN ISO 9227 [12] (Ascott CC1000IP salt spray chamber) [Pic. M. Garbacz]

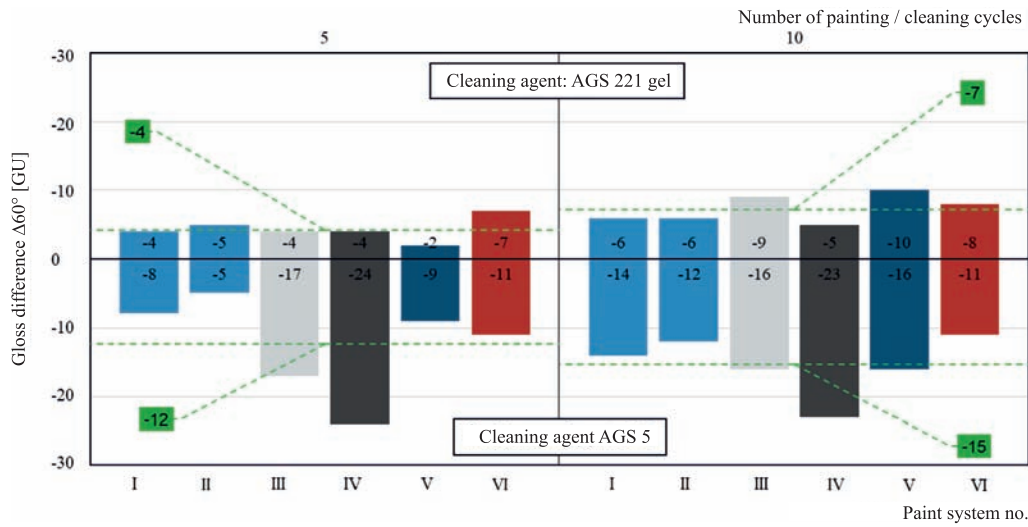
Fig. 5. Change in gloss value in 60° geometry after graffiti resistance test after 5 and 10 cycles of painting and cleaning for unaged samples (AGS-221 and AGS-5 remover) [own study]

Figures 5–8 show the changes in the measured gloss values for the 60° geometry, depending on the type of ageing method used and the graffiti remover, while Figures 9–14 show the changes in the measured colour values for ΔE^* – CIELAB 1976, depending on the type of ageing method used and the graffiti remover, measured using a sphere spectrophotometer with two measurement modes (with the specular component included and excluded). The results shown in Tables 6 and 7 and in the graphs (Figures 5–14) are the average for the 6 different markings used in the tests carried out (the markings are summarised in Table 2).

Based on the test results shown in Table 6 and Figures 5–8, it is concluded that:

- A high effectiveness of the anti-graffiti coating protection of the unaged samples for the tested systems and proper gloss retention was achieved. Similar results were obtained after 5 and 10 cycles of painting and cleaning (retention of the effectiveness of the anti-graffiti coating with respect to the number of paintings and cleaning), with the cleaning agent AGS-221 (gel) performing significantly better. The AGS-5 agent was ineffective and left visible streaks that slightly affected the gloss of the tested systems. In the case of gloss evaluation according to PN-EN ISO 2813 [19], the decreases in gloss values in the 60 geometry averaged –4 [GU] (5 cycles), –7 [GU] (10 cycles) for the cleaning agent AGS-221 (gel), and –12 [GU] (5 cycles) and –15 [GU] (10 cycles) for the cleaning agent AGS-5.

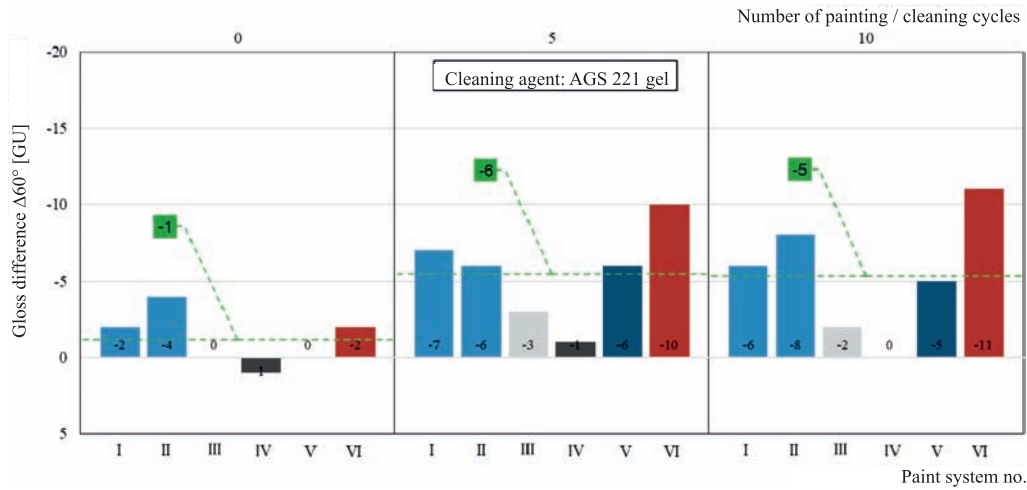
Fig. 8. Change in gloss value in 60° geometry before and after graffiti resistance test after 5 and 10 cycles of painting and cleaning for samples aged according to PN-EN ISO 9227 [12] (AGS-221 remover) [own study]

- The salt spray test according to PN-EN ISO 9227 [12] did not significantly deteriorate the protective function of the paint systems against graffiti and is comparable with the results obtained for unaged samples in the evaluation of the change in gloss properties of the coatings. This indicates that the corrosive agent of sodium chloride does not significantly affect the gloss parameter of the coating, even when intense changes in the form of blistering occur (systems II, V, VI). In the case of gloss evaluation according to PN-EN ISO 2813 [19], the decreases in gloss values in the 60° geometry averaged -6 [GU] (5 cycles) and -5 [GU] (10 cycles) for the cleaning agent AGS-221 in gel form.

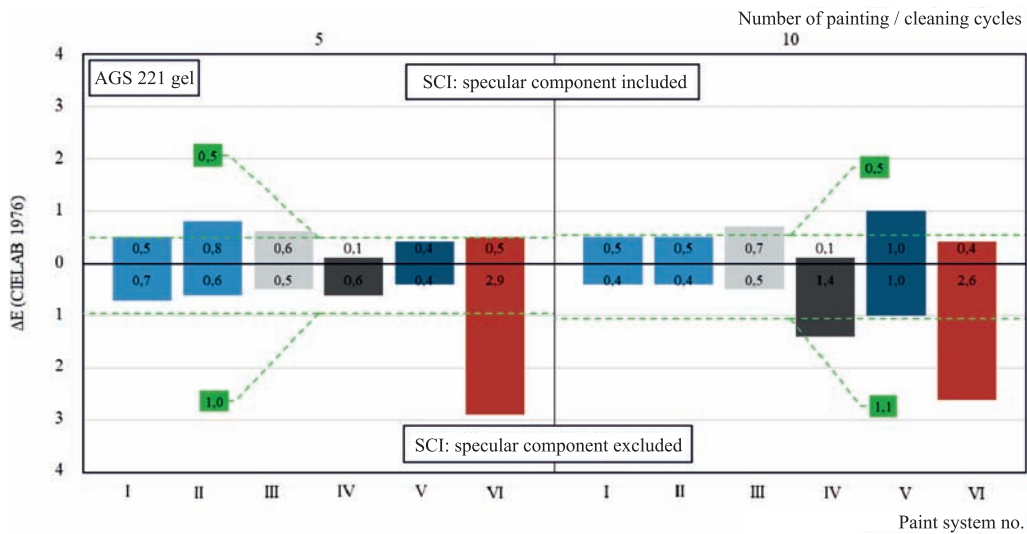
Fig. 9. Change in colour value for ΔE^* – CIELAB 1976 after graffiti resistance test after 5 and 10 cycles of painting and cleaning for unaged samples (AGS-221 remover with the specular component included and excluded) [own study]

The Ulbricht sphere in the spectrophotometer used for the measurements also has a hole called a light trap, which allows gloss to be eliminated from the measurement. In this so-called SCE mode (i.e. with the specular component excluded), the sphere instrument imitates the directional geometry quite well (colour, gloss, texture included). In practice, it is first necessary to determine the difference between two samples (in this case, measurements before and after graffiti painting) by evaluating their measurements made in SCE mode. Then, by checking the SCI data, it can be determined whether the deviation is caused by differences due to pigment changes (caused, for example, by the under-cleaning of the graffiti agents used) or whether its main source is differences in surface structures (e.g. increased roughness) caused by the graffiti paintings and/or the cleaning agent [2, 32]. Based on the test results shown in Table 7 and Figures 9–14, it is concluded that:

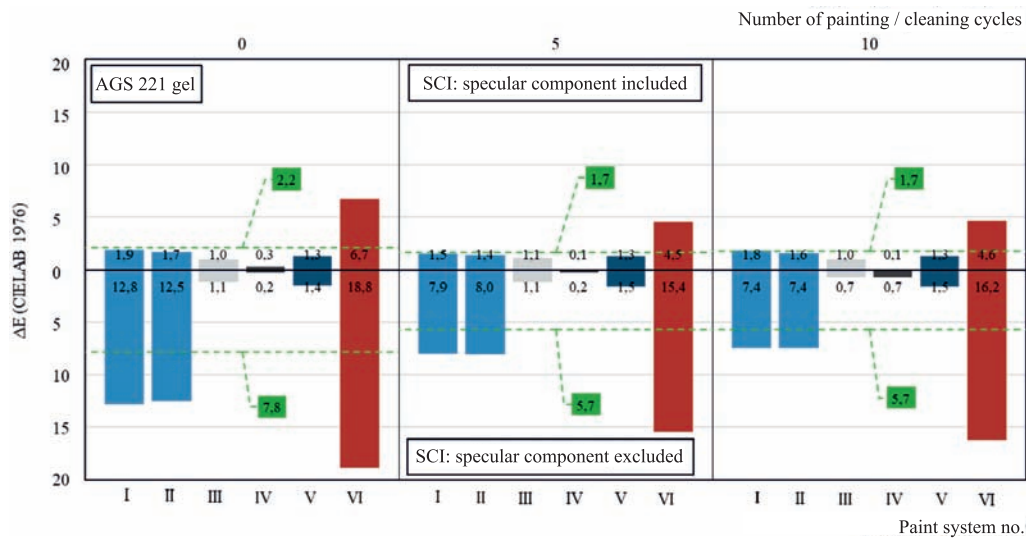
Fig. 11. Change in colour value for ΔE^* – CIELAB 1976 after graffiti resistance test before painting and after graffiti resistance test after 5 and 10 cycles of painting and cleaning for samples aged according to PN-EN ISO 16474-2 [7] (AGS-221 remover with the specular component included and excluded) [own study]

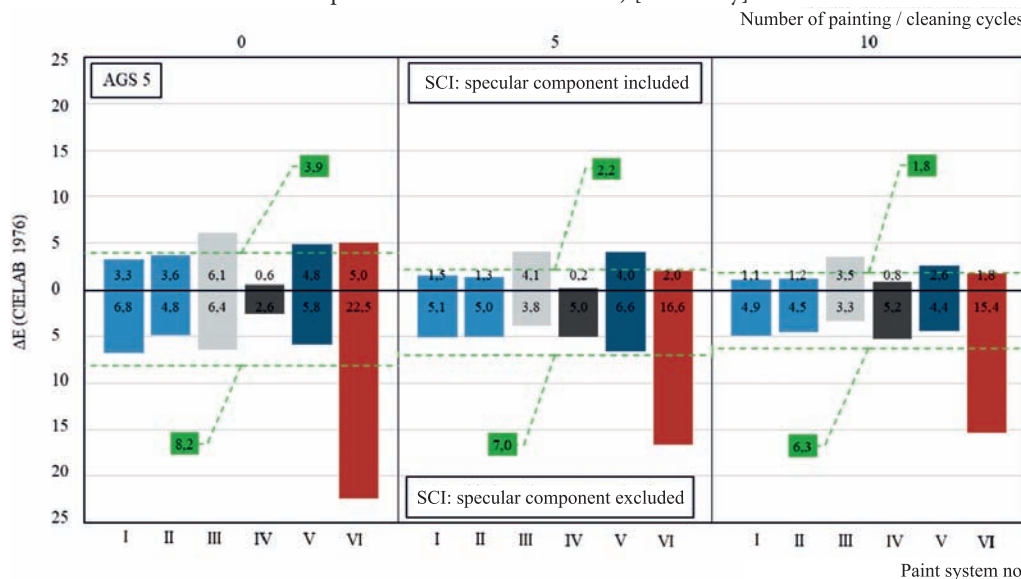
Fig. 13. Change in colour value for ΔE^* – CIELAB 1976 after graffiti resistance test before painting and after graffiti resistance test after 5 and 10 cycles of painting and cleaning for samples aged according to DN 001/08/A2/16 [10] (AGS-5 remover with the specular component included and excluded) [own study]

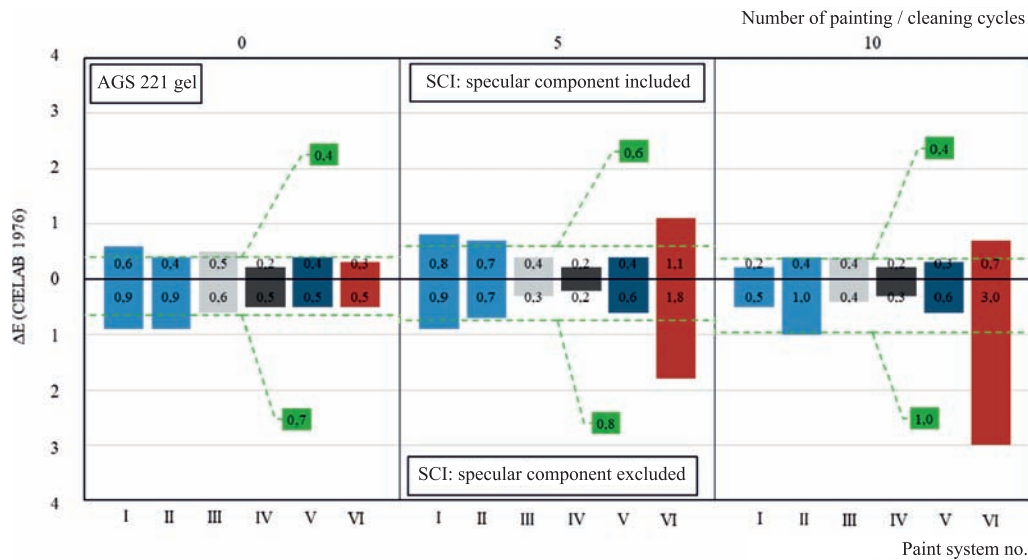
Fig. 14. Change in colour value for ΔE^* – CIELAB 1976 after graffiti resistance test before painting and after graffiti resistance test after 5 and 10 cycles of painting and cleaning for samples aged according to PN-EN ISO 9227 [12] (AGS-221 remover with the specular component included and excluded) [own study]
