Fractography analysis of Inconel 718 fatigued at 700°C

Abstract. This work deals with the fractography analysis of nickel-base superalloy Inconel 718 fatigued at 700°C in air atmosphere in the high cycle region. During cyclic loading of this alloy at high temperatures some different mechanisms compared to cyclic loading at ambient temperature take place. Cyclic plastic deformation at high temperatures causes some structural changes, which could have some influence on the fatigue process.

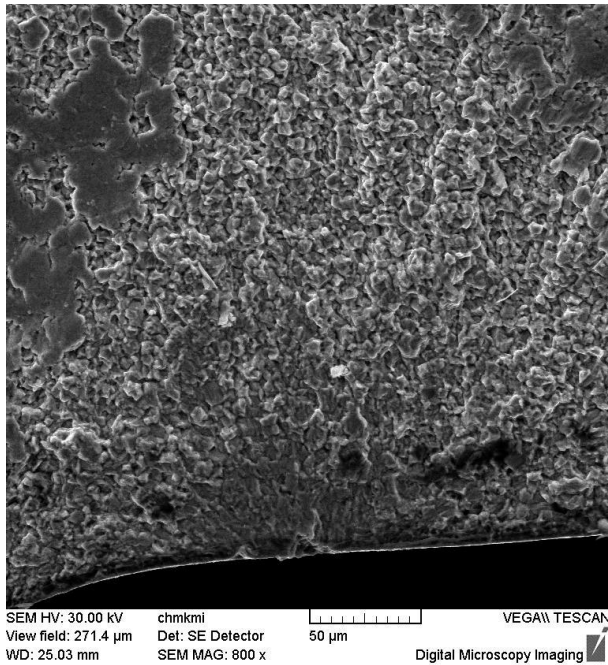
Fig. 1. Typical initiation site, In 718 cyclically loaded at 700°C, REM.

Initiation of the fatigue crack takes place solely on the carbidic or carbonitridic particles at surfaces or subsurface area (Fig. 1 and 2), which is in clear contrast with the crystallographic initiation observed at fracture surfaces of specimens fatigued at ambient temperatures. In the study of (ABIKHI M. ET AL. 2013)

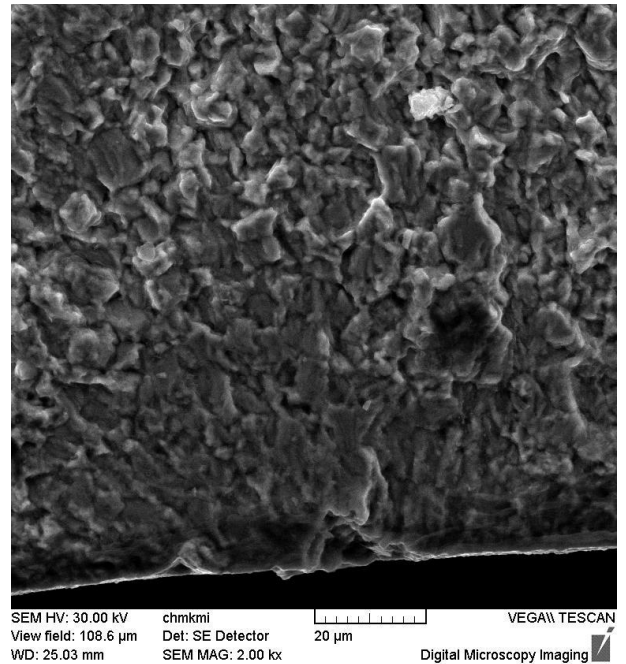
Fig. 2. Detail of the initiation place, there is clearly visible that initiation of fatigue crack took place on the carbonitridic particle, REM .

was well described mechanism of crack initiation of carbide particles at specimens cyclically loaded at high temperature at small frequencies of loading (oxidation and subsequent volume expansion of carbide particles caused internal stresses in the matrix, which serves as a preferred initiation places). Implementation of this mechanism in the study is questionable, and it needs some more research to confirm or reject this claim, but in general, for example, the specimen broken after $N_f = 3.6 \times 10^6$ cycles, had quite sufficient time to oxidation of carbide particles, because in the high cycle fatigue, initiation stage consume more than 90% of the whole time of the fatigue test and duration of test was 7.5 hours.

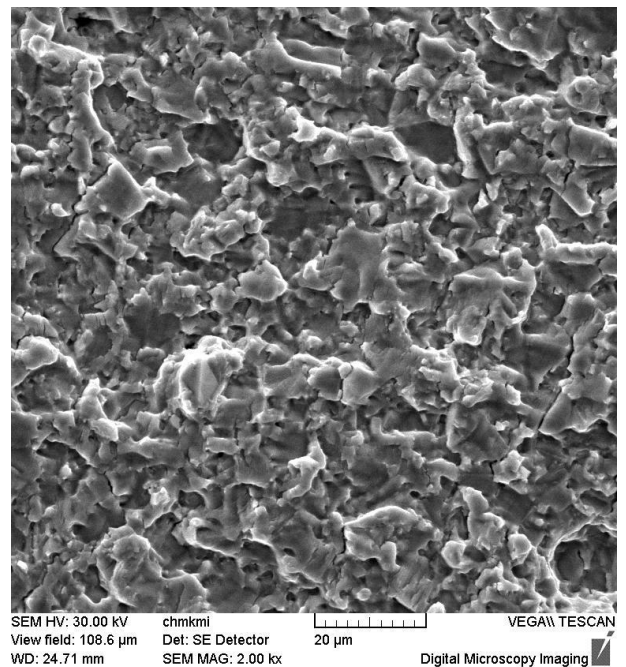
Fig. 3. Area of fatigue crack propagation, there is visible rough character of fracture surface, REM.

Fatigue crack propagation occurs by the transcrystalline ductile mechanism (Fig. 3), while on the fracture surface a great number of the secondary cracks was observed. Facets of intercrystalline fatigue crack propagation weren't observed in neither case. Formation of intercrystalline fracture is in the case of In 718 is conditional on the present the high content of laves phase (which is not possible in the wrought material) or by very high level of oxidation of the grain boundaries region, but this case is possible only when specimens are loaded at very low frequencies. On the fracture surfaces, in the crack propagation area striations could be observed, but they were hard to detect due to a certain degree of oxidation at the surface and a significant roughness topography of the fracture surfaces. Fracture profiles observations, showed, that by increasing length of the crack (and thus K_{II}), the fracture profiles had higher roughness, which is well documented on Fig. 5 and 6.

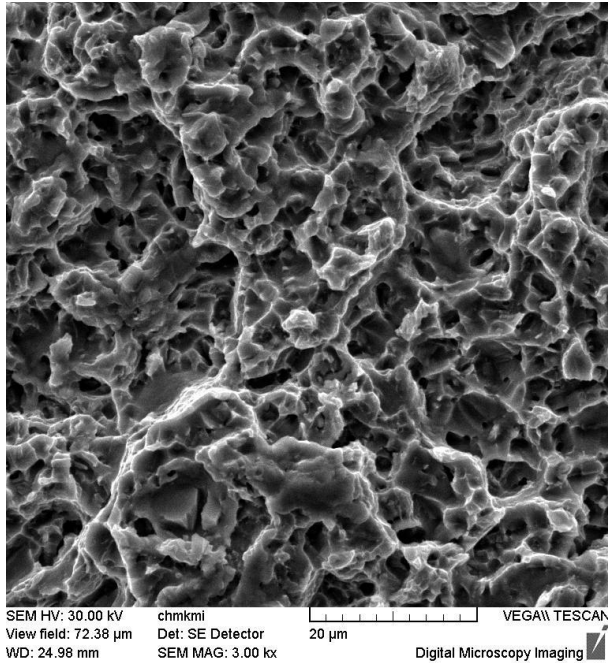
Fig. 4. Final rupture, transcrystalline ductile mechanism with strong dimple morphology, REM.

Final rupture took places by the transcrystalline ductile mechanism with very strong dimple morphology (Fig. 4), which was caused increased ductility in testing temperature. Facets of intercrystalline fracture were not observed in the final rupture region, and it shows a good state of microstructure, even some struc-

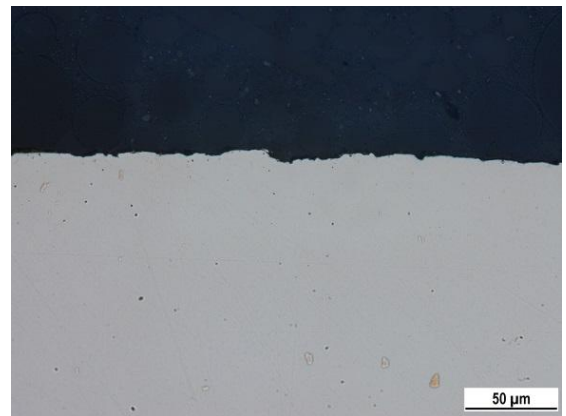
Fig. 5. Crack profile at crack length 2.5 mm.

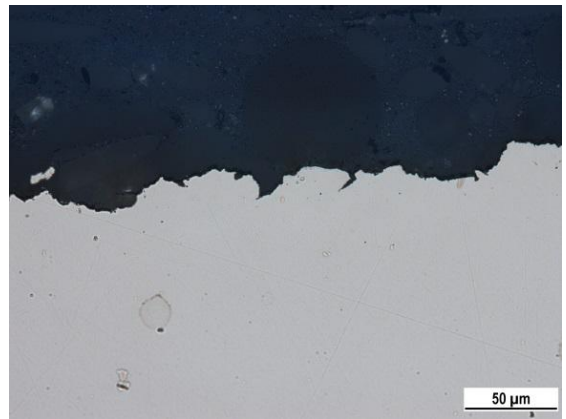
Fig. 6. Crack profile at crack length 7.5 mm.

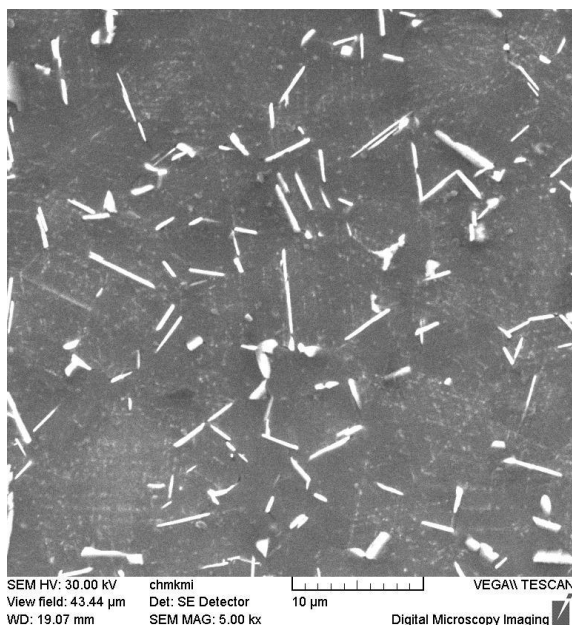
Fig. 7. Microstructure of In 718 of initial state, electrolytically etched in CrO₃ water solution, REM.

Microstructural observation showed that the cyclic plastic deformation at high temperature (700°C) caused significant microstructural changes. Microstructure of the initial state (Fig. 7) consists of the fine grains of gamma matrix, delta phase particles at grain boundaries and with a primary carbides Nb(Ti)C and carbonitridic particles TiNC. In structure there are also fine precipitates gamma prime and gamma double prime, but these are not detectable by this kind of observation due their small dimensions and the strong coherency with the matrix. In the microstructure of the specimen cyclically loaded at 700°C (Fig. 8) were observed significant changes, especially in the form and the amount of the delta phase particles. Cyclic plastic deformation caused mechanical dissolving of gamma double prime particles (this mechanism is described in the work (WORTHEM D.W. ET AL. 1990), which leads to faster transformation of gamma double

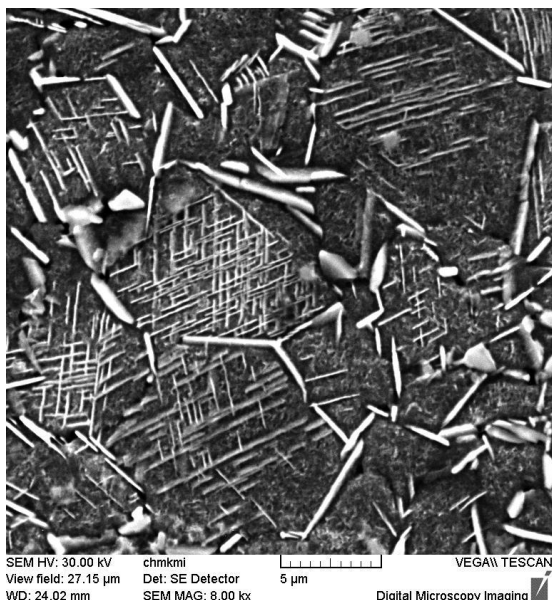
Fig. 8. Microstructure of In 718 after cyclic loading at 700°C, sample from fracture subsurface, great increase of intragranular delta phase, electrolytically etched in CrO₃ water solution, REM.

prime to the intragranular delta phase (delta precipitate as a plates – in the cross section needles). Despite the fact that the volume of delta phase in the structure dramatically increased, it could be stated that it has no effect of the fatigue process in the Inconel 718 superalloy.
