Baltic Sea port waters extreme events of last 30 years caused by climate-weather hazards

Baltic Sea port waters, sea accident, climate-weather states, extreme weather hazard states

The paper deals with the sea accidents that have occurred at the Baltic Sea port waters for last three decades. For each accident, the climate-weather change process state is fixed to examine the weather hazard influence on this accident. Moreover, the Baltic Sea port waters accidents caused by the extreme weather hazard states are described.

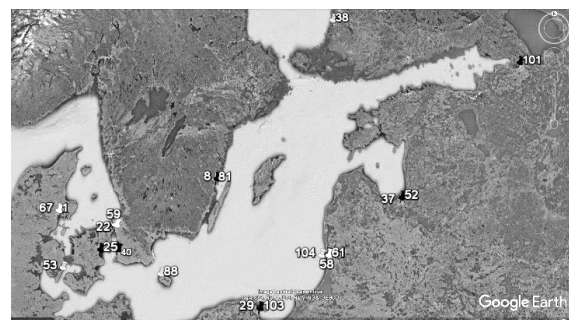
Figure 1. Ship accidents the Baltic Sea, port waters (the number on the map is corresponding to the accident number in *Table 1* in [Bogalecka et al., 2017a].

Despite the lack of exhausting, detailed and completed documents on ship accidents at the Baltic Sea for last three decades, we collected more than 100 sea accidents that have happened at the Baltic Sea area for last three decades [Bogalecka et al., 2017a]. A lot of them (81%) occurred at the Baltic Sea open waters [Bogalecka et al., 2017b]. The remaining accidents (19%) happened at the Baltic Sea ports (*Figure 1*).

The accidents that happened when the climate-weather change process was at the state c_4 and c_5 are marked with black pin on the map in Figure 1. We described these accidents in detail below.

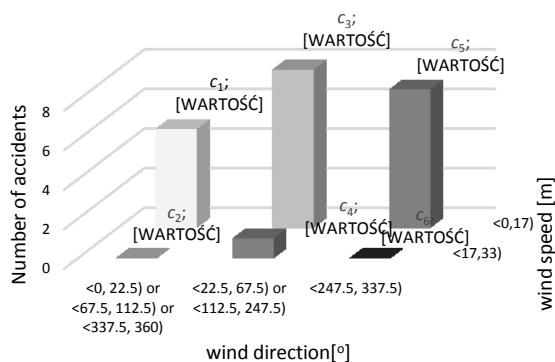
Figure 2. Number of the Baltic Sea port area accidents according to the states of the climate-weather change process.

In the compilation of accidents occurred at the Baltic Sea port areas there are 5 ones that happened when the climate-weather change process was at the state c_1 . In opposite, there are no accident that happened when climate-weather change process was at the state c_6 , means the extremely bad weather condition, but there are 1 and 7 accidents when the climate-weather change process was at the state c_4 or c_5 respectively, mean the moderate weather hazard states (Figure 2).

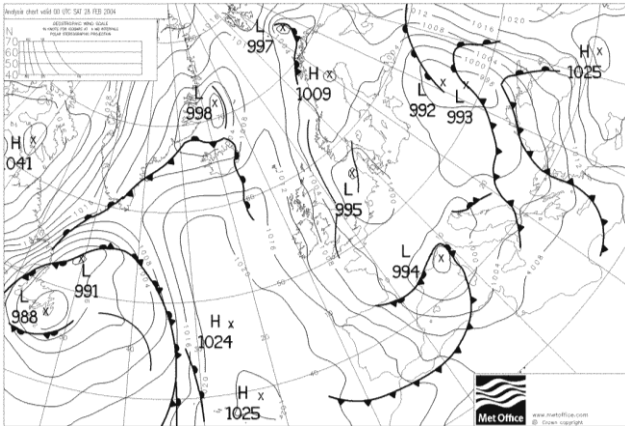
Figure 3. Synoptic map for Europe on February 28, 2004.

The Baltic Sea was influenced by the col in the zone between the area of low pressure with the central pressure value of 995 hPa over the North Sea and the depression with the central pressure value of 992 hPa which was moving from Ukraine over the eastern Russia. Secondary weather fronts across the North Sea indicated an unbalanced polar maritime air mass (Figure 3).

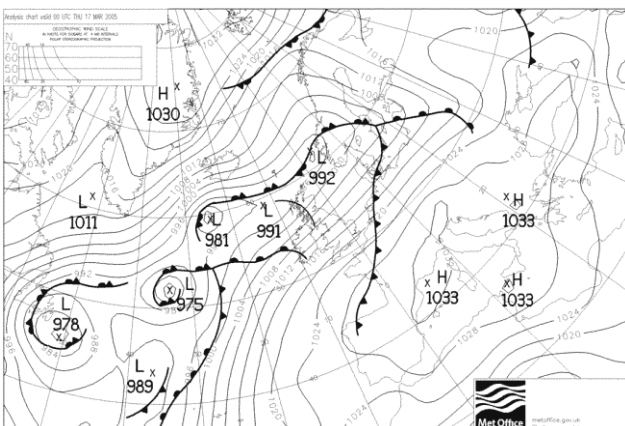
Figure 4. Synoptic map for Europe on March 17, 2005.

Over the Baltic Sea a trough of low pressure between Scotland and southern Norway was moving east. The previous day, the weather was influenced by a traveling warm front. The warmer part of the polar maritime air mass modified the weather at night. Whereas during the day the weather was subject to a cold front bringing a cooler polar maritime air mass (Figure 4). Despite the moderate weather hazard during the accident, the weather condition had the irrelevant influence on it.

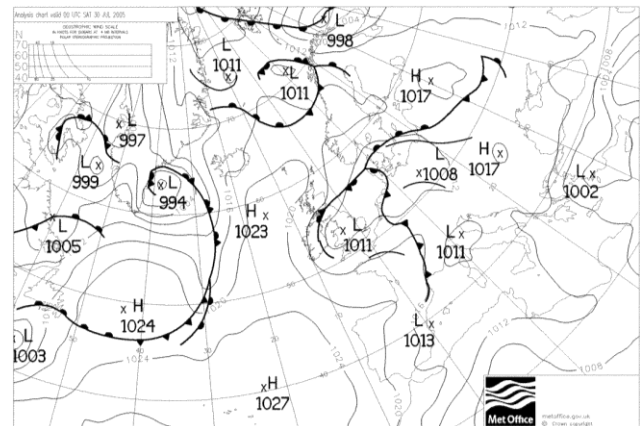
Figure 5. Synoptic map for Europe on July 30, 2005.

The Baltic Sea and northern Poland were influenced by a surface low pressure area originated over Denmark with a fronts system traveling east and northeast. Warm part of the low pressure area stagnating at night over Poland contained a warm, moist and unbalanced air mass (Figure 5).

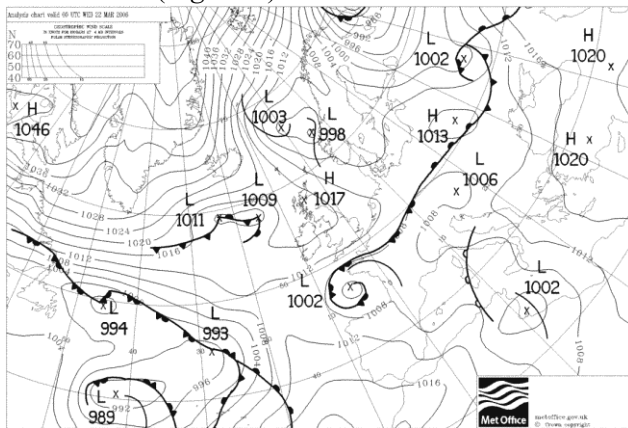
Figure 6. Synoptic map for Europe on March 22, 2006.

The Southeastern Baltic Sea was influenced by the col characterized by a weak pressure gradient, which was related to the cold air mass approaching from Scandinavia (Figure 6).

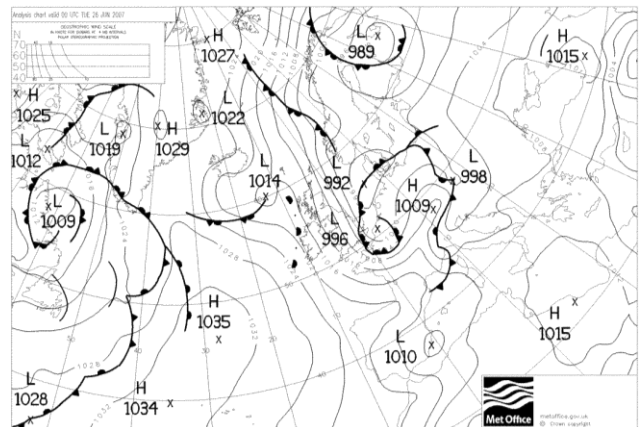
Figure 7. Synoptic map for Europe on 26 June 2007.

An active depression originated over the North Sea and Denmark associated with a fronts system was deepening and moving northeastwards (Figure 7). Despite the moderate weather hazard during the accident, the weather condition had the irrelevant influence on it.

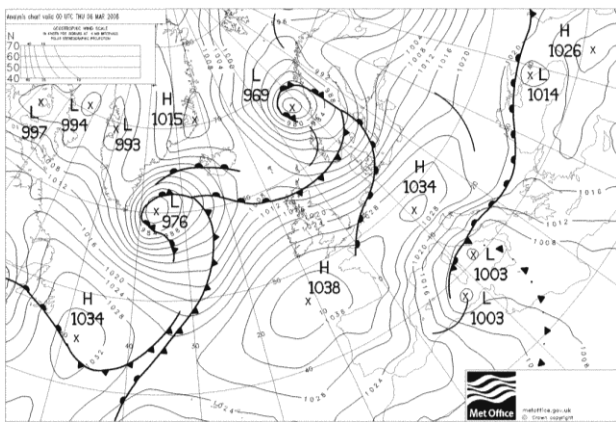
Figure 8. Synoptic map for Europe on March 6, 2008.

The weather in Central Europe was influenced by a polar maritime air mass which was rapidly approaching from the Atlantic. The Baltic Sea was influenced by the through of low pressure in a weather fronts zone associated with a low pressure area. The depression center was dissipating and moving towards Scandinavia from the Norway Sea (Figure 8).

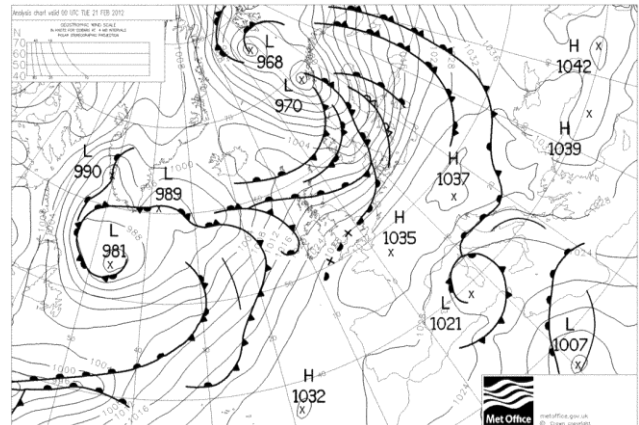
Figure 9. Synoptic map for Europe on February 21, 2012.

The polar maritime air mass in the deep and extended trough of low pressure area was spreaded over the Baltic Sea and northern Poland. A weather was influenced by rapidly moving fronts systems (Figure 9).

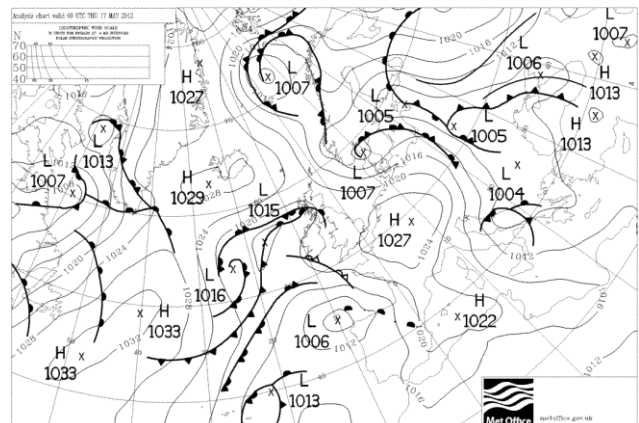
Figure 10. Synoptic map for Europe on May 17, 2012.

The trough of low pressure area was deepening and moving north along with the fronts system from southern Scandinavia and the North Baltic Sea. An area of high pressure was moving eastwards. A polar maritime air mass was approaching from the North Sea (Figure 10).
