*Roger Abang\**, *Alexander Findeisen\**, *Hans Joachim Krautz\**

## CORROSION BEHAVIOUR OF SELECTED POWER PLANT MATERIALS UNDER OXYFUEL COMBUSTION CONDITIONS

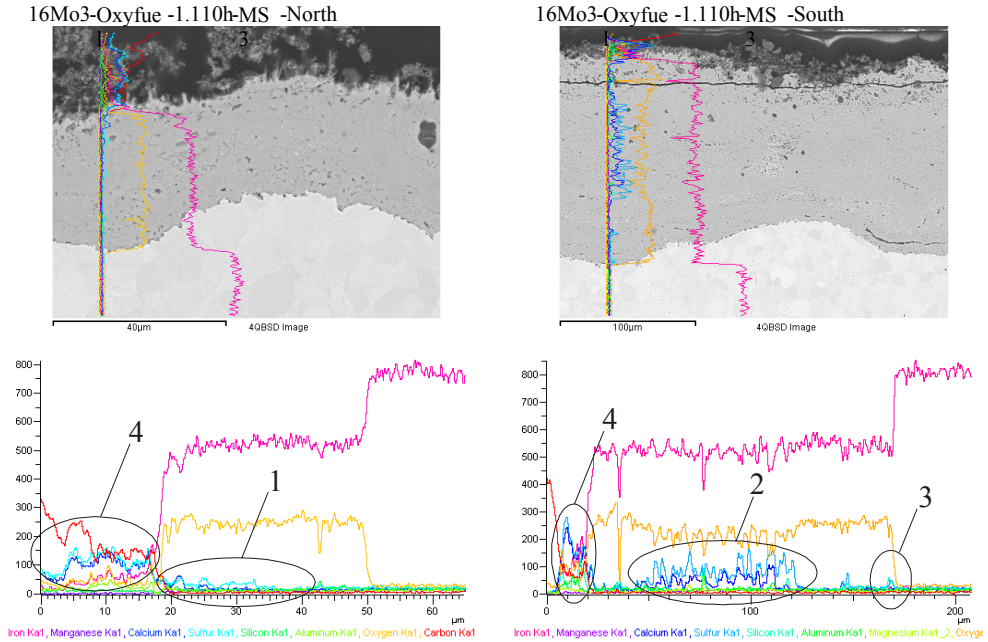
**Fig. 5.** Scanning electron microscope image of the material 16Mo3

The light microscopic images showed porous surface layers as well as loose, overlying and partly-flaked layers of ash under both operating conditions. The main components of the porous surface layer were hematite ( $\text{Fe}_2\text{O}_3$ ) and magnetite ( $\text{Fe}_3\text{O}_4$ ). Iron (II) sulphide ( $\text{FeS}$ ) could not be confirmed. A comparison of the thickness of the layers showed similar layer thickness of the probes on the north side under both air and oxyfuel. However, under oxyfuel conditions the thickness of the layer on the south side was considerably greater than that on the north side. This was due to the existing ash bed and the reactive components within it as can be seen in the SEM image of the material 16Mo3 (Fig. 5).

Furthermore, the SEM images indicated that under oxyfuel conditions sulphur formed on the surface layers. Therefore, the embedding of the probe in the ash bed seemed to have increased the depth of the inward diffusion of sulphur (see 1 and 2 in Fig. 5). Moreover, sulphur was also present in the partially existing layers of ash (see 3 in Fig. 5). In all cases sulphur peaks were accompanied by calcium peaks. This suggested that sulphur was present as calcium sulphate ( $\text{CaSO}_4$ ). However, the bonding of sulphur to calcium under oxyfuel conditions was less pronounced which therefore means that other metal-sulphur compounds may have been formed (compare 2 and 4, Fig. 5).

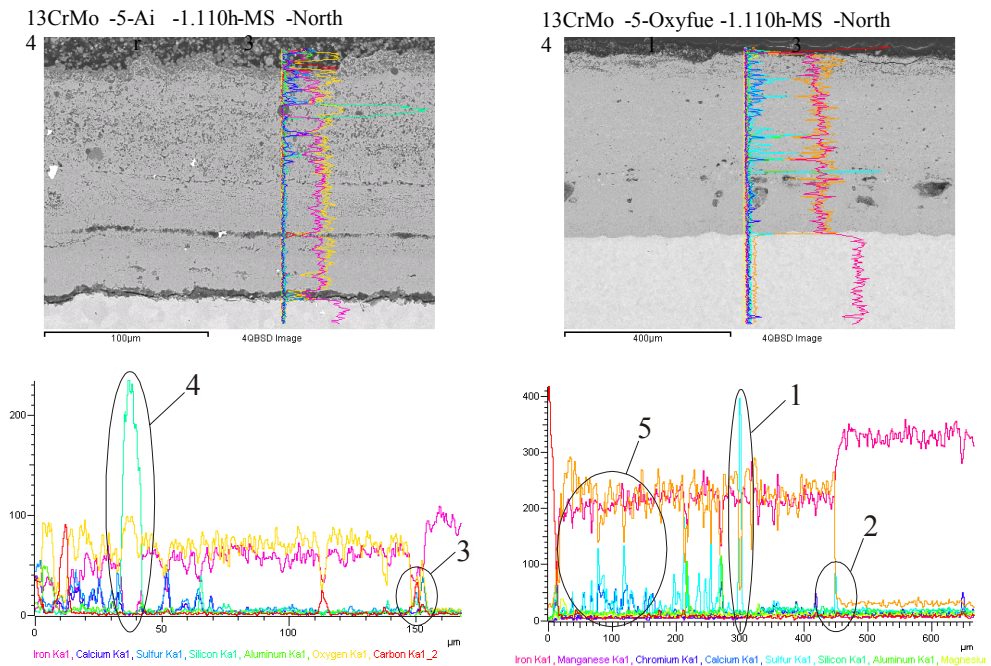
**Fig. 7.** Scanning electron microscope image of the material 13CrMo4-5

The main components of the defining surface layers were hematite ( $\text{Fe}_2\text{O}_3$ ) and magnetite ( $\text{Fe}_3\text{O}_4$ ) as well as the first Fe-Cr spinels, resulting from the chromium present in the base material. This could be accounted for by iron (II) sulphide ( $\text{FeS}$ ) under oxyfuel conditions (see 1 in Fig. 7).

The SEM images showed that sulphur was present under both operating conditions for the entire cross-section of the line-scan. The existence of sulphur near the interface of the base material / oxide layer indicated that the Fe-Cr spinels were permeable and therefore

not protective (see 2 and 3, Fig. 7). The existing sulphur found at the interface comprised of ash particles with a high amount of silicon (see 4, Fig. 7) which indicates that the sulphur was sulphate-bound. The parallel presence of sulphur, chromium and iron as well as the decrease in oxygen ( $O_2$ ) under oxyfuel conditions indicated that iron-chromium-sulphate compounds ( $CrS_2$ ,  $FeS$ ) and presumably also chromium sulphides ( $Cr_2(SO_4)_3$ ) were formed (see 5, Fig. 7).

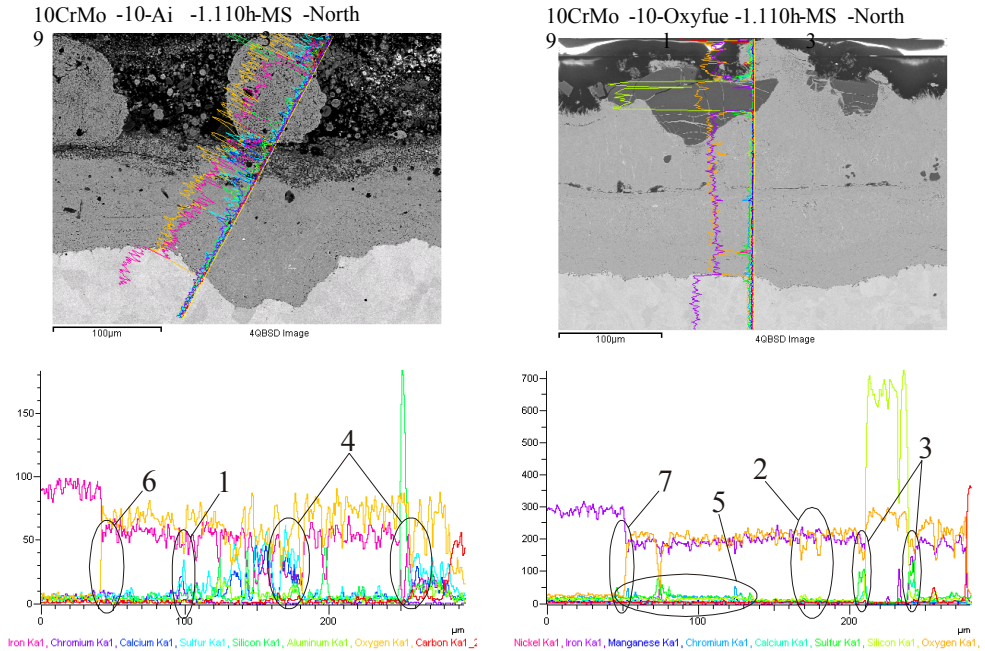
**Fig. 9.** Scanning electron microscope image of the material 10CrMo9-10

Inward diffusion of sulphur into the ash and oxide layers occurred under both operating conditions. The formation of sulphuric acid in connection with calcium in the border areas around ash particles could be seen (see 3 and 4, Fig. 9). In the line-scan of the north side under oxyfuel conditions a distinct chromium-rich inner corrosion zone was identifiable (see 5, Fig. 9). The parallel presence of sulphur, chromium and iron as well as the decrease in oxygen under oxyfuel conditions indicated the formation of iron-chromium-sulphate compounds ( $\text{CrS}_2$ ,  $\text{FeS}$ ) and presumably also chromium sulphides ( $\text{Cr}_2(\text{SO}_4)_3$ ) (see 5, Fig. 9). However, the formation of a thick and protective layer of Fe-Cr spinels was not possible because sulphur was present up to the border of the base material / oxide layer. The sulphur present could be sulphate- or sulphide-bound (see 6 and 7, Fig. 9).

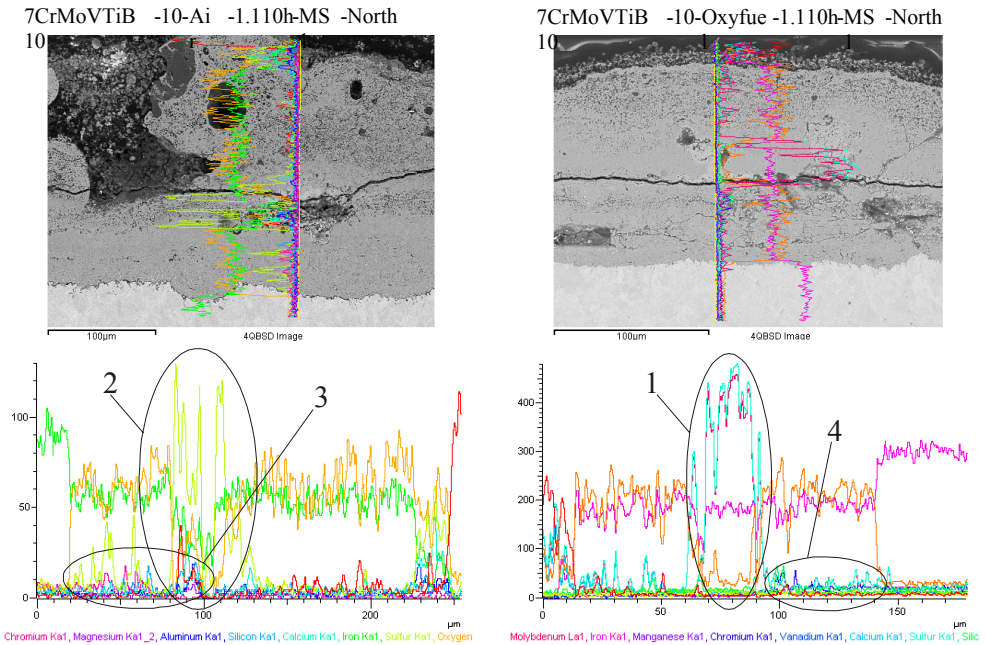
**Fig. 11.** Scanning electron microscope image of the material 7CrVTiB10-10

formation of iron sulphide was unequivocal. The formation of an iron sulphide phase was due to the increase in sulphur bonded with the simultaneous decrease in oxygen components and the unaltered number of iron components in this zone. In contrast to this, the sulphur components were sulphate- and sulphide-bound under air conditions. Iron and sulphur were both present but there was also a significant decrease in the concentration of oxygen and thus, it was assumed that iron sulphide could also be present. Directly beside this iron, sulphur and calcium as well as some oxygen could be accounted for and so the formation of calcium sulphate and iron sulphide occurred (see 2, Fig. 11).

The underlying crack in the oxide layer was found under both operating conditions around the inner corrosion layer, which was evident from the considerable deposits of chromium. Sulphur was present on the inner corrosion layer up to the interface between the base material and oxide layer but which did not originate from a thick and non-protective layer of Fe-Cr spinels (see 3 and 4, Fig. 11).

The parallel presence of sulphate, chromium and iron and the reduction in oxygen and the formation of iron-chromium-sulphate compounds ( $\text{CrS}_2$ ,  $\text{FeS}$ ) and presumably also chromium sulphides ( $\text{Cr}_2(\text{SO}_4)_3$ ) were found in the material under air conditions (see 3, Fig. 11). This was contrary to the results from the materials 13CrMo4-5 and 10CrMo9-10, where the described phases were only present under oxyfuel conditions.

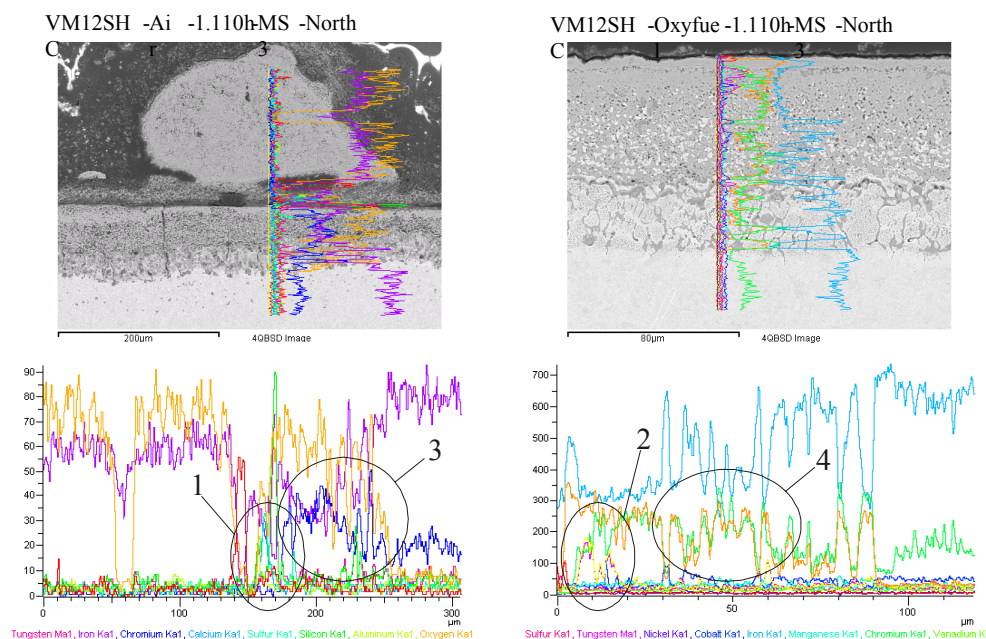
**Fig. 13.** Scanning electron microscope image of the material VM12 SHC

The VM12 SHC probe displayed similar sulphur formation characteristics under both operating conditions. These were sulphate-bound within the oxide layer (see 1 and 2, Fig. 13). Therefore under air conditions further phases were present and so area 1 (Fig. 13) displayed a loose, porous layer. No sulphur peaks were found at the interface between the base material and the oxide layer and this was due to the increased formation of Fe-Cr spinels thus the associated passive effect of sulphur diffusion. Under oxyfuel conditions a significant formation of Fe-Cr spinels was apparent (see 3 and 4, Fig. 13).

Under air conditions the SEM images featured ash particles that had accumulated above the oxidised surface layer. Between the particle and the surface layer no reaction-dependent interactions were evident. It was therefore assumed that a non-reactive surface layer had formed.
