EXAMINATION OF CHANGES IN MICROSTRUCTURE OF TURBINE VANES WITH THE USE OF NON-DESTRUCTIVE METHODS

Józef BŁACHNIO

Białystok University of Technology
ul. Wiejska 45 C, 15-351 Białystok, Poland
tel.: +48 22 6851982, fax: +48 22 6851041
e-mail: jozef.blachnio@itwl.pl

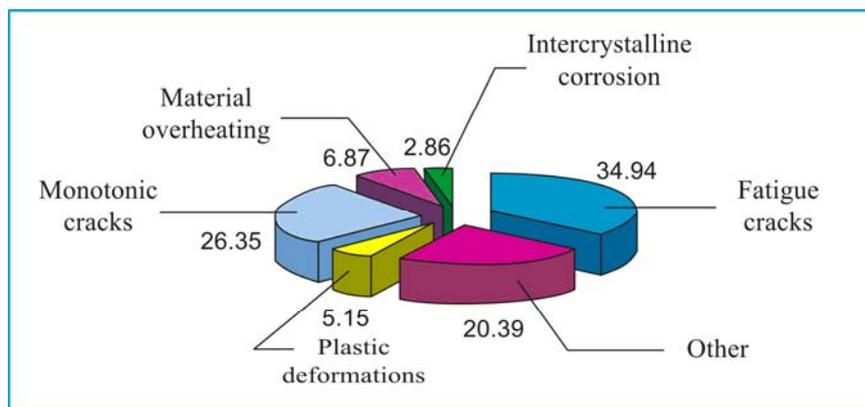
Fig. 1. Percentages of causes of damages to aircraft-engine turbines in service [3]

Operation of gas turbines always entails various damages to their components. The analysis of own research works [3, 4, 5] as well as literature references [6, 7, 8, 9, 10] shows that most of defects is associated with incorrect operation (adjustment) of parts and subassemblies that collaborate with turbines, in particular the combustion chamber and the outlet jet in case of turbojet engines (Fig. 1). Only a very small number of defects that happen to turbine subassemblies arise as a result of material deficiencies, improper design or technological faults.

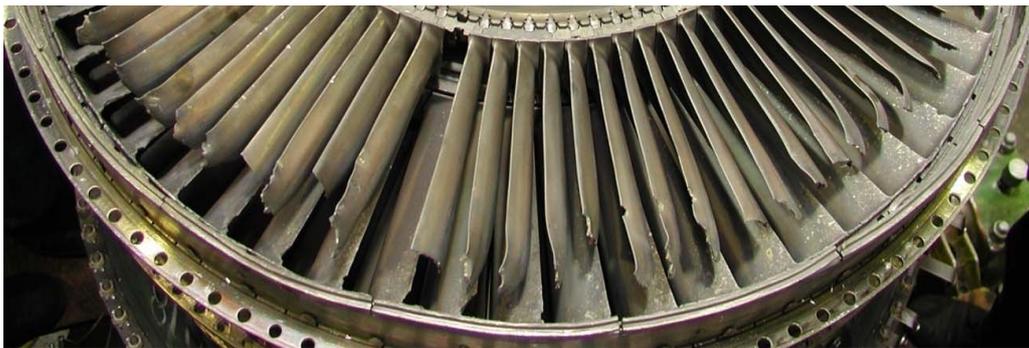
Fig. 2. Example forms of temperature defects demonstrated by vanes of the turbine rotor [6]

More frequently turbines suffer from adverse alterations to the material structure of vanes – overheating, thermal fatigue – caused by excessive temperature and exposure times as well as by aggressive composition of the combustion gas (Fig. 2). Overheating of the turbine vane material results from exceeding the permissible average temperature of combustion gas as well as due to non-uniform distribution of the thermal field along the turbine perimeter (Fig. 3). Non-uniform distribution of temperature downstream the turbine may happen due to improper atomizing of fuel due to carbon deposition on injection jets.

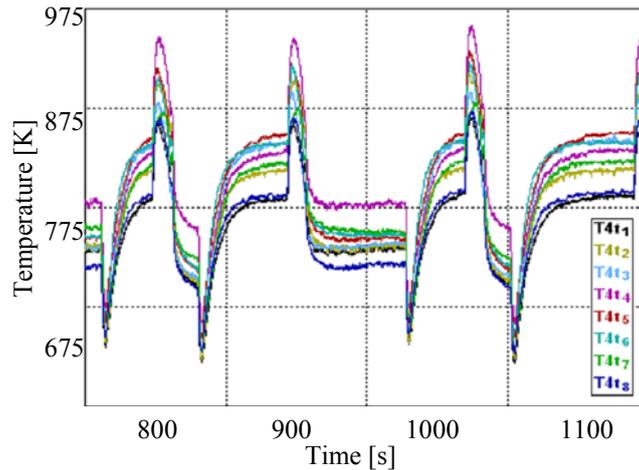
Fig. 3. Exemplary distribution of unevenness of the T4 temperature on the perimeter of the turbine in the function of time and rotation speed of an aircraft aerial engine, measured with help of thermoelements (T4t₁ - T4t₈) behind the turbine [11]

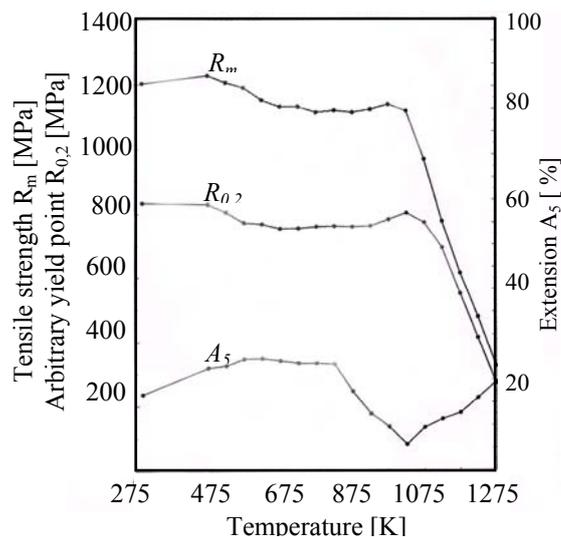
Fig. 4. Mechanical properties of EI-867 alloy in function of temperature [9]

After exceeding the critical temperature the alloy subjects to overheating, which results in deterioration of its mechanical properties (Fig. 4). Overheating of the turbine vane material leads to malfunctioning of the gas turbine and sometimes even to accidents with disastrous consequences, which is particularly hazardous in aviation. Anyway, refining of the damaged turbine is always associated with a major overhaul and entails enormous expenses.

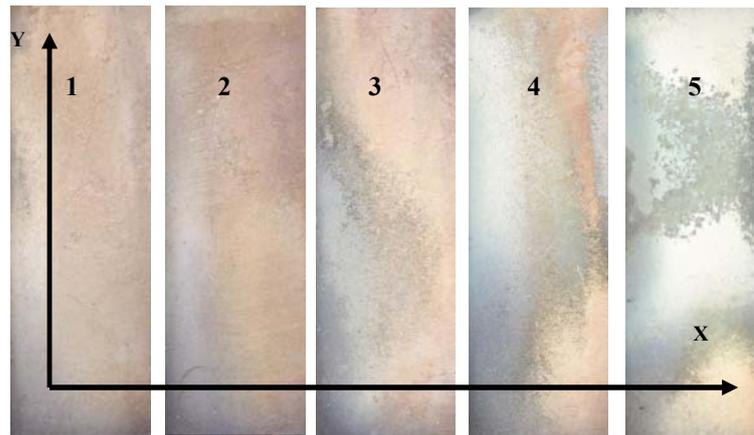
Fig. 5. Images for surfaces of gas turbine blades made of the ŽS6-K alloy, ordered according to the criterion of the increasing degree of the material overheating

The RGB imaging consists in recording of three components that make up each colour (R- red, G – green and B – blue) and takes advantage of interrelationships between wave properties of light that correlate with physical and chemical properties of examined surfaces. These interrelationships decide about angular features of the incident and reflected light as well as absorption of individual wavelengths within the spectrum of electromagnetic irradiation [12]. Evaluation of vane condition is based on colour analysis for surface images and is interrelated with the material criteria (alterations of the item shape and increase in emission of the reinforcing phase γ'), i.e. deterioration in heat-resistance and high-temperature creep resistance after exceeding the combustion gas temperature that is specific for each material. Based on the nomograms that binds alteration of surface colours (either RGB colours or greyscale) and heating temperature of vanes one can assess how the alloy microstructure has been changed. The images are recorded with the use of a CCD matrix and analyzed by means of dedicated software that takes advantage of sophisticated algorithms for image processing and already developed patterns. Thus, qualitative assessment of the examined surface can be made. The foregoing method was applied to the assessment of gas turbine vanes made of the ŽS6-K alloy (Fig. 5).

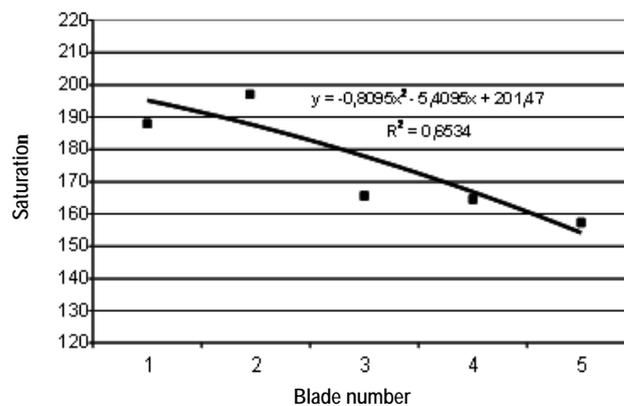
Fig. 6. Variations of the position value for the maximum amplitude of the image intensities for various technical conditions of blades from Fig. 5 (grey scale)

Owing to m-files developed within the Matlab software environment it is possible to extract features of the recorded images for examined surfaces. These images are represented by histograms that combine distribution of intensities for individual components of colours and other parameters determined on the basis of the event matrix. Essential parameters of histograms, such as location of the maximum amplitude (chromaticity for RGB colours), averaged values for images (chromaticity values added up along rows of the matrix and divided by the number of rows) as well as the maximum amplitude value are calculated for the examined section of the vane image. Therefore, histograms contain quantitative information on overall brightness of images recorded for the items under test. Fig. 6 presents examples for translocation (bias) of the maximum amplitude for the image saturation associated with various degrees of deterioration demonstrated by vanes from Fig. 5.

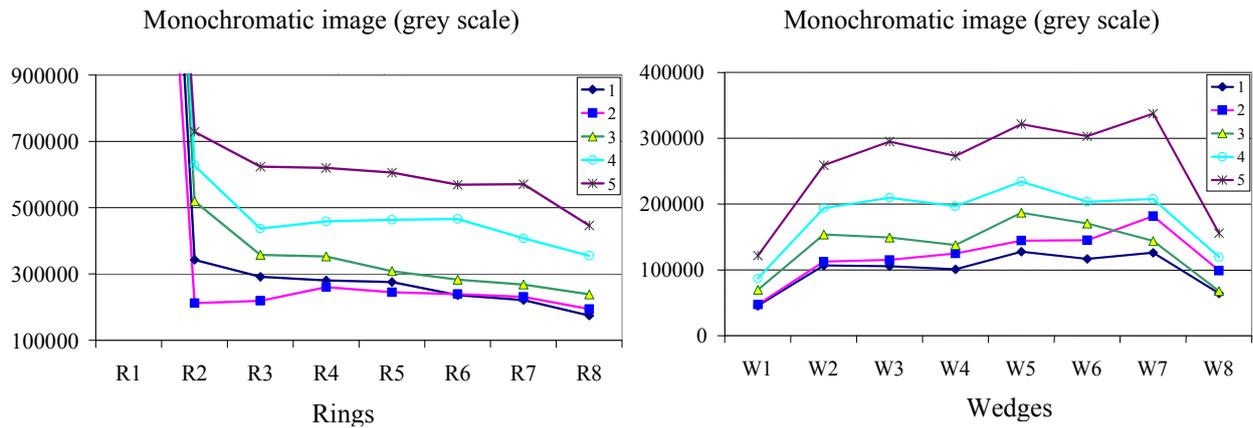
Fig. 7. Values of rings and wedges in the grey scale for individual deterioration degrees of wedges from Fig. 5

Analysis of images can be successfully carried out with the use of a use of a ring-wedge detector. The ring-wedge detector represents a ring-shaped model and is made up of two parts. The first part consists of concentrically disposed rings whilst the second part incorporates wedges with their common apex in the detector geometrical centre. Each of these areas represents a surface photo detector that converts the intensity of the incident light into an electric signal that is proportional to the intensity of that light.

The computer generated hologram (CGH) has a shape that is analogical to the ring and wedge detector and is also made up of rings and wedges. Therefore CGH performs the role of an extractor that derives item features from images transformed to the frequency domain. Results from imaging and the analysis completed for surface of turbine vanes from Fig. 5 are shown in Fig. 7. Figures for wedges and rings for overheated vanes no. 4 and no. 5 clearly differ from the corresponding values for all the remaining items.

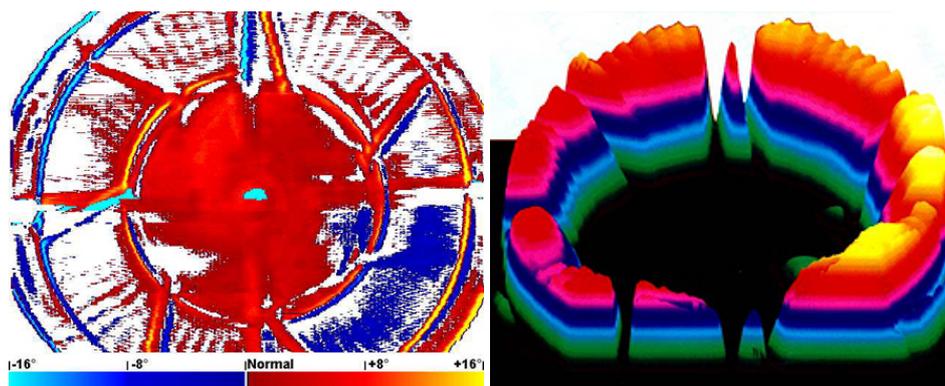
Fig. 8. Thermographic images for the stream of combustion gas that leaves the gas turbine of a helicopter engine [13]

The infrared thermographic method is based on detection of infrared irradiation and can be split into the passive and active options. The diagnosing of gas turbines with the use of the technique of passive thermography consists in recording images for distribution of temperatures at the turbine outlet (Fig. 8). When the turbine operates smoothly reference images (patterns) are recorded. Routine inspection during the lifetime period consists in the comparison of currently obtained thermographic images against patterns. Such an approach enables detection of even such defects (e.g. erosion of the entire turbine, damages to vanes, disturbed operation of the combustion chamber) that are poorly detectable with the use of other non-destructive techniques [10].

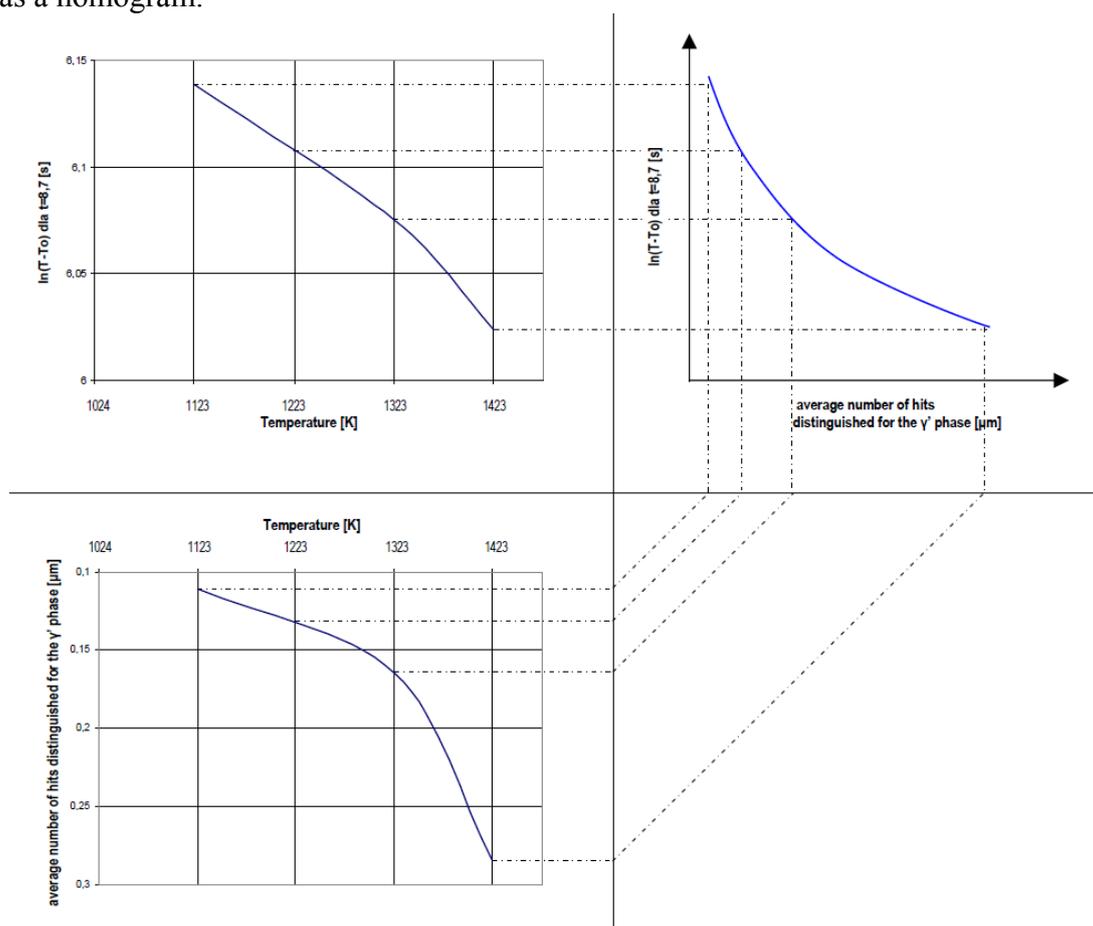
Fig. 9. The nomogram to assess microstructures of samples taken from a gas turbine made of the EI – 867 WD alloy plotted on the basis of the relationship between variation of the parameter $\ln(T-T_0)$ for the signal attributable to the thermographic method and variation in the number of hits for the γ' phase at various ageing temperatures [15]

Thermographic examinations employed samples of turbine vanes made of the Ei-867WD alloy. Samples were subject to heating within the temperature ranging from 1023 to 1423 K. Obtained results made it possible to find out that relationships between parameters associated with a thermal response of the material for examined vanes to a heat pulse was altered. Then, metallographic examinations were carried out to assess alterations in the microstructure of samples – chiefly alterations to the reinforcing phase γ' - Ni₃(Al,Ti). Results of those studies are demonstrated in Fig. 9 as a nomogram.

The relationship between the thermal response of the sample material, represented as the value of $\ln(T-T_0)$ and the average number of hits for the γ' phase enables to assess the technical condition of the sample material. This relationship, in conjunction with the permissible alterations to the microstructure, serves as a basis to judge whether the sample material is suitable or not for further service. High temperature affects both the variations of the aluminium coating and the alterations to the structure of the γ' phase.

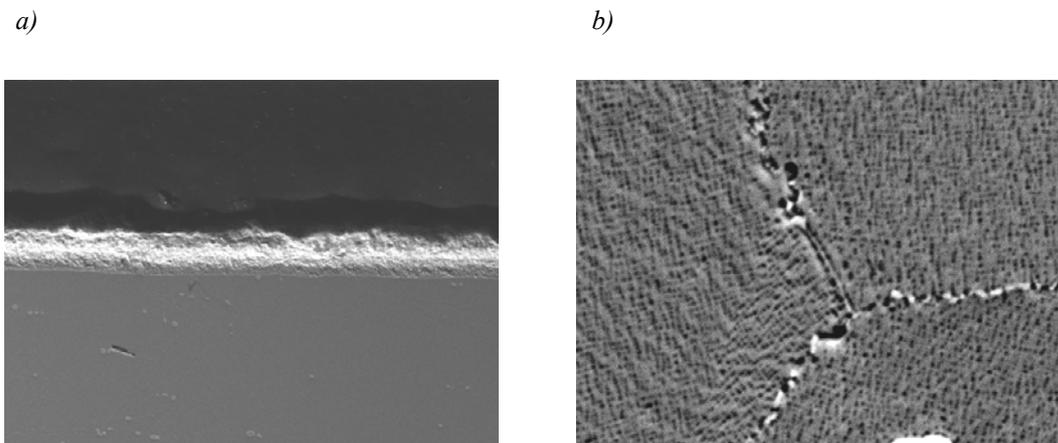
Fig. 10. The metallographic structure of a blade that has been aged at temperature of 1023K: a) coating (x450); b) the surface-beneath layer (x4500)

The investigated microstructure of the surface-adjacent layer reflects changes in the EI – 867 WD alloy and confirms overheating of the alloy structure after the vane samples had been heated at temperatures ranging from only 1223K (Fig. 10 and 11). When the material criterion is adopted, i.e. how the number of hits to the γ' phase has changed and it is the criterion that determines the applicability of vanes for further operation, one is able to determine a threshold limit for the vane lifetime. Results from metallographic tests confirm that the vane material loses its high-temperature creep resistance at the temperatures above 1223K due to clustering of fine-grained cubical particles of the γ' phase (Fig. 10), and formation of plates (Fig. 11).

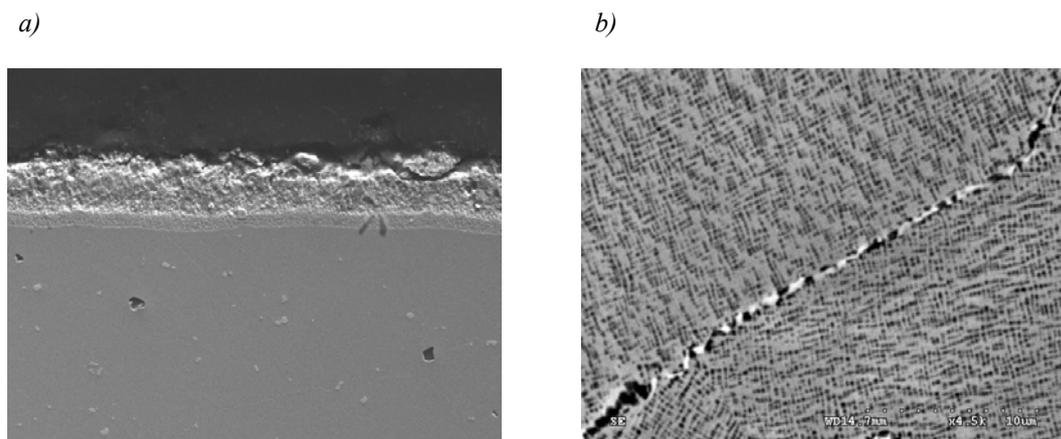
Fig. 11. The metallographic structure of a blade that has been aged at temperature of 1223K: a) coating (x450); b) the surface-beneath layer (x4500)

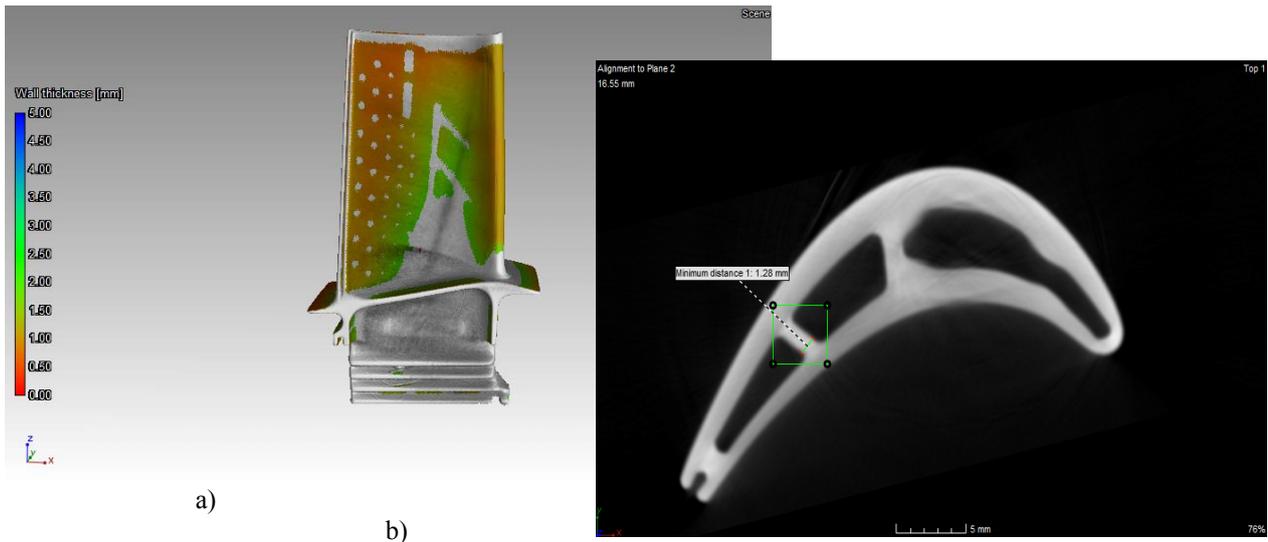
Fig. 12. Image for the gas turbine vane obtained by means of the tomograph from YXLON [17]:
 a) determination of the profile thickness, b) example how to measure dimensions of internal walls.

The CT numbers range from -1000 to +4000. Best results of diagnosing the condition demonstrated by vanes of gas turbines are obtained when the technique with a linear detector is applied. Results of CT examination can be used for measurements of geometrical parameters of vanes, for instance to measure the thickness of their internal walls with cooling channels or to examine structures of materials, to detect defects or to support the diagnostic process during repairs or overhauls. Images for scanned items can be presented with the use of colours (Fig. 12) and scaled to desired dimensions to determine shapes of internal walls (size and location of defects). Geometrical parameters of internal components can be also measured with a high accuracy to establish tolerances for their actual dimensions. In addition, spectrum of the CT signal can be used to analyse alterations to microstructure of the alloy (Fig. 13).

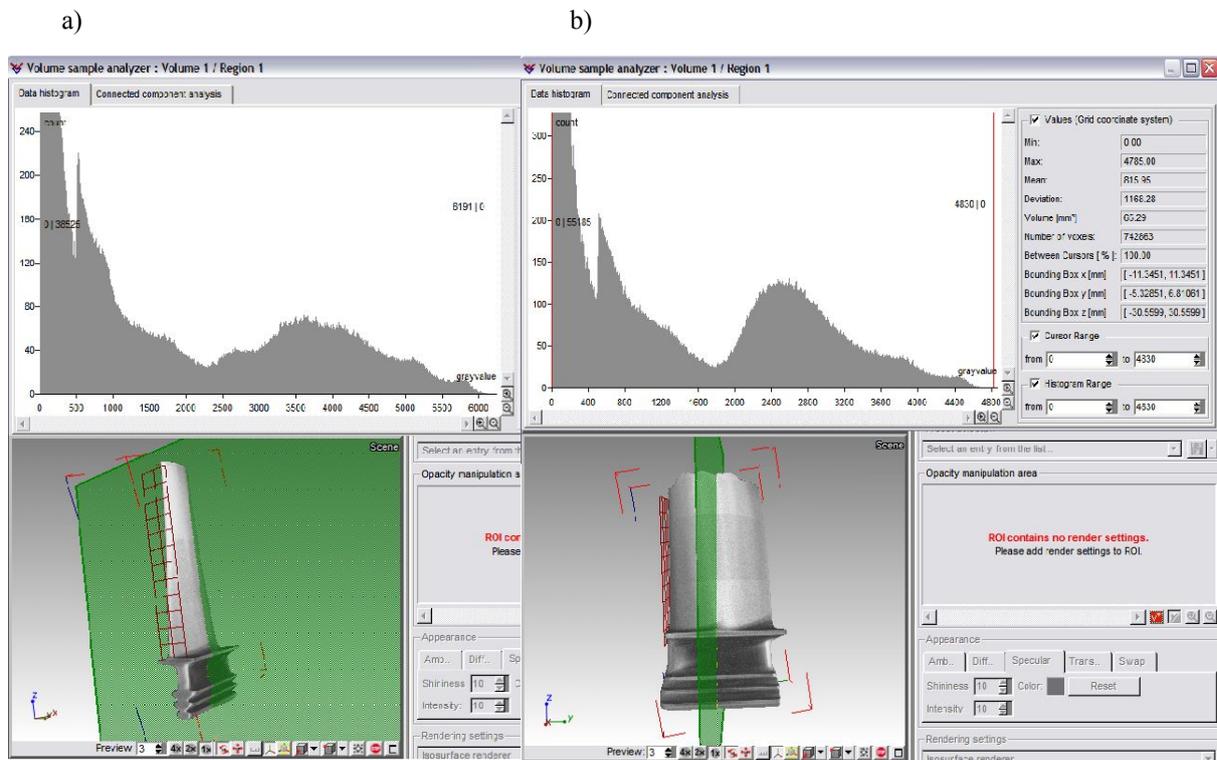
Fig. 13. Spectra for CT signals obtained by means of the tomograph from YXLON [17] for vanes made of the EI-867WD alloy with a) correct microstructure, b) overheated microstructure.
