M. ROZMUS-GÓRNIKOWSKA\*, J. KUSIŃSKI\*, M. Blicharski\*

## THE INFLUENCE OF THE LASER TREATMENT ON MICROSTRUCTURE OF THE SURFACE LAYER OF AN X5CrNi18-10 AUSTENITIC STAINLESS STEEL

The influence of laser shock processing (LSP) on microstructure of the surface layer of an X5CrNi18-10 austenitic stainless steel was studied. The laser treatment was performed using a Q switched Nd:YAG ReNOVAL laser.

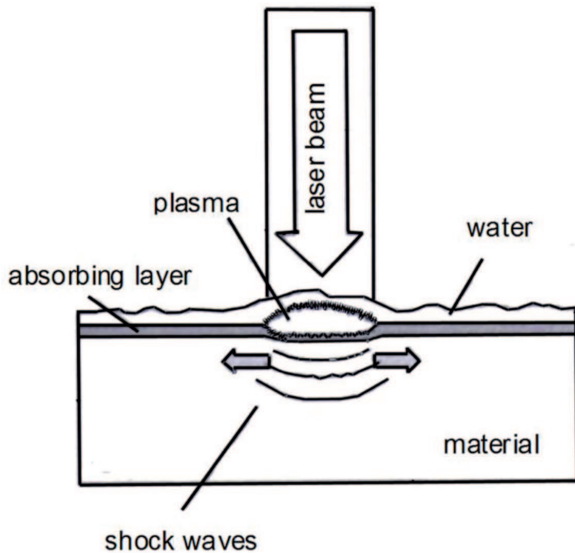
Fig. 1. The scheme of the Laser Shock Processing

higher than 0.1 GW/cm<sup>2</sup> at the surface of the treated material. Before the LSP the treated sample is usually coated with a black paint (absorbing layer) and immersed in water (transparent layer) [3-5]. The scheme of the Laser Shock Processing is shown in Fig. 1. When the laser beam is directed onto the treated surface, it passes through the water which is transparent to the laser beam and strikes the black coating. The absorbing coating is instantly heated and vaporized, due to the absorption of laser beam energy. The vaporization of the black paint produces a rapidly expanding plasma, that is confined against the surface of the material by a constraining

layer of water. The plasma causes a shock wave by its expansion and leads to the plastic deformation of the material. Water decreases the expansion of plasma in the surrounding atmosphere and produces up to ten times higher pressure on the material surface [6]. The pressure propagating into the treated material as a shock wave can induce microstructural changes, cause a high increase of dislocation density, influence the surface roughness of the material as well as produce high residual surface compressive stresses [7-9].

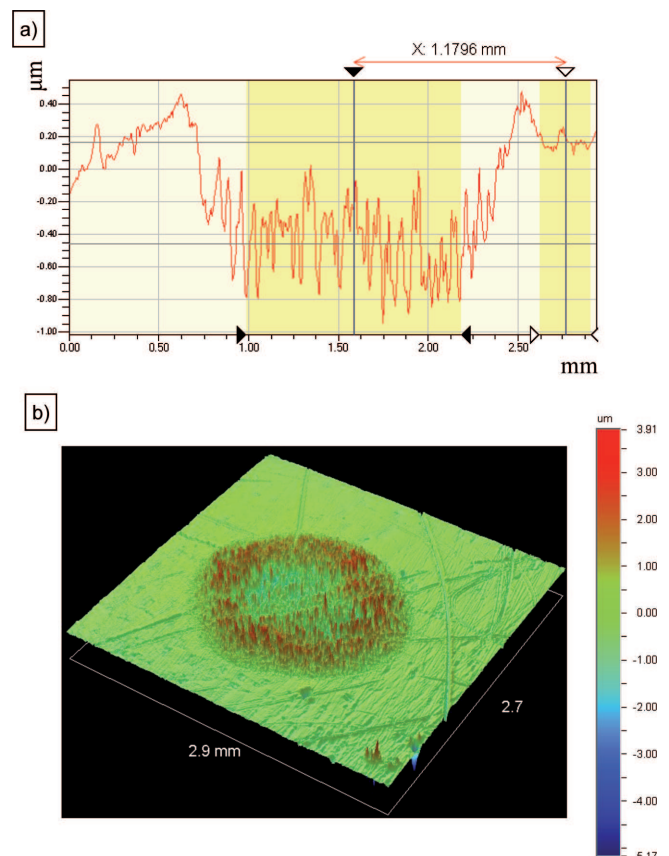
Fig. 5. Surface roughness of the steel after laser treatment (a) 2d (b) 3d

The typical roughness profile of the surface after laser treatment is shown in Fig. 5. The measurements indicated that Nd:YAG laser treatment produced an increase in the surface roughness. Ra (arithmetic average of the absolute values of all points of the profile) in-

creasing from  $0.1 \mu\text{m}$  before treatment to  $0.33 \mu\text{m}$  after LSP.
