Morphological changes within road incision forms in the blowdown area in the Slovak Tatra Mountains after termination of intensive forest works

The aim of this paper is to estimate the direction and rate of changes within road dissections after intensive forest works. To achieve this task, the results of measurements of the depth of road incision along selected profiles situated at places differing by inclination and the type of exploitation were used.

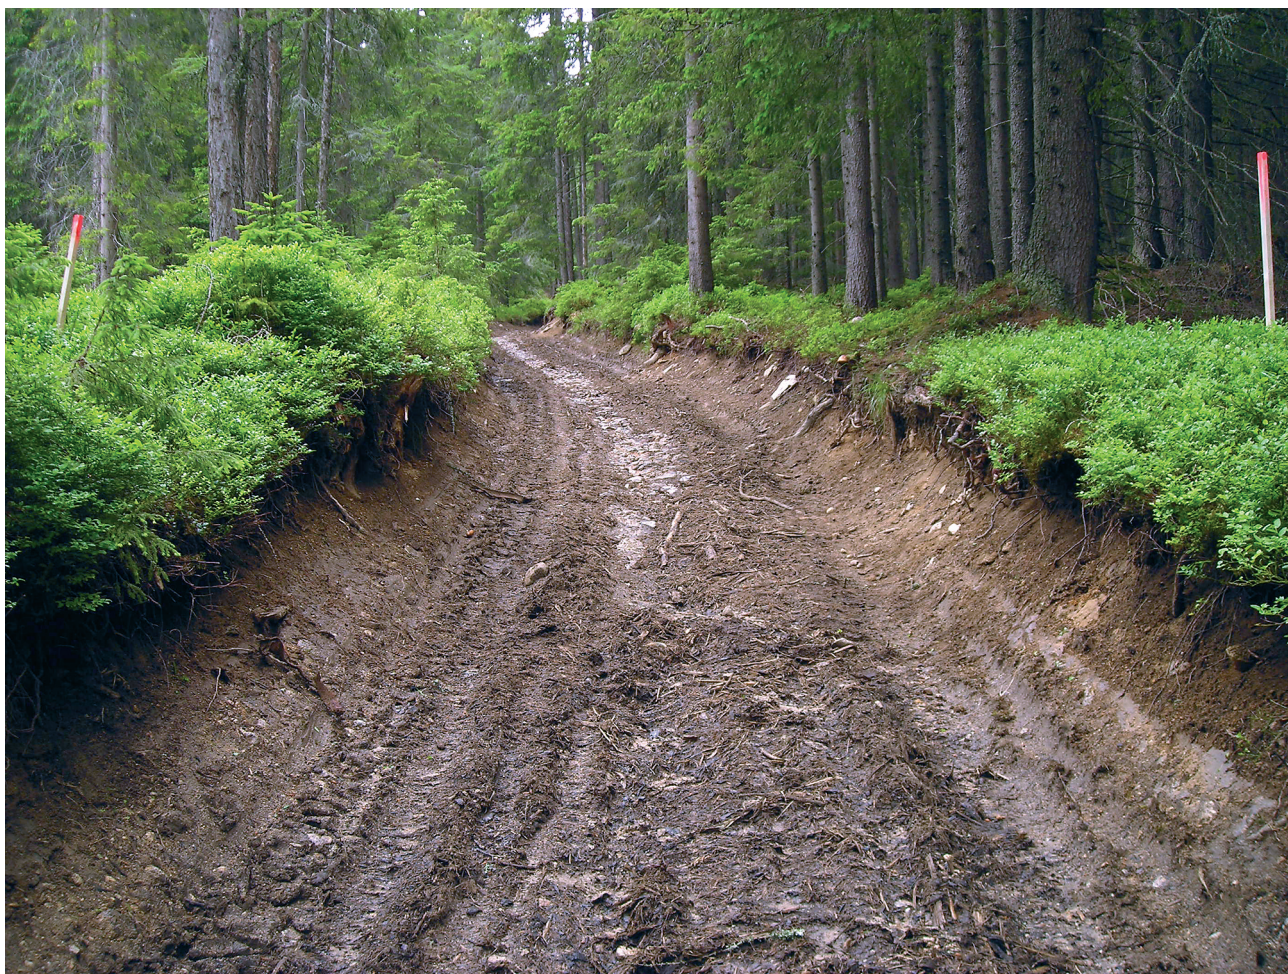
Fig. 2. Cart road in Vyžne Hagy test area. Profile VH1

Profile VH1 (Table 2) was installed on a road near Vyžné Hagy. This road was intensively used for cutting and taking down the wood during the period of damage mitigation works. Its substratum was then lowered by even 50 cm, being accompanied by undermining of road scarps. During the first measuring period, the intensity of road exploitation was fairly high, then considerably diminished. The road crosses the “REF” test area, located in a forest zone that remained nearly intact after the November 19, 2004 event (Fig. 2).

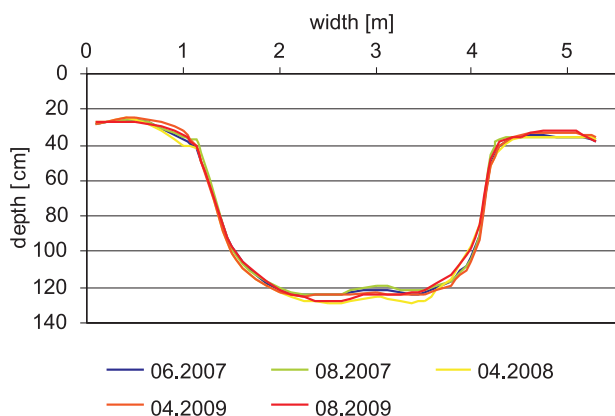
Fig. 3. Profile of cart road VH1 in Vyžne Hagy

During the entire observation period (25.06.07–12.08.09), the depth of the road cut changed insignificantly at site VH1 (Fig. 3), and even minor prevalence of aggradation (5.5 cm) was noted. Close to the road’s axis, in turn, a small erosional incision (3.5 cm) occurred. Moreover, a certain seasonality of dominance of different processes took place: warm seasons were characterized by aggradation (6–8 cm), while the cold ones were dominated by erosion (up to 6 cm).

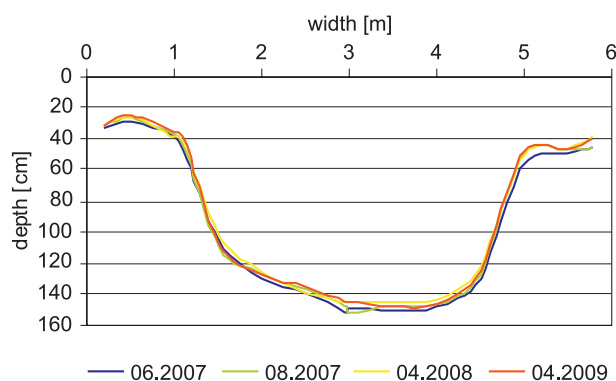
Fig. 4. Profile of cart road VH2 in Vyžne Hagy

Profile VH2 (Table 2) was established 322 m below profile VH1 along the same road. Aggradation prevailed throughout the observation period (Fig. 4) attaining 9.5 cm within the furrow. Even in winter time, aggradation did slightly prevail (4 cm), except one site where dominating erosion (ca. 6.3 cm) was noted.

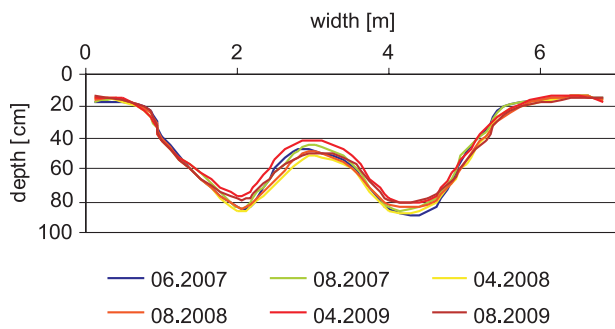
Fig. 8. Profile of cart road NP in Nová Polanka

Changes in road’s profile can be analysed in a seasonal pattern. During the first summer minor aggradation occurred (up to 7 cm), while during the first winter erosion of the bottom of the road between furrows took place (Fig. 8). During the following summer (2008), nearly the entire profile was dominated by insignificant aggradation (to 4 cm), and after the following winter the road surface was placed even 12.5 cm higher compared to the former

season, while after the last summer it became lowered to 10.5 cm.

Throughout the observation period, aggradation (up to 9.5 cm) of the material took place in both ruts, accompanied by minor (up to 5 cm) erosion between them.

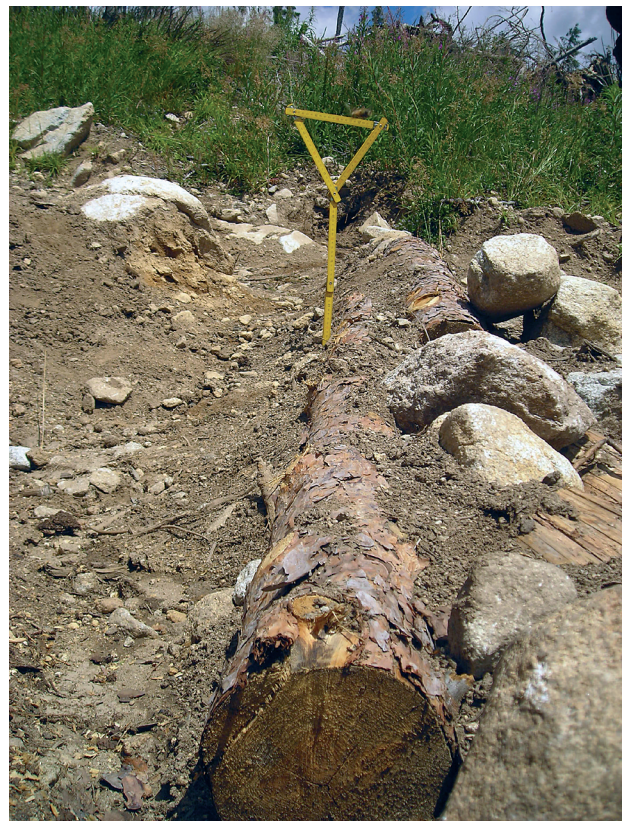
Fig. 7. One of anti-erosion steps on a cart road in Nová Polanka

Profile NP (Table 2) is located on a road segment in Nová Polanka. This road used to be one of main roads on this area during after-disaster management works. The latter largely controlled the rate and amount of transformation within the road, being additionally enhanced by relatively high slope inclination, higher annual precipitation totals compared to those at Vyžné Hagy, and road’s course concordant with slope inclination. Few tens of anti-erosive protective steps were built from tree trunks, branches, boulders, stones and earth. The mapped road segment, 308 m long, bears 19 steps spaced every 3.5 to 21.5 m (Fig. 5, 6, 7). Below step no. 5, site

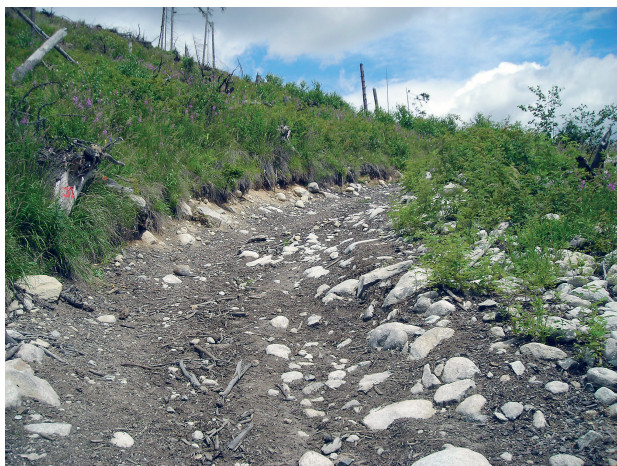
Fig. 10. Cart road close to Jamy near Tatranská Lomnica. Profile JA

Profile JA (Table 2) is situated on a road leading to the “NEXT” test area near Jamy, close to Tatranská Lomnica. Owing to the type of this test area, the road is infrequently used. Its fragment cuts obliquely strongly inclined slope (Fig. 10).
