# THE ASSESSMENT OF CHANGES IN THE MICROSTRUCTURE OF A GAS TURBINE BLADE WITH A NON-DESTRUCTIVE THERMOGRAPHIC METHOD

**Artur Kułaszka, Józef Błachnio**

**Dariusz Zasada, Paweł Józwik**

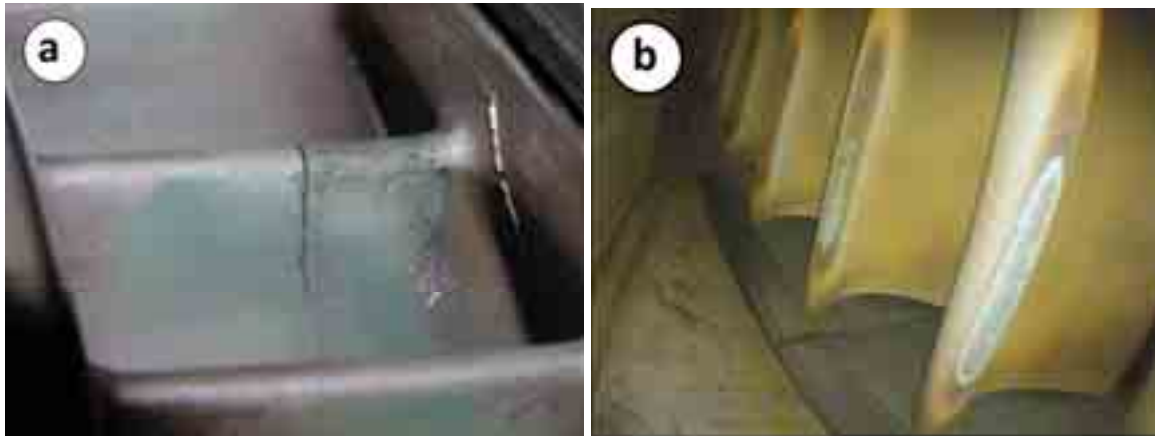
Fig. 1. Forms of thermal deterioration of gas turbine blades: a) overheating of the blade material visible as discoloration of surface colour to pale blue and glaucous, b) local melting of the protective coating

Deterioration of protective coatings (Fig. 1) that covers turbine blades, with simultaneous impact of high temperature and aggressive effect of exhaust gas leads to overheating of the blade parent material. Further operation of the turbine with such defects entails total damage of turbine blades and presents a hazard to operation safety of engines.

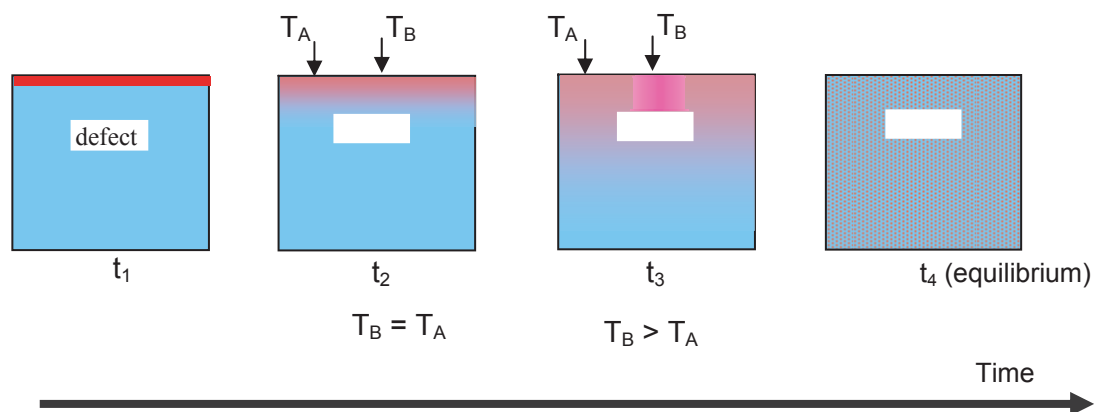
Fig. 2. Variation of the surface temperature of a sample after stimulation with an external pulse of heat [5]

The essence of active thermography consists in determination of thermal response received from a material already stimulated with an external pulse of heat [11]. Nowadays an intense growth of interest is witnessed to research studies on application of active infrared thermography to detection of flaws in surface-adjacent layer of materials. When some amount of energy is delivered to the material surface, e.g. in the form of a pulse of heat, the surface temperature begins to change rapidly when the stimulation is ended. Owing to diffusion of heat, the thermal front starts travelling towards deeper layers of the material. The presence of areas that differ in thermal properties (containing flaws) from the ones without such flaws results in variation of the diffusion velocity (Fig. 2).

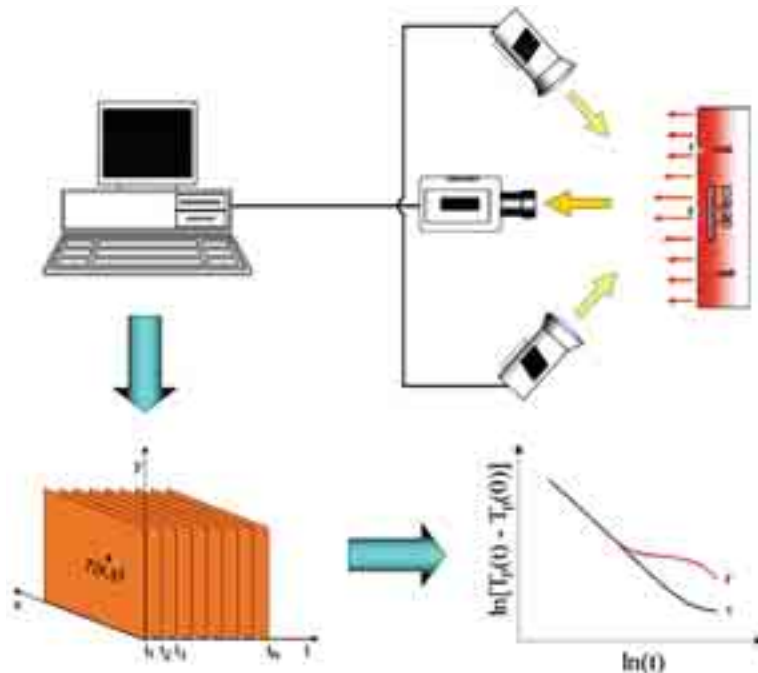
Fig. 3. Application diagram for the pulsed thermography [5]

The *pulsed thermography* is considered as a relatively simple technique of the active thermography. It consists in determination and analysis of the temperature distribution over the surface under test when it is being cooled down after preliminary uniform heating by means of a thermal pulse (Fig. 3). Monitoring of the temperature field on the surface of the cooling sample makes it possible not only to analyze discontinuities in the cooling sample but also to detect unfavourable amendments to the microstructure of the material under test.

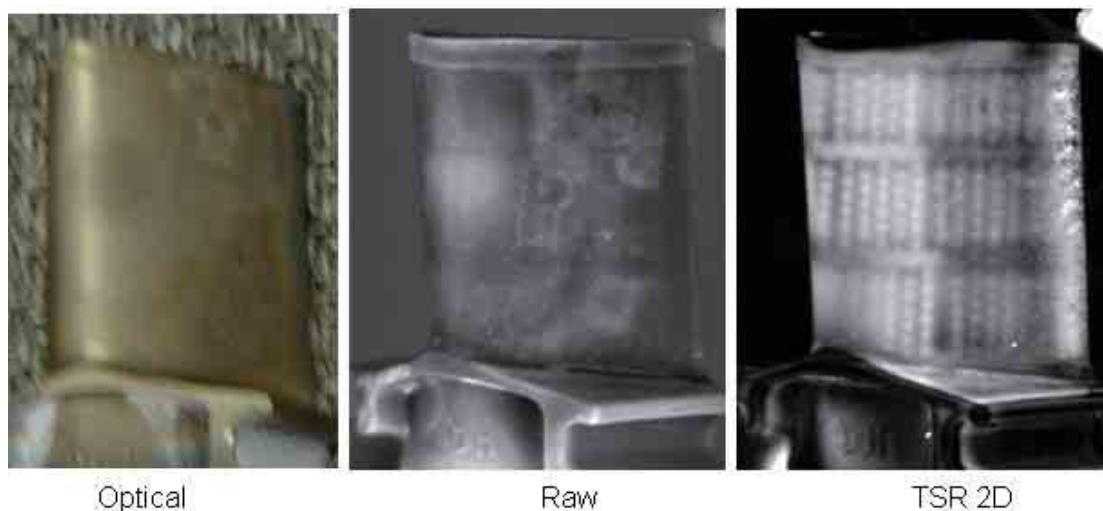
Fig. 5. Images for blades of high-pressure (HP) turbine incorporated into an avionic engine and examined with use of various methods: visual (optical) inspections, RAW and TSR techniques [5]

The pulse thermography has already been applied to a series of research studies, including the ones intended to assess applicability of the method to examine obstruction-free condition of cooling ducts for turbine blades. The overall improvement of the turbine efficiency and increase of the power factor are directly related to the temperature of exhaust gas. Since elevation of this temperature lead to problems with the material strength, interiors of turbine blades must be cooled down with airstreams that pass through labyrinths of air ducts with sophisticated shapes. It is the design solution that makes the manufacturing process of turbine blades more difficult as well as diagnostics of their technical condition. Operational experience and examination of turbine blades at overhaul workshops demonstrated that a frequent reason for their damages, besides defects of materials, are disturbances in their internal cooling system caused by insufficient throughput of cooling ducts. Fig. 5 shows images of a typical blade, where imaging was carried out by means of a conventional optical method, the RAW method as well as the Thermographic Signal Reconstruction (TSR) method that is implemented to tomography devices. Application of the pulse thermography with accordingly developed software makes it possible easily inspect the internal system of blade ducts (the labyrinth) and lack of congestions. The advantage of this method over the X-ray inspection is the lack of dangerous radiation the test engineer is exposed to, hence no special test rooms with radiation-proof insulation are necessary for execution of tests. The unit prices of thermographic inspection are lower as no expensive consumable must be purchased. The waiting time until test results are available is also shorter. Another method that is based on measurements of fluid volume that passes through cooling channels of blades is less accurate and more time-consuming as compared to thermographic tests.

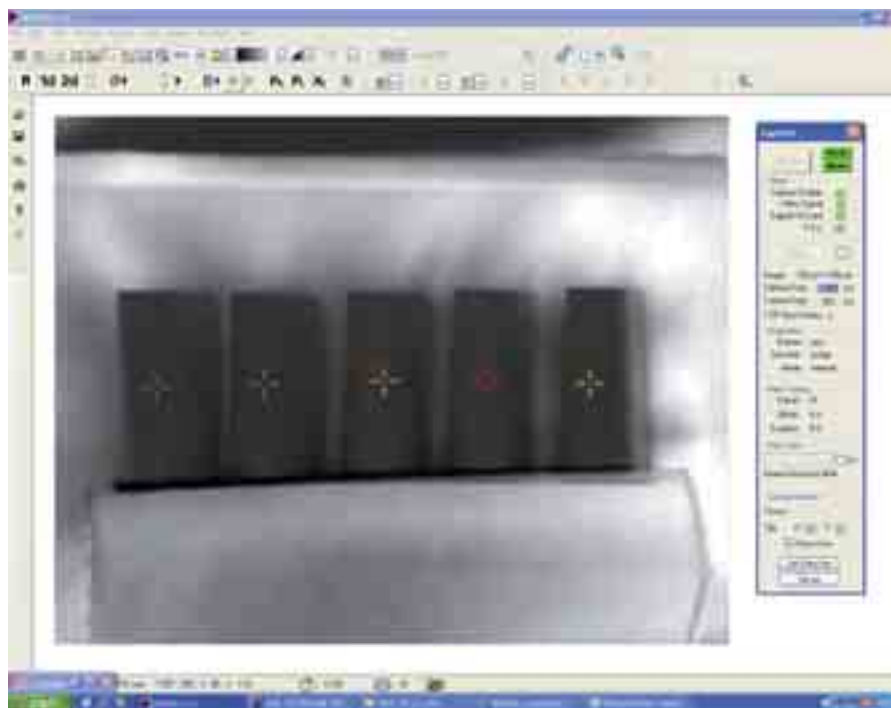
*Fig. 6. Images of turbine blades examined with use of the Echo Therm System workbench*

New blades were subjected to the effect of a very short thermal pulse and the thermal response was acquired by means of measuring and recording instruments to find out temperature variation on the surface under test within the selected areas. Then the blades were heated in an oven at presence of exhaust gases from combustion of aviation kerosene, where the heating temperature ranged from 1123 to 1523K. After heating the examination, procedure in a thermographic apparatus was repeated. The completed investigations made it possible to find out differences in thermophysical response received from examined blades before and after heating at various temperatures (Fig. 6, Fig. 7).

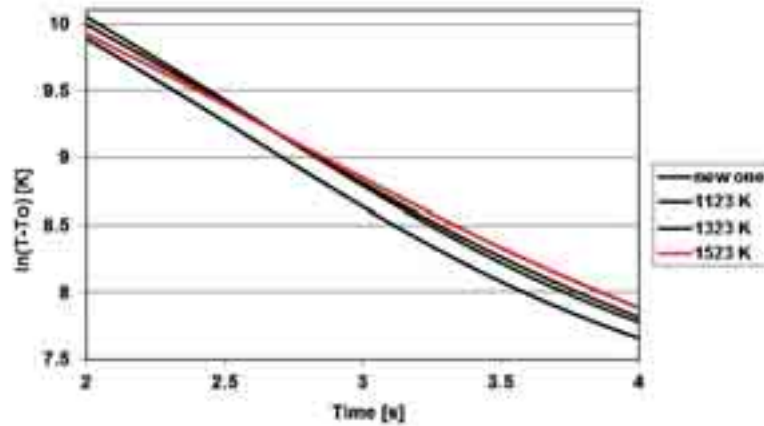
Fig. 7. The graph  $\ln(T-T_0) = \ln(t)$  for the response of turbine blades to a heat pulse – a new one and the blades heated at the temperatures of 1123 K, 1323 K and 1523 K

Searching for a non-destructive test method suitable for assessment of technical status demonstrated by the material of turbine blades has led to establishing the thermographic technique as the most beneficial one. Application of that method made it possible to find out differences in thermophysical responses received from examined blades before heating and after heating at various temperatures (Fig. 7).

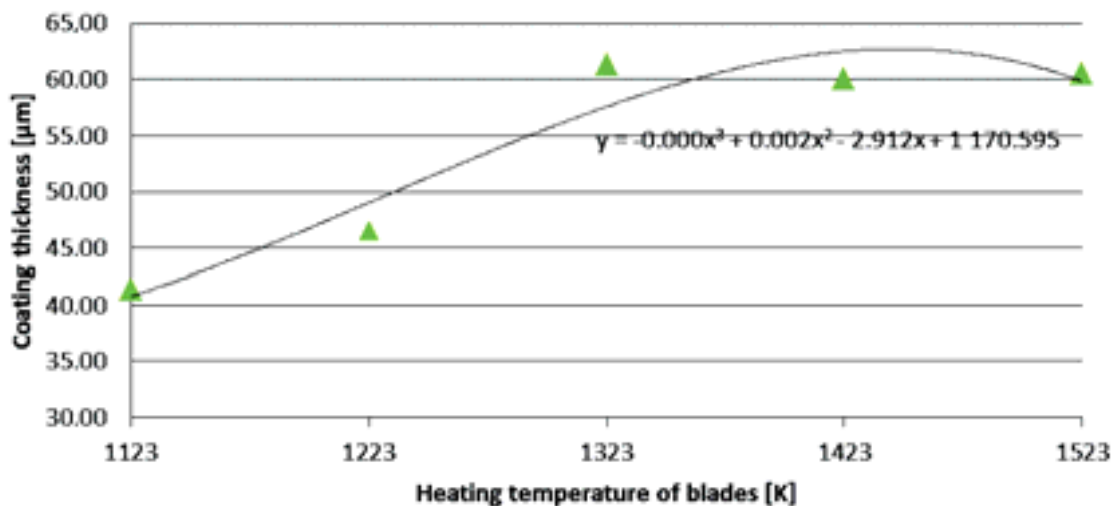
Fig. 8. The graph for the thickness of aluminium coating on turbine blades – a new one and the blades heated at the temperatures of 1123 K, 1323 K and 1523 K

The completed metallographic investigations of blades heated at various temperatures evidenced that high temperature leads to alterations of microstructures, both of the coating material and the EI-867 WD alloy, where gradual growth of the aluminium protective coating is observed in pace with the temperature growth (Fig. 8).

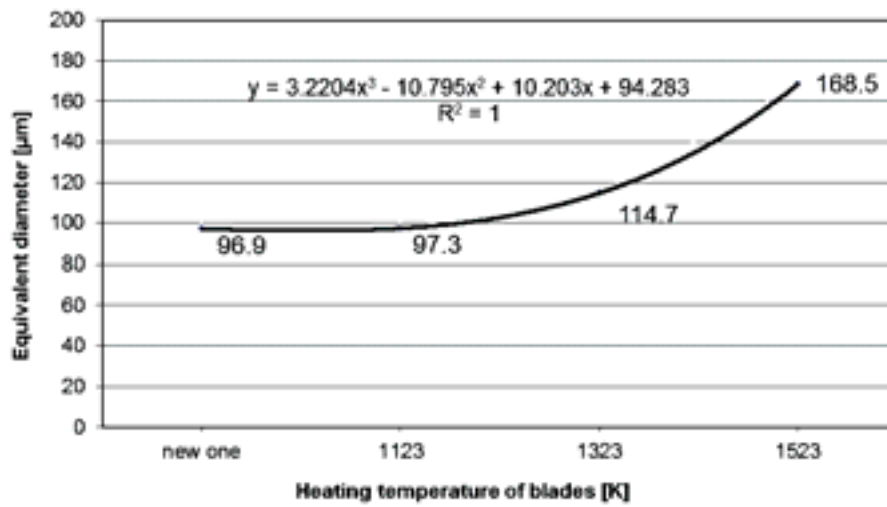
Fig. 9. Alteration of the average grain size for the EI-867WD alloy used to manufacture the turbine blades, for a new blade and blades heated at various temperatures. The average grain size is expressed as the diameter of an equivalent circle with the same surface as of the grain

The graph demonstrated that heat resistance of blades subjects to deterioration. The growth of grains by more than 50% is observed in the alloy microstructure (Fig. 9), which adversely affects mechanical properties of the alloy [4, 13]. In particular, these alterations are clearly visible within the reinforcing  $\gamma'$  phase as modification of the structure is observed for that phase (Fig. 10, 11). The temperature of 1123 K is conducive to growth of small particles within the  $\gamma'$  phase. At the temperature of 1323 K, mid-sized particles of that phase expand. Finally, at the temperature of 1523 K the particles with the largest initial size exercise further growth due to coagulation. In consequence, the number of particles with the fines sizes gradually decreased in pace with the temperature growth and is much less than in the material of new blades and the ones subjected to heating at the temperature of 1123 K. At the same time the distance between individual particles of the  $\gamma'$  phase is getting larger and larger. The revealed growth, clustering and corrugation of particles within the  $\gamma'$  phase leads to substantial deterioration of heat resistance demonstrated by

The relationship between the thermal response of the blade material, expressed as the function  $\ln(T-T_0) = \ln(t)$  (Fig. 8) related to alterations of average grain size (Fig. 9) as well as the average size of the  $\gamma'$  particles precipitated during tests (Fig. 11) make it possible to infer about amendments to the material microstructure. These relationships, with consideration of limit

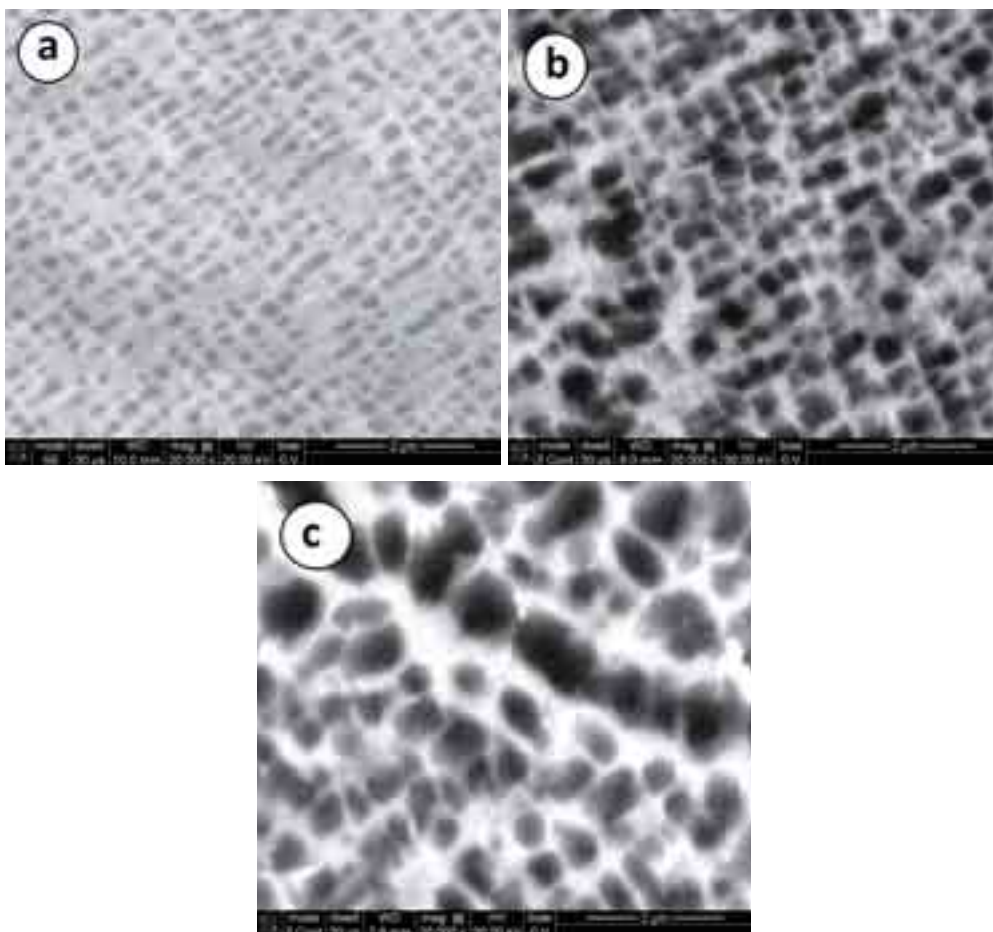
Fig. 10. The microstructure of blades heated for 2 hours at the temperatures of a) – 1123K, b) - 1323K, c) – 1523K (magn.  $\times 20,000$ ) – visible effects of coagulation, alteration of particle shapes and corrugation of particles within the  $\gamma'$  phase

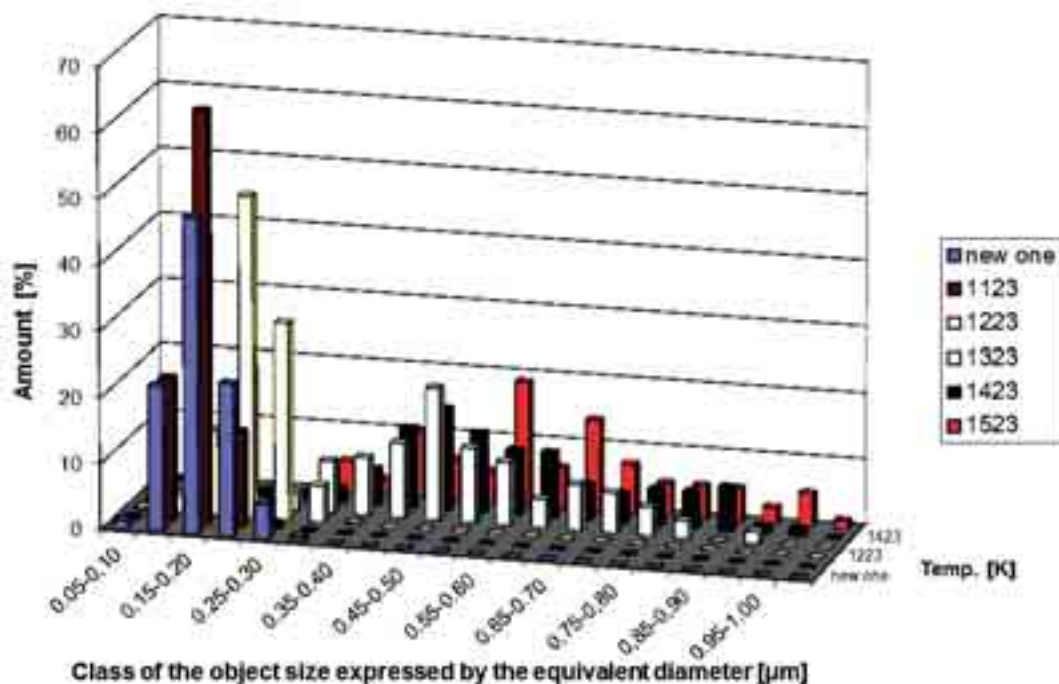
Fig. 11. Number of precipitations within individual size classes of  $\gamma'$  phase particles for the material of turbine blades, for a new blade and blades heated to the temperatures of 1123 K, 1323 K and 1523 K
