Management of liquid wastes on floating docks in the aspect of its impact on the environment

Piotr Marcinowski, D.Sc., Eng.
Joanna Biernacka, M.Sc., Eng.
Maria Olesiejuk-Kowalska, M.Sc., Eng.
Warsaw University of Technology

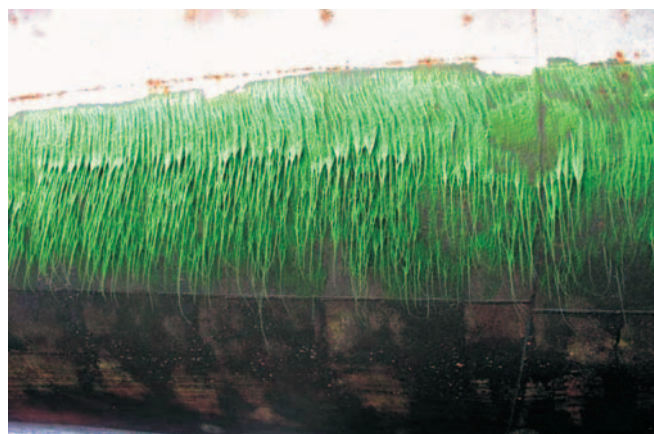
Fig. 4. Algae fouling the ship hull .
