RISK ANALYSIS IN THE REALIZATION OF BUILDINGS IN REVITALIZED AREAS

A. SOBOTKA¹, A. RADZIEJOWSKA²

Keywords: revitalization, preservation of the historic substance, sources and risk factors, risk management, execution of a construction project

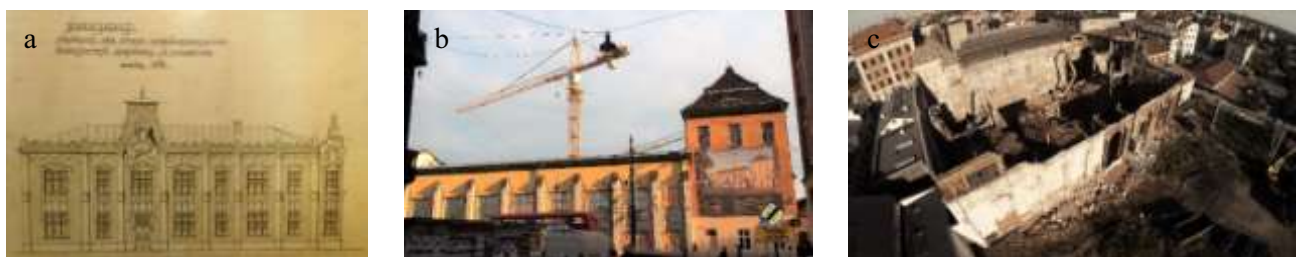
Fig. 2 a) view of the elevation of the Municipal Power Plant in Kraków, years 1906-1908; source: State Archive; b) front wall of power plant before renovation, view from Wawrzyniec Street, 21.09.2015, own archive, c) bird's eye view of the property in 2015 source: <http://tekton.krakow.pl/w19-krakow/>

An exemplary investment is the construction of an apartment complex on the area including the buildings of the former municipal power plant (administration building, machine hall, boiler room). Built (and extended) at St. Wawrzyńca Street, in the historic district of Kazimierz, the power plant, from 1905 until the 1960s, supplied almost half of the city with energy. In the following years, the importance of the power plant declined, its operations stopped and for almost 30 years the property had been empty (Fig. 2).

Fig. 2 a) view of the elevation of the Municipal Power Plant in Kraków, years 1906-1908; source: State Archive; b) front wall of power plant before renovation, view from Wawrzyniec Street, 21.09.2015, own archive, c) bird's eye view of the property in 2015 source: <http://tekton.krakow.pl/w19-krakow/>

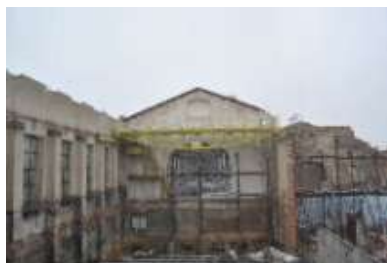
Fig. 4 Old power plant after partial demolition, view of left, 12.10.2015, own archive

The St. Wawrzyńca Quarter Revitalization Program provided for preservation of many historical elements for the investment. It was decided to **keep the entire administration building and the adjacent front wall of the former turbine hall B2 from Wawrzyńca Street (Fig. 4). Manual demolition of masonry walls of power plant buildings** was carried out, so that after cleaning and preparation of bricks, they could be used again in the new buildings (Fig. 5). Similarly, a part of the power plant's interior furnishings were used, i.e. a part of **window and door joinery (Fig. 6), a stone panel, a steel balustrade and a commemorative plaque of the manufacturer [12].**

Fig. 4 Object after partial demolition, view of left fragments of the old power plant, 12.10.2015, own archive

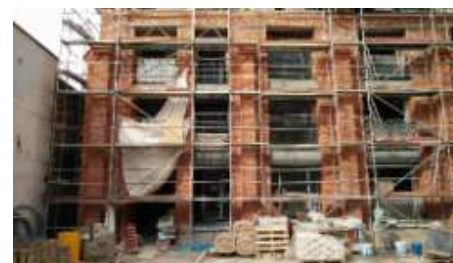
Fig. 5 Built-in historic brick in a newly-built structure 21.03.2017, own archive

Fig. 5 Built-in historic brick in a newly-built structure 21.03.2017, own archive

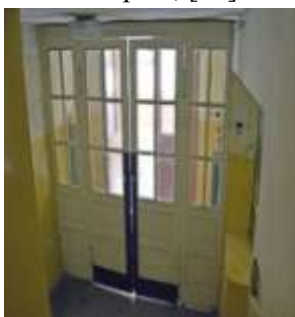
Fig. 6 Paneled wall and double swing doors, Cracow, 2014; source: M. J. Łukacz,

Fig. 6 Paneled wall and double swing doors, Cracow, 2014; source: M. J. Łukacz,

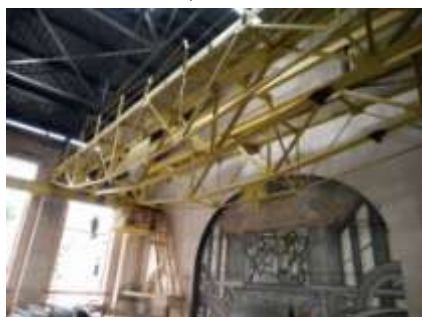
Fig. 7 Historic gantry located in building B2, in the former control room and switchgear before the renovation, 28.06.2016, own archive

Industrial equipment of power plants have the character of technical monuments. It was therefore decided to keep several technical equipment in new buildings. This is mainly **the gantry** in building B2 (Fig. 7), which was one of the most serious sources of risk, and **the stoves** located in the passageway to the courtyard of the apartment complex (Fig. 8).

Taking into account the conservator's requirements, the technical equipment of the power plant was also renovated of which the most problems were caused by a large gantry located in building B2. The gantry had to be renovated, which was planned by the conservator and designer outside the construction site. Due to its considerable size, weight and lack of consent of the conservator to divide it into smaller parts (for transport), it was decided to leave it for the entire duration of the construction, and to renovate it on site. This decision required the construction of a wall to support the gantry, which was not included in the work schedule. A new wall (Fig. 11) was erected as a substructure, and then the existing wall was demolished, which posed a threat due to its poor technical condition. These works increased the workload and investment costs, in which the General Contractor and the Investor participated.

Fig. 7 Historic gantry with a lifting capacity of 125 kN located in building B2, in the former control room and switchgear before the renovation, 28.06.2016, own archive

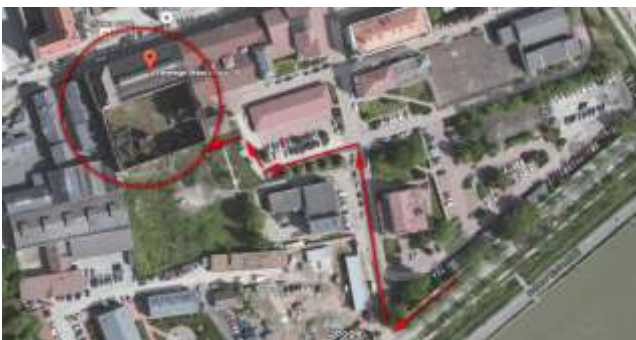
Fig. 9 Location of the investment with marked access for technological transport, may 2014

The logistics of supplying the construction site with materials and equipment and the logistics of construction works in the existing conditions was extremely complicated. Due to the location of the investment, only a narrow, winding access to a small strip of the storage yard (leased from the neighboring investment) located at the back of the building complex, in the southern part, was possible. Difficult access required proper planning of deliveries of materials with large dimensions and/or long lengths (e.g. reinforcing bars were delivered in sections not exceeding 12 meters). Fig. 9 shows the route of material delivery, which took place from Podgórska Street.

Fig. 9 Location of the investment with marked access for technological transport, may 2014

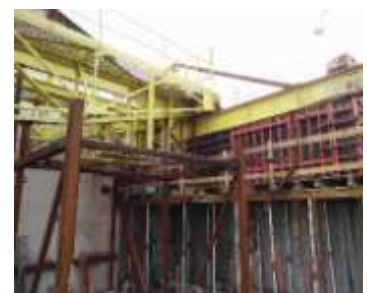
Fig. 11 Construction of a new supporting wall for a historic gantry, own archive, 09.03.2016

Fig. 11 Construction of a new supporting wall for a historic gantry, own archive, 09.03.2016

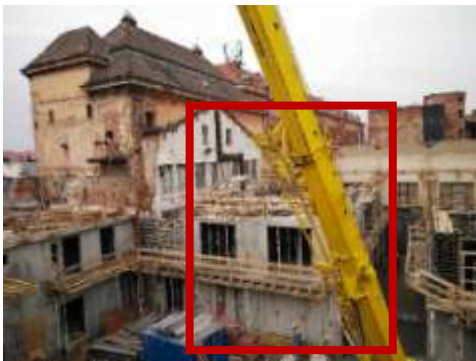
Fig. 12 Technological entry to the construction site, own archive, 03.03.2016

The location of landfills, containers, as well as the indication of material and entry points for machines also required difficult decisions. In addition to planning the changing location of storage sites, a technological entrance was designed and built in the future structure of the building on the side of St. Wawrzyńca Street (Fig. 12). The slab above the garages, constituting a temporary

entrance to the construction site, has been additionally reinforced here to allow entry of concrete mixer truck, pumps and an additional car crane into the courtyard of the future building complex. Moreover, during the implementation of the project (in mid-March 2016), in order to accelerate the concrete works, it was also decided to install a second tower crane (from the west) at the level of the already existing slab above the garages. The decision to rent an additional tower crane for the duration of the reinforced concrete works, as well as the costs of renting it, were taken by the subcontractor. The reason for his actions was originally too slow execution of the works, which could lead to exceeding the deadline and the associated large financial penalties. In order to reduce the impact of this risk, the subcontractor decided to speed up the work by hiring additional working brigades and leasing more formwork, which also required the hiring of an additional crane. In the second stage of construction (May 2016), the technical corridor was plugged. As the works progressed, material storage sites and social rooms changed their location several times.

Fig. 12 Technological entry to the construction site, own archive, 03.03.2016

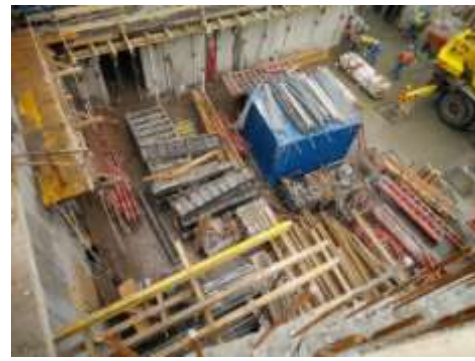
Fig. 13 One of the temporary storage yards, own archive, 03.03.2016

Fig. 13 One of the temporary storage yards, own archive, 03.03.2016

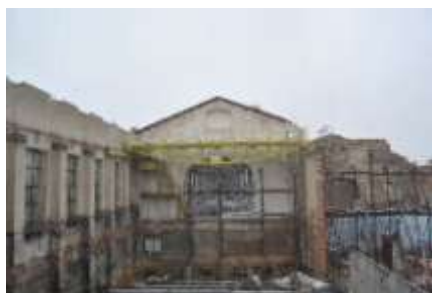
Rys. 1 Obiekt po częściowej rozbiórce, widok pozostawionych fragmentów starej elektrowni, 12.10.2015, archiwum własne

Program Rewitalizacji Kwartału Świętego Wawrzyńca, przewidywał dla realizowanej inwestycji zachowanie wielu elementów zabytkowych. Zdecydowano zachować cały budynek administracyjny oraz przylegającą do niego ścianę frontową byłej hali turbin B2 od ulicy Wawrzyńca (Rys. 1). Wykonano ręczną rozbiórkę ścian murowych budynków elektrowni, aby po oczyszczeniu i przygotowaniu cegieł, użyć je ponownie w budowanych obiektach (Rys. 2). Podobnie wykorzystano część wyposażenia wnętrz elektrowni tj. część stolarki okiennej i drzwiowej, kamienną płycinę, stalową balustradę oraz pamiątkową tablicę producenta.

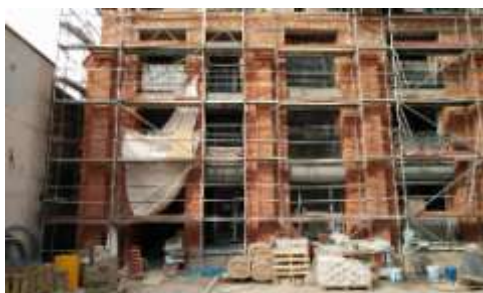
Rys. 2 Wbudowana zabytkowa cegła w nowopowstającą konstrukcję 21.03.2017, archiwum własne
