PROBLEM OF NON-MEASURED POINTS IN SURFACE TEXTURE MEASUREMENTS

This work is focused on the issue of non-measured points – one of the most important problems in surface texture measurements using optical methods. The fundamental aim of this research is to analyse errors of surface texture measurements caused by the presence of non-measured points. This study is divided into two parts. In the first part, circles with non-measured points were artificially created on peak portions of measured surfaces. In the second part – the results of measurement by a Talysurf CCI Lite interferometer were analysed. A measurement area of 3.3×3.3 mm contained 1024×1024 points. The measurements were performed with different intensity of light. Changes of parameters regarding the analysed errors depended on a surface type. The following parameters are susceptible to errors: skewness *Ssk*, areal material ratio *Smr*, as well as the following feature parameters: *Spd*, *Sda*, *Sdv*, *Sha* and *Shv*. Inaccuracies of measurement in valley parts of two-process textures led usually to larger errors of parameter computations compared with deviations in peak portions.

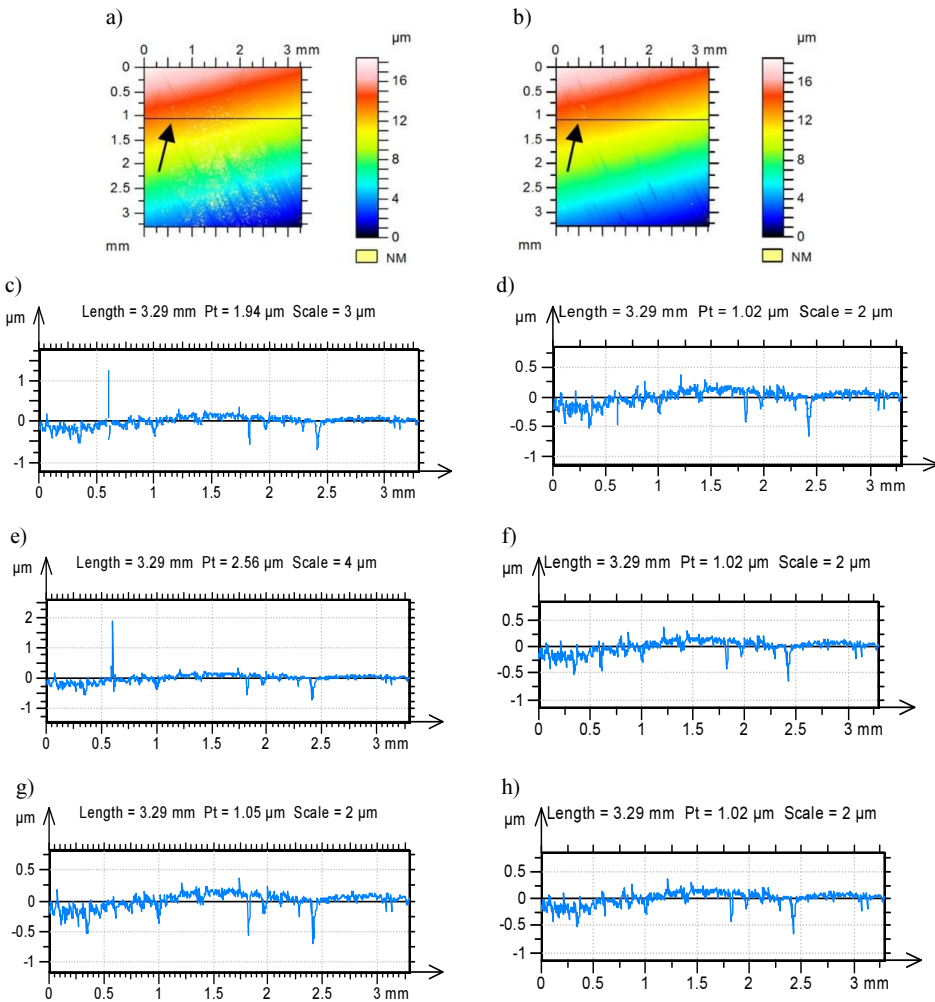
Fig. 7. Contour plots (a, b), extracted profiles before correction – filling in (c, d), after correction of the whole surface (e, f) and after profile correction (g, h); NM ratio 6.68% (a, c, e, g) and 0.079% (b, d, f, h).

An incorrect light intensity could lead to the presence of spikes (Fig. 6). However, erasing non-measured points from the whole honed surface can cause an increase of profile height (Fig. 7c and 7e), contrary to a similar correction of profile only (Fig. 7g). When the light intensity was smaller (Fig. 7b, 7d, 7f and 7h) the non-measured points appeared in the same place (see arrows), but without the presence of spikes. The same profile was obtained after correction of the whole surface or profile (see Fig. 7f and 7h). The Sp parameter value for the corrected surface after form removal with a smaller NM ratio was $1.21\ \mu\text{m}$, but with a higher one – $3.07\ \mu\text{m}$. The arrows indicate positions of errors.
