ARCHIVES  
of  
FOUNDRY ENGINEERING

# Cavitation Erosion of Nodular Cast Iron – Microstructural Effects

The paper deals with susceptibility of nodular cast iron with ferritic-pearlitic matrix on cavitation erosion. Cavitation tests were carried out with the use of a cavitation erosion vibratory apparatus employing a vibration exciter operated at frequency of 20 kHz. The study allowed to determine the sequence of subsequent stages in which microstructure of cast iron in superficial regions is subject to degradation. The first features to be damaged are graphite precipitates. The ferritic matrix of the alloy turned out to be definitely less resistant to cavitation erosion compared to the pearlitic matrix component.

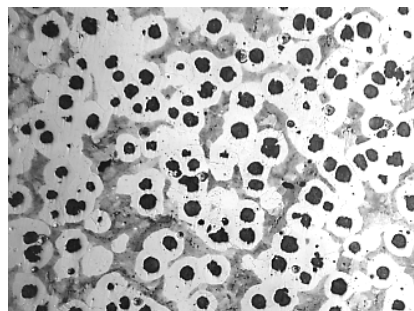
Fig. 2. Microstructure of the nodular cast iron used in the present study. Ferrite, pearlite, graphite. Magnification  $100\times$ . Section etched with 4%  $\text{HNO}_3$

Microstructure of the nodular cast iron used for the purpose of the present study is shown in Figure 2.

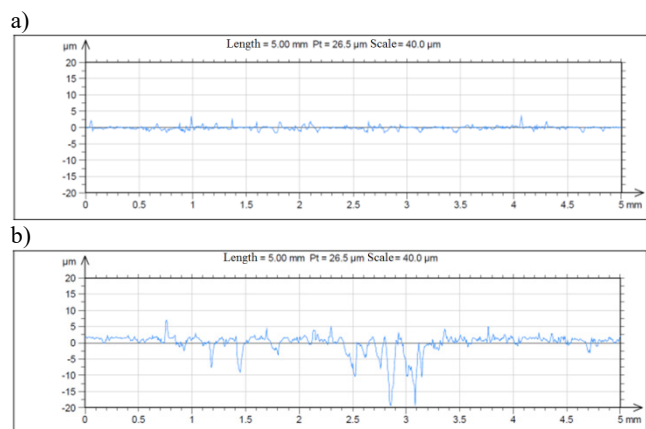
Fig. 3. Example profilograms of nodular cast iron specimen surfaces subject to cavitation erosion test for: (a) 30 minutes, (b) 120 minutes

Example 2D profilograms of specimen surfaces in the cavitation activity region after 30-min and 120-min test are shown in Figure 3.

Values of the parameter  $R_t$  characterizing geometrical structure of specimen surface after cavitation erosion resistance test in central portion of the cavitation interaction area are summarized in Table 1.

The obtained results indicate that with the increase of cavitation interaction time from 30 min to 120 min, value of parameter  $R_t$  increase more than fivefold.

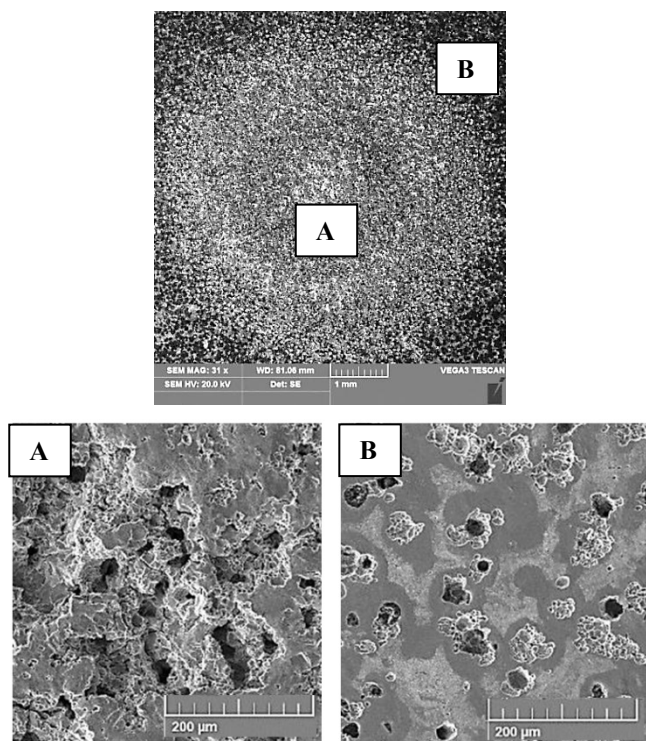
Fig. 4. Example views of specimen surface after 120 minutes of cavitation erosion resistance testing; A — central and B — outermost area of cavitation interaction spot

An example view of specimen surfaces after the cavitation erosion resistance test lasting 120 minutes is shown in Figure 4. To reveal microstructure of matrix, specimens were etched with 4%  $\text{HNO}_3$ .

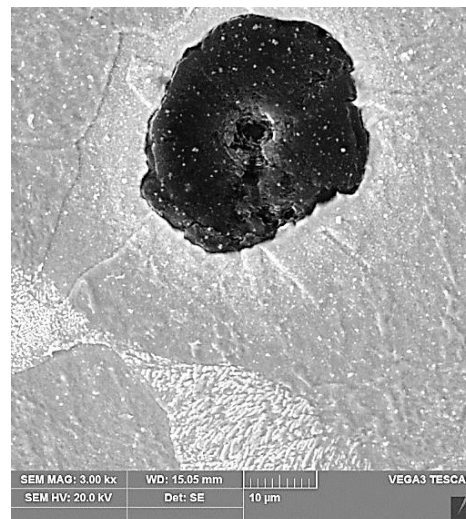
Fig. 5. The first stage of cast iron microstructure degradation. Outermost portion of cavitation interaction spot. Destruction of graphite precipitates in ferritic matrix progressing from center towards graphite-matrix interface

Figures 5–8 illustrate characteristic changes in microstructure of areas subject to cavitation interaction.

The obtained results allowed to establish the sequence of stages in which microstructure of nodular cast iron with ferritic-pearlitic microstructure is subject to degradation. Destruction starts with graphite precipitate tear-offs occurring in their central portions. The most durable is a thin graphite film in contact with matrix.

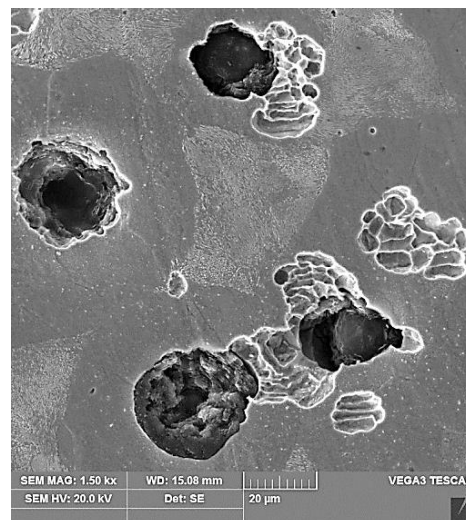
Fig. 6. The second stage of cast iron microstructure degradation. An outermost portion of cavitation interaction spot. Note high degree of graphite precipitate degradations progressing in layers but always from center towards graphite-matrix interface. Partial graphite tear-offs initiate degradation of ferritic matrix

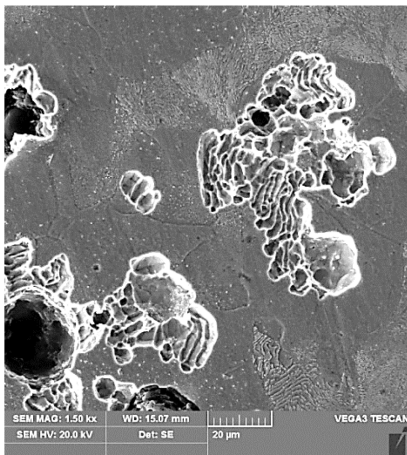
Fig. 7. The second stage of cast iron microstructure degradation. Uttermost region of the cavitation interaction zone. Significant progress in ferritic matrix degradation blocked locally by pearlite precipitation areas

In the next stage, degradation spreads onto ferrite precipitates surrounding graphite nodules. Further development of erosion of the ferritic matrix are suppressed by pearlite precipitation areas.

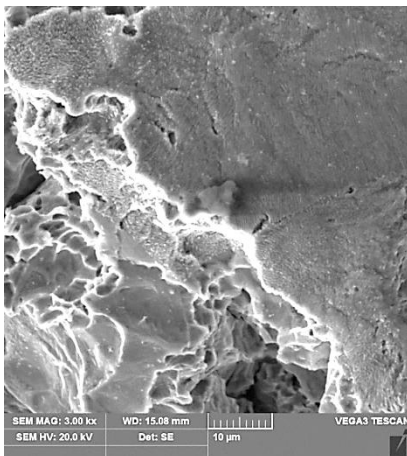
Fig. 8. The second stage of cast iron microstructure degradation. A central portion of the cavitation interaction spot. Deep cavitation-induced cavities in ferritic matrix with visible initial stage of destruction of an exposed, deeply lying graphite precipitate. No visible damages to pearlite precipitates

After the longer test cycle of 120 minutes, no evidence was found of degradation in pearlite precipitates. The obtained results do not confirm any structural response of nodular cast iron microstructure to cavitation interaction in aqueous environment reported by authors of [12]. It seems to be a reasonable assumption that the material examined in the above-quoted study was in after a heat treatment after which the cracks on the graphite-matrix interface occurred as a result of diffusion processes. The cracks could provide easy paths for propagation of cavitation-induced destruction.
