## RESEARCH ON DURABILITY OF COMPOSITE MATERIALS USED IN REPAIRING AIRCRAFT COMPONENTS

*The paper presents methodology and results of research on durability of composite materials, which were applied to expedient repair of damaged aircraft components. Numerical calculation and experimental tests were conducted during research. The obtained results proved that failure of aircraft components is connected with local loss of stability in case of aircraft's skin and stiffness in case of girders and beams. The damaged components were repaired with the use of a metal insert and a composite patch. The use of a metal insert, which had the same stiffness as repaired elements, was a solution which allowed to restore local stiffness of repaired components. Composite patches which were formed with glass, carbon or aramid fabrics impregnated with epoxy resins, also created an adhesive bonds and joined all elements of repaired zone. The experimental tests proved that the executed repairs whose time was limited to 120 minutes improved stability, stiffness and fatigue life of the repaired components.*

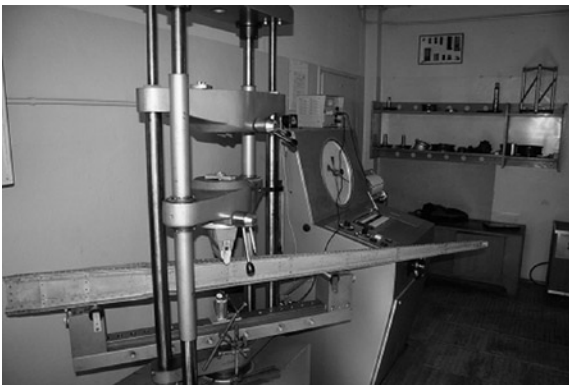
Fig. 3. Method of a girder mounting in the research stand

The effectiveness of girder repair was checked by a comparative analysis of stiffness of girder which was undamaged, damaged and repaired. The stiffness was determined during bending tests. The fixing method of the tested girder and the used research stand is presented in the Fig. 3. The distance between supports was 717 mm and the girder was loaded between supports with use of loading stanchion. A change in strain of the loaded girder was determined in function of the force. A strain sensor was mounted under flange of the girder. On the basis of the obtained results it was possible to assess an effectiveness of applied repairs.

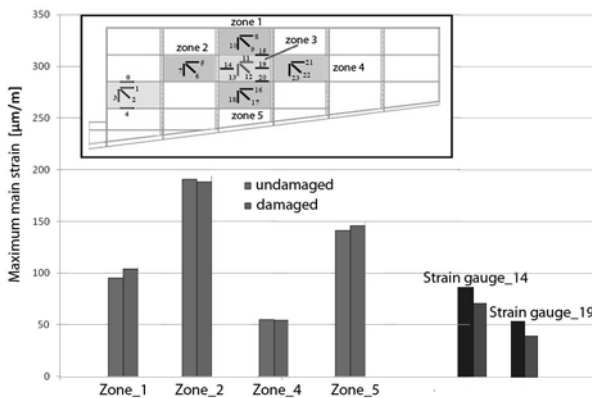
Fig. 8. Maximum main strain in the chosen zones of loaded construction

The horizontal tail was loaded with the force of 880 N that corresponded with a displacement of the actuator of 25 mm. The values of maximum main strain were determined on the basis of the strain gauges' rosettes placed in the subsequent construction zones. The values of strain were defined in chosen zones of undamaged and loaded construction (case no. 1) and in damaged and loaded construction (case no 2). The results are presented in the Fig. 8.

The results of performed tests showed that maximum main strain in the zones adjacent to damaged zone (outside the supporting elements) did not change significantly. A significant decrease in strain

was registered in strain gauges no. 14 and 19 which were located in the damaged zone. The obtained results confirmed conclusions of the numerical calculations.

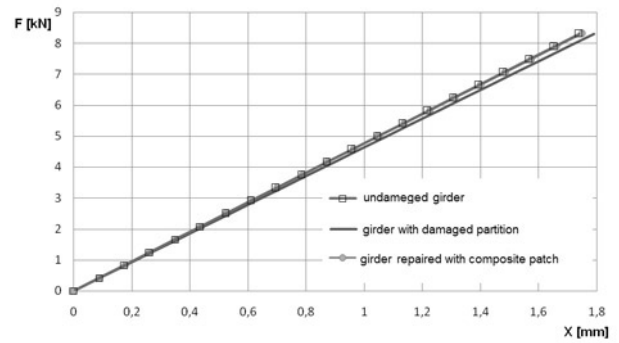
Fig. 18. Dependence of the girder's strain in function of the force changes –  $F=f(x)$

Then stiffness was determined by means of bending test which was conducted in the same conditions as the undamaged girder. As a result, a curve  $F=f(x)$  was determined (Fig. 18). It was noticed that the applied repair allowed us to restore the initial stiffness of the damaged girder.

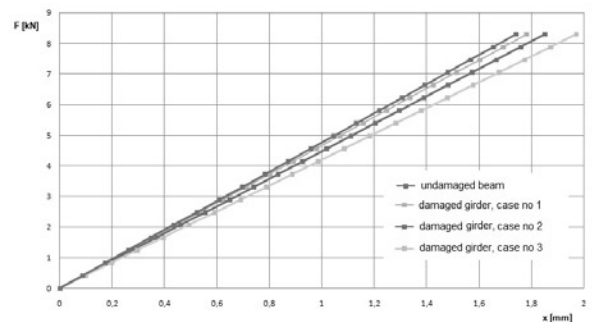
Fig. 20. Dependence of the girder's strain in function of the force changes –  $F=f(x)$

The obtained results of the dependence of  $F = f(x)$  are presented in the Fig. 20.

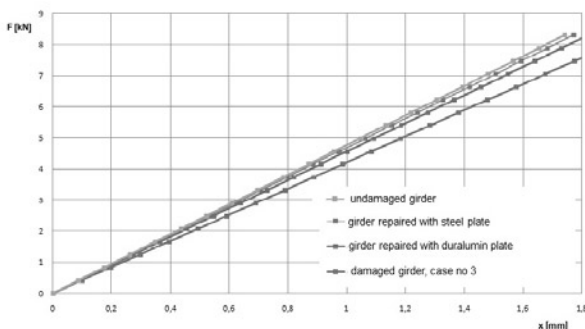
Fig. 22. The comparison analysis of the girder's stiffness which was undamaged, damaged and repaired with riveted metal plates –  $F=f(x)$

The comparison analysis of the girder stiffness which was undamaged, damaged and repaired with riveted plates, is presented in the Fig. 22.

As a result of the researched repairs it was not possible to restore initial stiffness of the girder. According to predictions the stiffness of the repaired girder was closest to the initial stiffness in case of using steel plate.

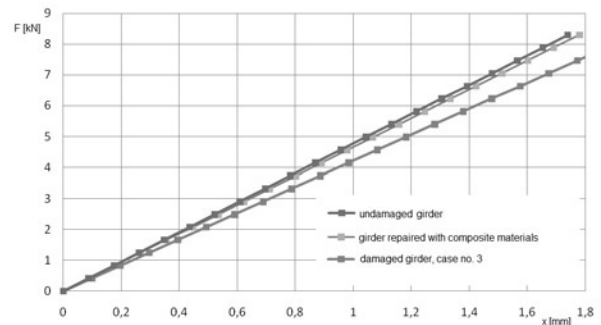
Fig. 25. The comparison analysis of the girder's stiffness which was undamaged, damaged and repaired with composite patch –  $F=f(x)$

The view of the repaired zone is presented in the Fig. 24 and research on the girder's strain in function of the force changes ( $F=f(x)$ ) is presented in the Fig. 25.

The initial stiffness of the girder was not restored as a result of the conducted repair. However, the obtained stiffness was close to the one which was determined for the girder that was repaired with steel riveted plate. Furthermore, fatigue tests of the repaired girder were executed. The girder was subjected to cyclical force in the range of  $0 \dots 8.3$  kN. The load cycle was repeated 50 and 100 times and organoleptic assessment of the repaired zone was executed. No re-damages were detected but the stiffness of the repaired girder changed little according to the curve presented in the Fig. 26.

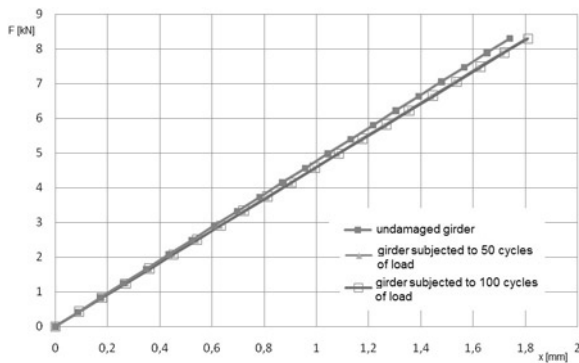
Fig. 26. The comparison analysis of the girder's stiffness which was undamaged, damaged and repaired and subjected to fatigue tests –  $F=f(x)$
