MONITORING OF CRACK GROWTH IN A STRUCTURE UNDER A COMPOSITE PATCH

Abstract

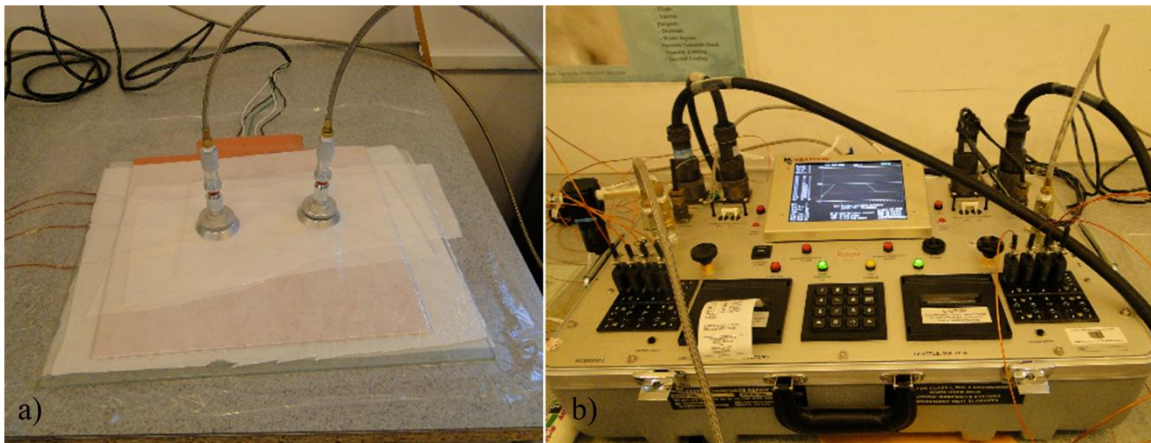
Fig. 2. Cure cycle by hot bonder: a) vacuum bag with hot bonder, b) control unit

The test repairs were performed using prepreg materials, in accordance to existing standards [5-7]. Metal specimens' surface was degreased, sandblasted and subsequently covered by anti-corrosion and adhesion-improving compound. The composite patch was bonded to the repaired structure using an adhesive epoxy film. The repair operation was performed in a single step (using a single heat cycle).

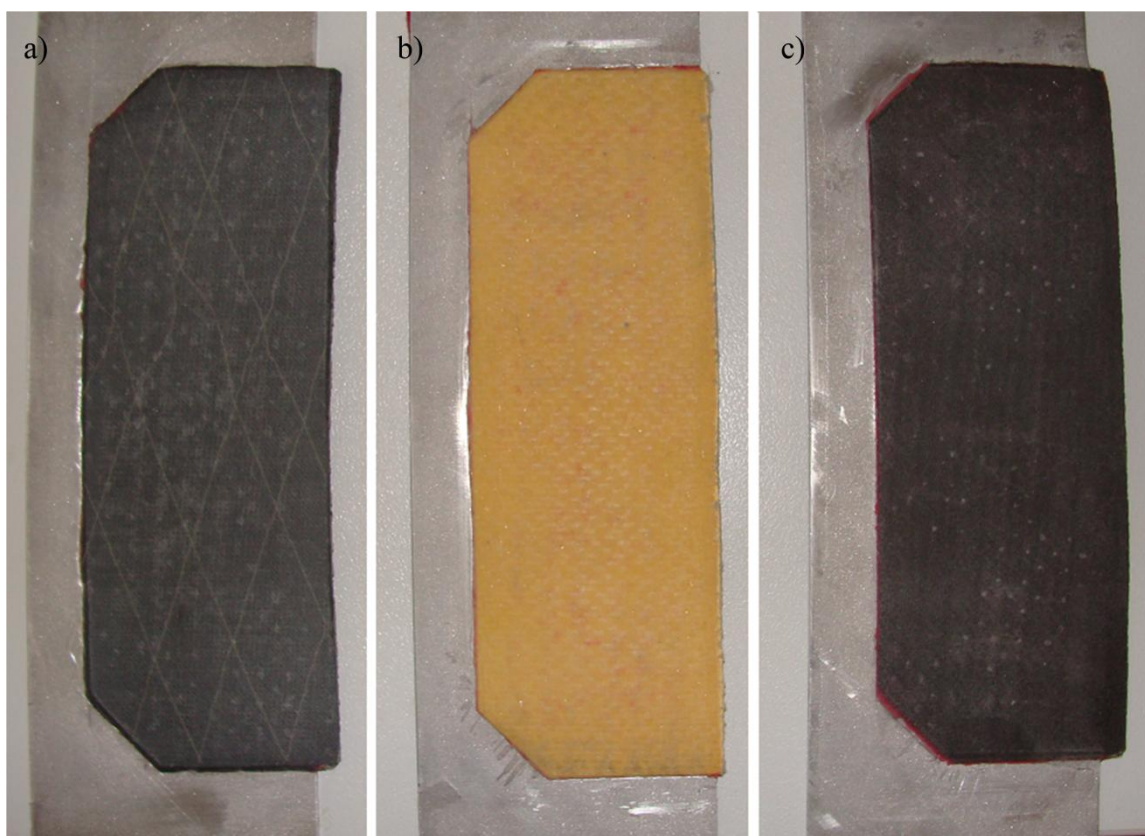
In the AFIT laboratory, CBR was performed on three of the specimens with the use of Carbon (CFRP), Aramide (ARFP) and Boron (bfrP) fiber reinforced polymer patches.

Fig. 3. The specimens after CBR: a) specimen repaired by CFRP patch, b) specimen repaired by ARFRP patch, c) specimen repaired by BFRP patch

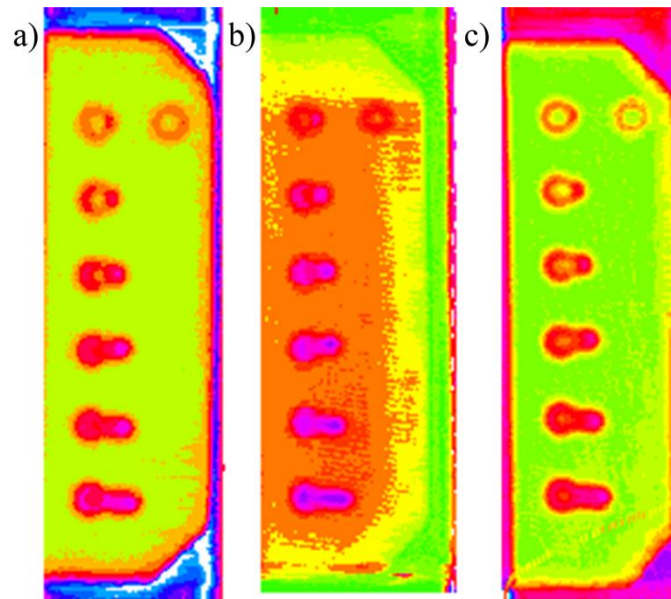
The ET investigation was performed with the use of a MAUS V system and with a MOI device. The authors conducted a series of tests with different test frequencies. These frequencies were chosen by way of earlier research. The results indicated that the frequency of 10kHz gives the clearest image of damage for all types of composite patches, equally for the MAUS system and for the MOI. The best visualization, regardless of the patch's material, was obtained with MAUS system's C-scan imaging (fig. 4), even for the smallest crack (2mm model).

Fig. 4. MAUS's C-scan: a) specimen repaired by CFRP patch, b) specimen repaired by ARFRP patch, c) specimen repaired by BFRP patch

- The ET method can be employed for the inspection of repaired metal structures. The use of experimentally chosen 10 kHz eddy current frequency filters out only the interesting response signal in metal alloys.

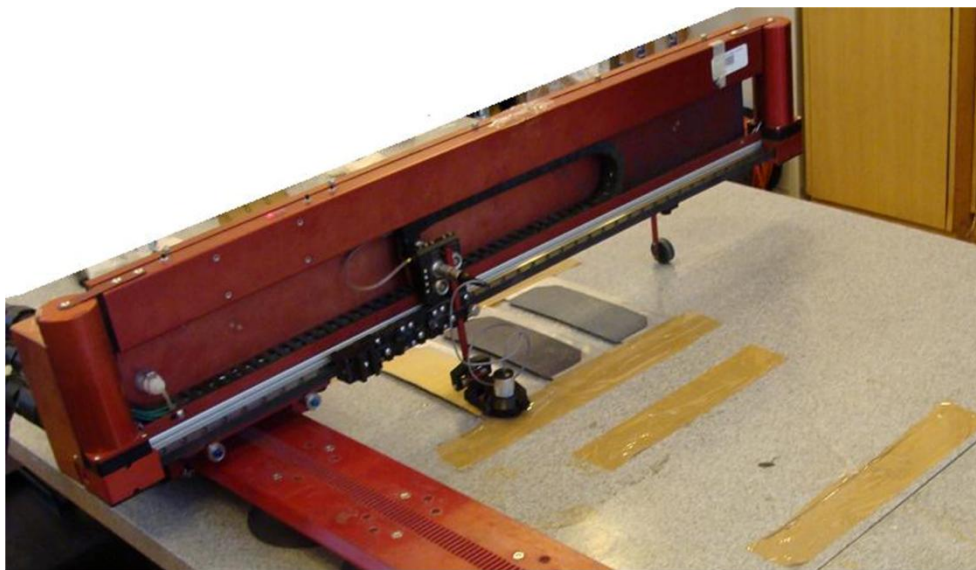
The automated MAUS system enables the examination of flat as well as of highly curved surfaces. However, access to the tested objects is limited by large dimensions of the sensor. Because of that, the system can only be applied to larger and easily accessible areas of aircraft skin or to particular components, de-installed from the craft.

Fig. 5. MAUS V during work

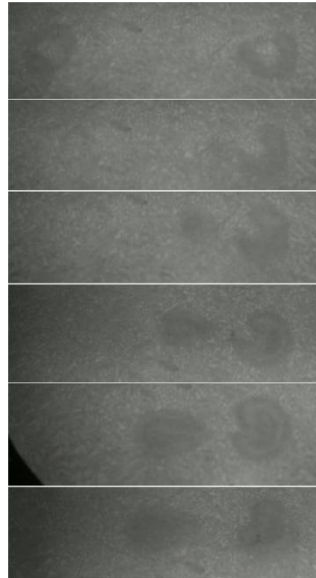
Fig. 6. Test results for the specimen repaired with the BFRP patch

For the MOI system, the resulting images' clarity and definition vary with the patch material. The best results were obtained for the BFRP specimens.

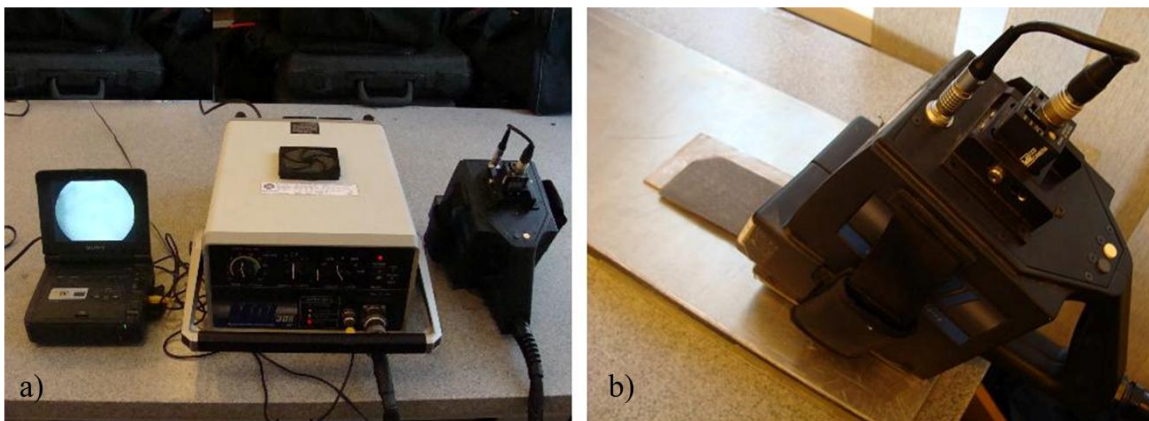
Operating principle of the MOI involves the ET method, as well as the Faraday effect (magneto-optic effect), in which the polarization plane of linearly polarized light ray is rotated by a certain angle while propagating through a medium in which magnetic field is present [11].

Fig. 7. MOI system: a) control unit, sensor, video recorder, b) sensor during work

One of the advantages of the MOI device is the capability to record and also to monitor in real-time the structure's condition. This property may be used for on-line observation of the crack propagation during a fatigue test.

Disadvantages of the MOI are the limited access to the examined object due to the sensor's large size, as well as the fact that the system's sensor must remain in contact with the surface inspected – therefore the object's surface should be flat or of low curvature.

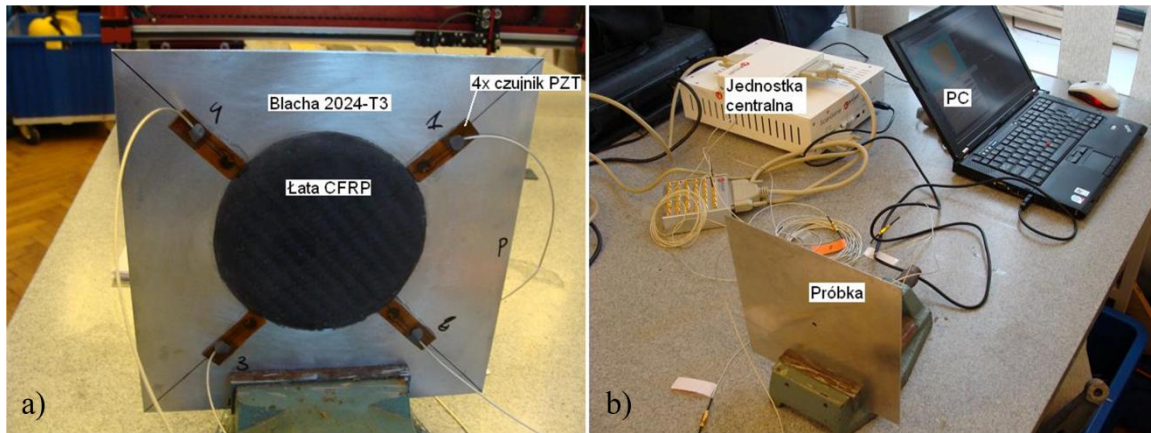
The use of PZT sensors is a modern approach in the field of structural monitoring. Some initial research on the application of such sensors for the monitoring of composite patch covered metal structures had been carried out at the IWTL. For this purpose, the commercially-available Accellent instrumentation system was used. The system includes the PZT sensor suite and a central unit containing an impulse generator and a measurement card. The system is controlled by PC-installed software.

Fig. 8. The test system: a) specimens with PZT, b) Acecent equipment

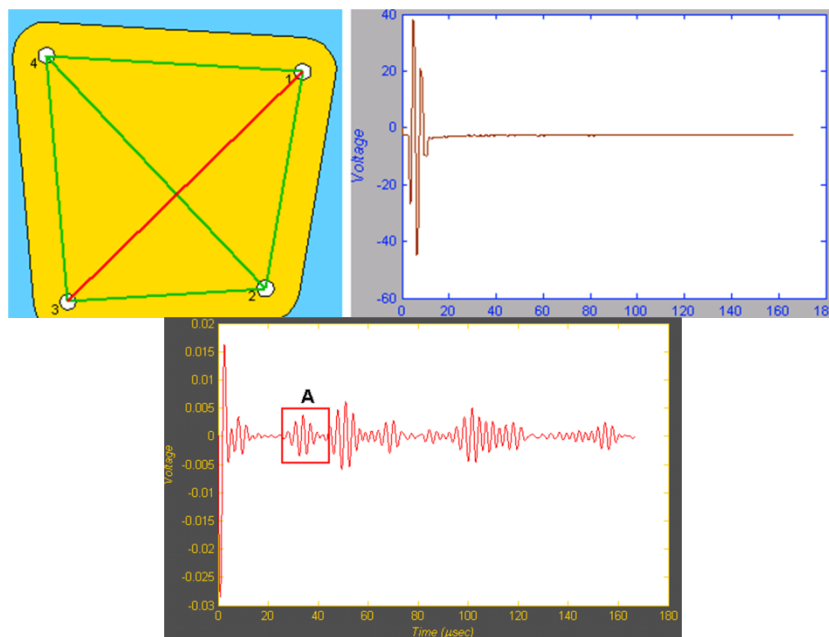
The sensors' location coordinates are input into the software and the baseline condition of the structure is captured by registering the structure's response to an impulse generated by each of the PZT units.

Fig. 9. Baseline: a) sensor locations, b) signal generated (300 kHz), c) baseline structure response

The PZTs serve both as sensors and generators. In this research a three-peak sine-burst signal has been used. The software, by taking into account the recorded baseline result, the sensors' coordinates, and the form of the crack, computes the crack's location. The baseline structure used for the PZT research had the form of a 6mm diameter hole. The 1.3 mm, 5 mm, 10 mm, 15 and 20 mm incisions (crack models) were used in the series of tests.

mm	Structure condition	Suitable, window A (FIGURE 9c) Transition 1-3	FFT Transition 1-3	Visualization
0				
1.3				
5				
10				
15				
20

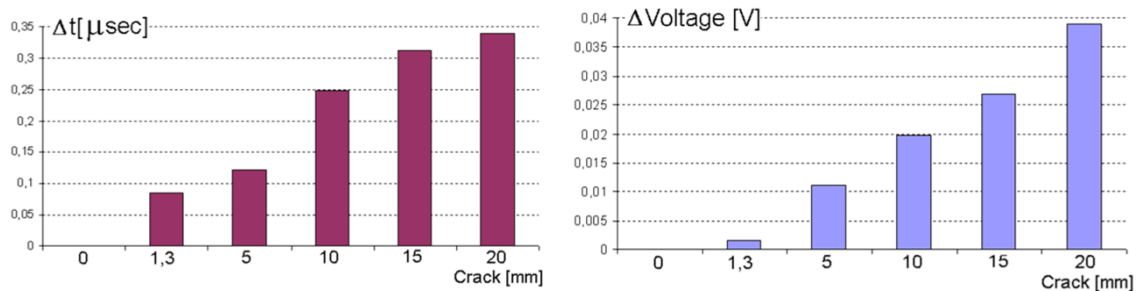
The recorded response signal is used for evaluating the crack's influence on amplitude loss and phase shift (when compared to signal responses of the baseline). The occurring phase shift may be explained by the increase of the shortest wave path between the generating and receiving unit (sensor). The increase occurs because of the interaction between the crack and the generated wave. This interaction leads to a deflection of the wave.

The diagrams show that the signal's measured electrical parameters and the crack length are related.

Fig. 10. Researches results: a) time delay (phase shift), b) amplitude loss
