Anna TURLEJ ORCID 0000-0002-9405-9753, anna.turlej@itwl.pl – corresponding author
Bolesław GIEMZA ORCID 0000-0001-5135-8860, boleslaw.giemza@itwl.pl
Marta SKOLNIAK ORCID 0000-0002-0850-6781, marta.skolniak@itwl.pl
Air Force Institute of Technology (Instytut Techniczny Wojsk Lotniczych)

IMPACT OF THE ANTIFREEZE COMPOSITION ON THE RISK OF CORROSION OCCURRENCE IN COPPER STRUCTURE ELEMENTS OF THE HVAC SYSTEMS

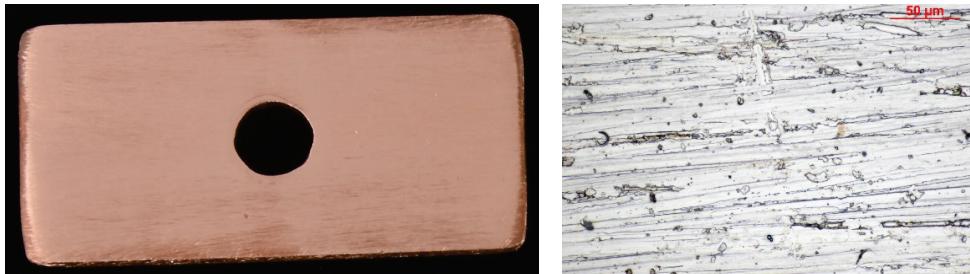
Macro- and microphotography of the copper plate before the test was shown in Figure 1.

Fig. 1. Plate before the test; on the left- macro photography - copper plate; on the right – microphotography - copper plate, BF technique, 10x50 BF

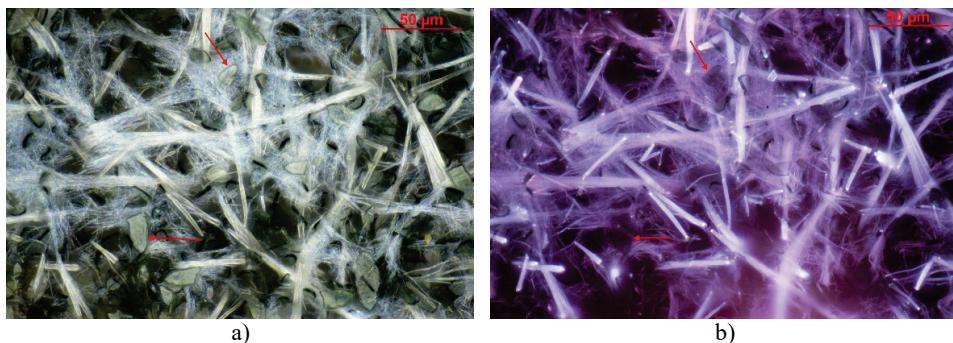
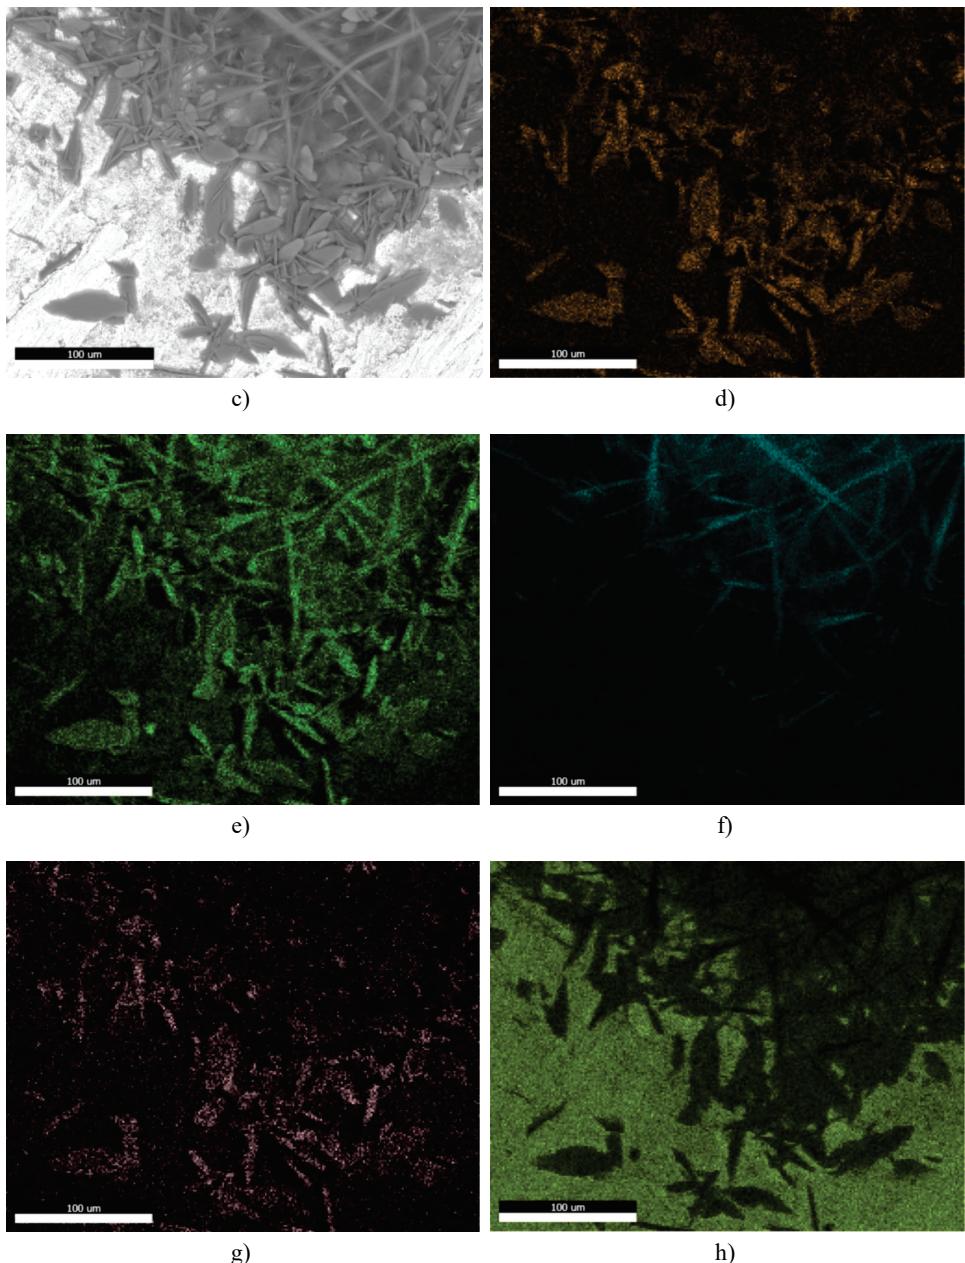
- The presence of numerous objects, probably flake-shaped precipitates (Fig. 3, a, b, red arrows) and fibre-shaped precipitates (Fig. 3, a, b, Fig. 4b, c black arrows).
- Flake-shaped objects are characterized by high concentration of sodium (Na), oxygen (O) and nitrogen (Fig. 3, d, e, g).
- Fibre-shaped objects are characterized by high concentration of oxygen (O) and calcium (Ca) (Fig. 3, e, f).
- For flake-shaped objects, MaxFeret <50 µm, and for fibre-shaped objects, the width (diameter) of fibres amounts to <1 µm.
- Precipitates occur in high density in cavities on the plate surface (Fig. 3 c).

Fig. 3. The plate examined in the original fluid - sample 1 - red arrows indicate flaky structure:
a) LOM 10x50 BF, b) 10x50 FLUO A

Fig. 3. cont. The plate examined in the original fluid - sample 1 - red arrows indicate flaky structure:
c) SEM, d) SEM – Na, e) SEM – O, f) SEM – Ca, g) SEM – N, h) SEM – Cu

Both in bright-field microscopy and fluorescence technique, the copper plate surface tested in the original fluid, the plate of which was fully covered with numerous objects in the form of flake- and fibre-like crystallites. No crystalline forms were observed on the surfaces of tested plated in diluted fluids. The plate surfaces tested in diluted fluids were covered with discontinuous tarnish layers, in which thicker areas are brittle (in morphologic assessment, cracks and chipping of the thicker tarnish layer were found). In the bright field technique, point blue changes were observed on copper plates. Using the polarisation technique, it was captured in the case of plates tested in diluted fluids that these stains could be the source of deeper surface changes.

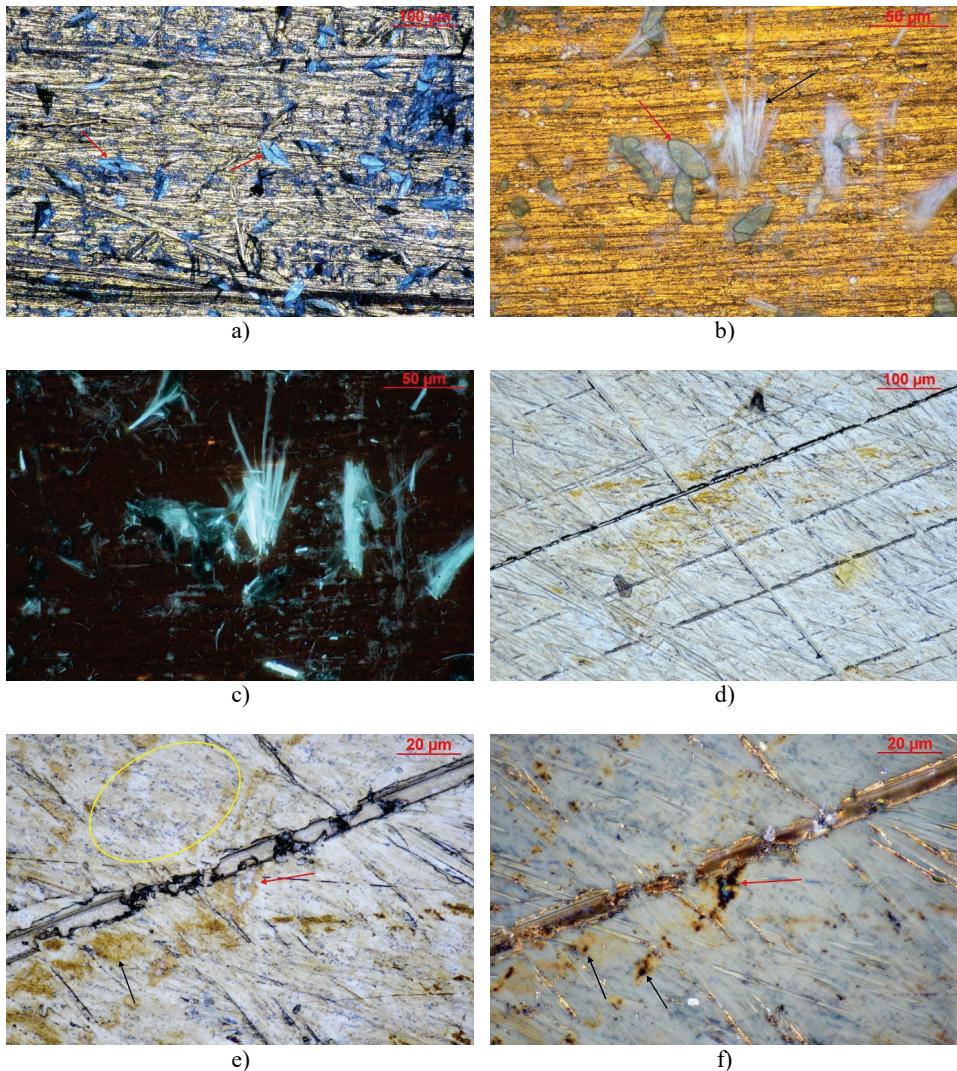
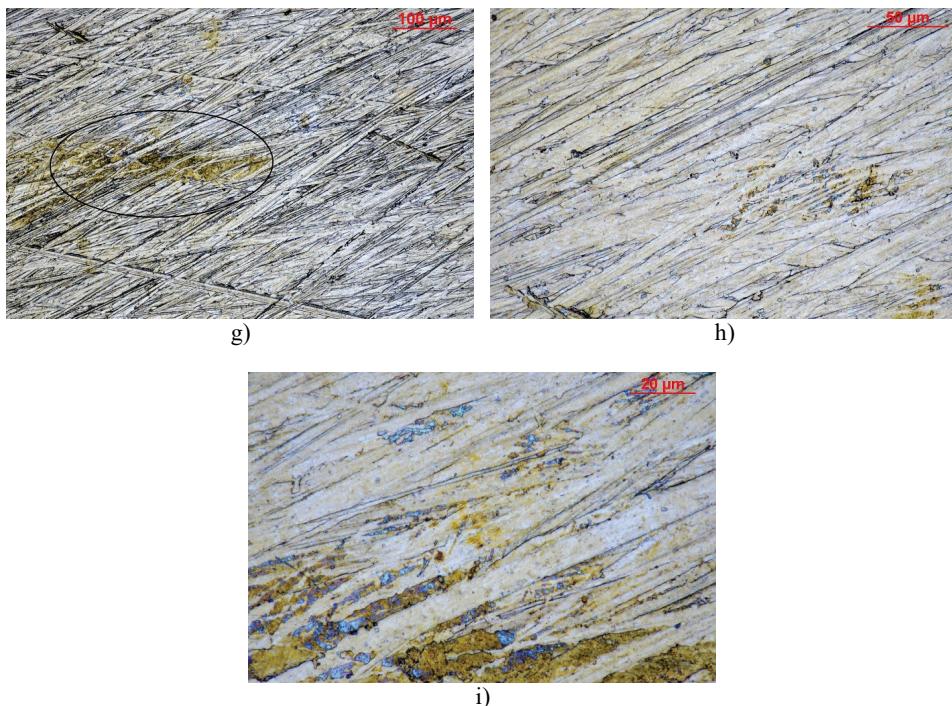
- Sparse yellow-brown (black area) discolouration, tarnish-like (Fig. 4 g).
- In Fig. 4 h, and it is observed additionally, point blue spots (MaxFeret<10 µm) are visible.

- Sparse yellow-brown discolouration (red and black arrows), looking like tarnish (Fig. 4 d, e).
- In Fig. 4e, there are numerous, very fine (MaxFeret<1 µm) point spots (yellow area).
- In Fig. 4f, it was demonstrated that the observed spots can be the source of deeper changes on the surface (black and red arrows).

Fig. 4. Copper plates: a) plate tested in the original fluid, BF 10x20 – red arrows indicate a flaky structure, b) plate tested in the original fluid, BF, 10x50 red arrows indicate a flaky structure, black arrows indicate a fibre structure, c) plate tested in the original fluid, FLUO A, 10x50, d) plate tested in sample 3, BF, 10x20, e) plate tested in sample 3, BF, 10x100 – area covered with very fine, point spots marked in yellow, red and black arrows indicate bigger discoloration, f) plate tested in sample 3, POL, 10x100 – red and black arrows indicate potential sources of deeper changes on the surface

Fig. 4. cont. Copper plates: g) plate tested in sample 2, BF, 10x20 – black area indicates tarnish-like
h) plate tested in sample 2, BF, 10x50, i) plate tested in sample 2, BF, 10x100
