Causes of the powerplants failures installed on Polish civil aviation aircraft

Key words: powerplant, aircraft engine failure, safety risk

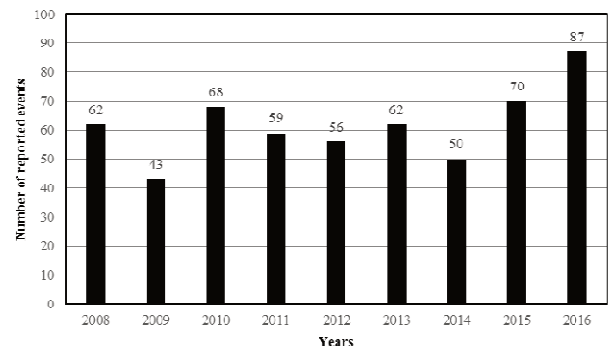
Figure 1 shows an annual number of reported aviation events caused by powerplant types considered in this article.

Fig. 1. Number of reported aviation events caused by powerplants installed on Polish registered aircraft

There was 557 reported events between 2008 and 2016 caused by all engine types installed on Polish registered aircraft.

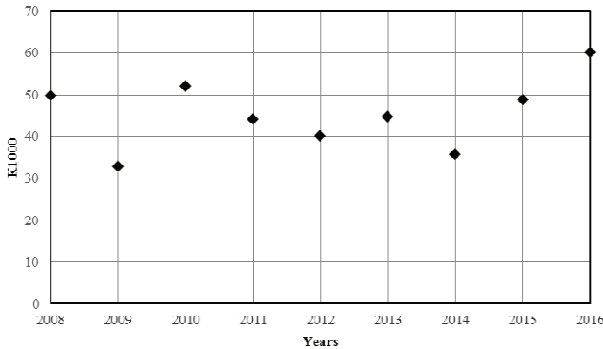
Figure 2 shows changes of the coefficient K_{1000} for aviation events occurred within 2008-2016, for all powerplant types. The below presented figures are showing increased trend of the reported aviation occurrences per 1000 registered aircraft for last two years. Such a situation

Fig. 2. Changes of the coefficient K1000 for SCF-PP aviation occurrence categories

is different considering various engine types. Next four chapters contains detailed information of aviation events have occurred for each of the powerplant type since 2008.

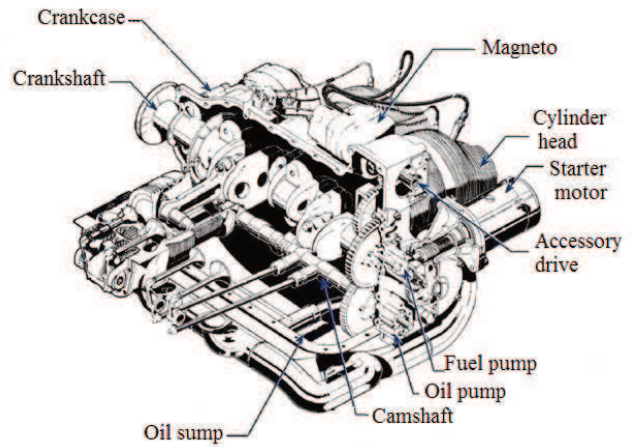
Figure 3 shows view of the contemporary utilized typical aviation piston engine with description of its main parts [3].

Fig. 3. Four cylinders, horizontally opposed, air cooled aviation piston engine

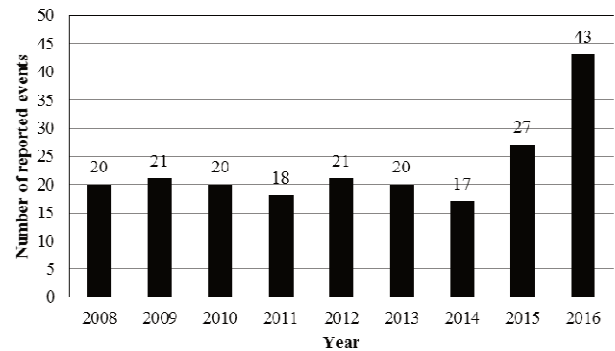
Figure 4 shows an annual number of reported aviation events caused by piston engines. Figure 5 shows changes of the coefficient $K_{1000pist.}$ between 2008-2016.

Fig. 4. Number of events caused by piston engines installed on Polish registered aircraft between 2008-2016

It has to be pointed out that for last two years sudden, significant increase in number of events caused by this

engine type is observed. From 17 in 2014 to 43 in 2016 – more than twice.

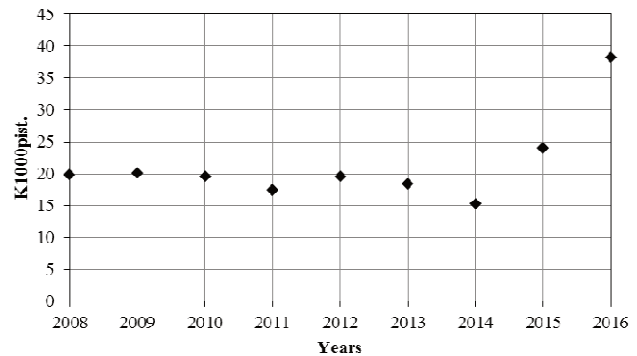
Fig. 5. Changes of the coefficient $K_{1000pist.}$

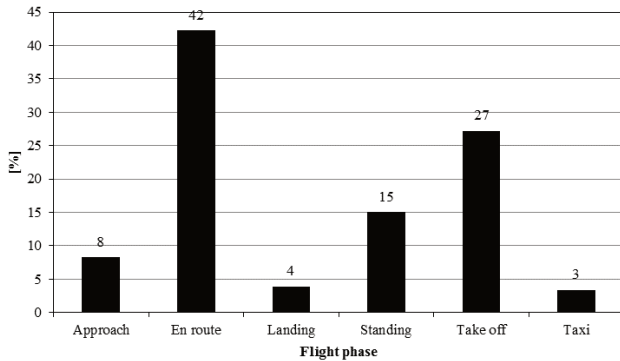
Figure 6 gives (in percent) information during which aircraft maneuver and how often reported event caused by piston engine took place in 2008-2016. It is unacceptable that the vast amount of the powerplant reported failures occurred during aircraft movement. Only 15% of them were detected during routine maintenance tasks.

Fig. 6. Flight phases share when piston engine malfunction took place

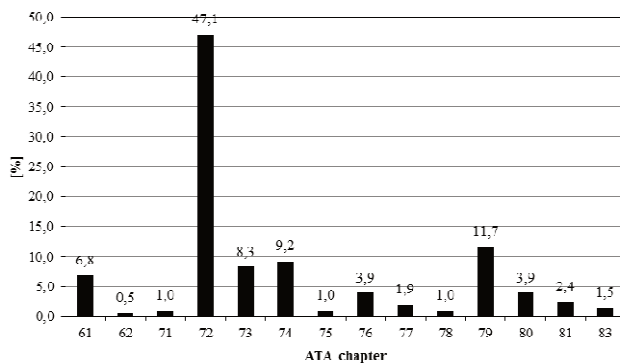
Figure 7 shows reported system defects frequency in percent assigned to the certain ATA chapter for the piston engines in the 2008-2016.

Fig. 7. Share of each powerplant system events coded by ATA 100 chapter between 2008 and 2016

The above Fig. 7 shows “share” of the certain ATA chapter in percent in the total volume of the piston engines reported events. It was assumed that the most frequently occurred event – ATA chapter 72 has occurrence probability level equal 5. Next 79, 74 and 73 level 4, 61 level 3, 76 and 80 level 2 and the remaining 62, 71, 75, 77, 78, 81 and 83 level 1. According to the methodology described in the introduction (Tab. 1, Tab. 2 and Tab. 3) to each from the above ATA chapters safety risk severity was assigned, based on events consequences described in the ECCAIRS reports. Then safety risk assessment matrix was developed for piston engines operated in Poland. Results of the analysis are presented in the Tab. 5.

Almost 50% out of the total (207) occurrences caused by powerplants can be assigned to the engine itself (see Fig. 7). Most of the events are connected with powertrain and cylinder systems. The events were caused by cracked exhaust valves. Also carbon deposit was observed on them. Other occurrences were caused by different failures of the cylinders. It can be presumed that those damages were mainly due to engines overheating that resulted from an improper exploitation.

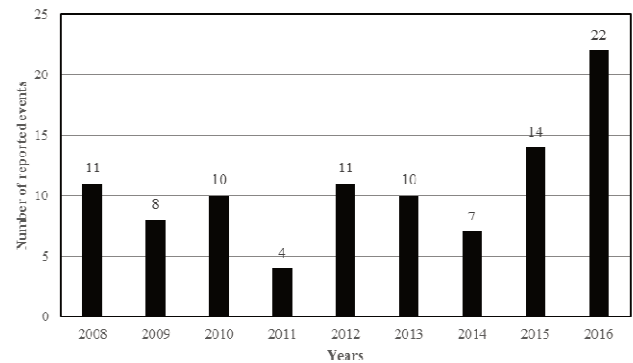
There were 97 reported aviation events in the ATA 72 chapter between 2008-2016. Figure 8 shows an annual number of reported events as a result of piston engine failures coded in that chapter.

Fig. 8. Number of events caused by piston engines installed on Polish registered aircraft in the ATA 72 chapter between 2008-2016

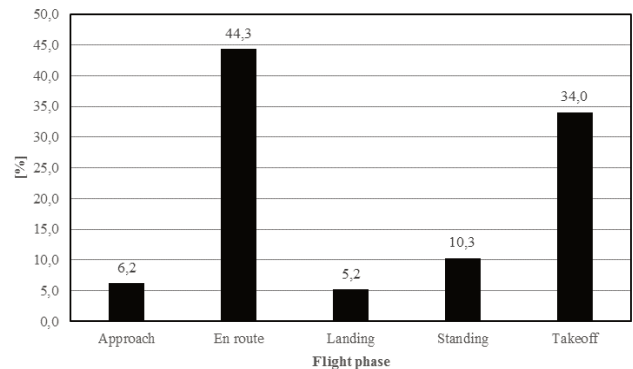
Figure 9 gives (in percent) information during which aircraft maneuver and how often failure of the piston engine in the ATA 72 chapter took place between 2008-2016.

Fig. 9. Flight phases share when powerplant malfunction ATA chapter 72 took place

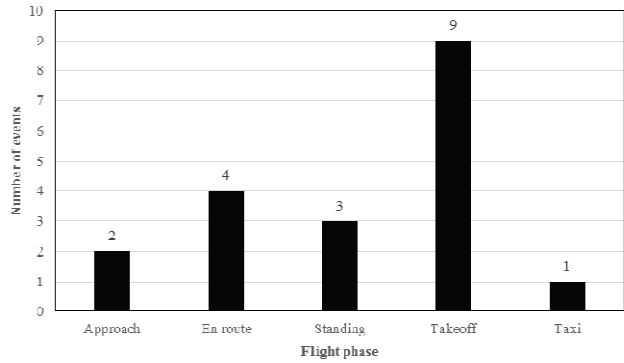
Figure 10 gives information during which aircraft maneuver a failure in the ATA 74 chapter took place within 2008-2016. The Tab. 7 shows in numbers result of the engine ignition system malfunctions, symptoms observed and precursors of the powerplant defects, where it was confirmed.

Fig. 10. Flight phases share when powerplant malfunction in the ATA 74 chapter took place

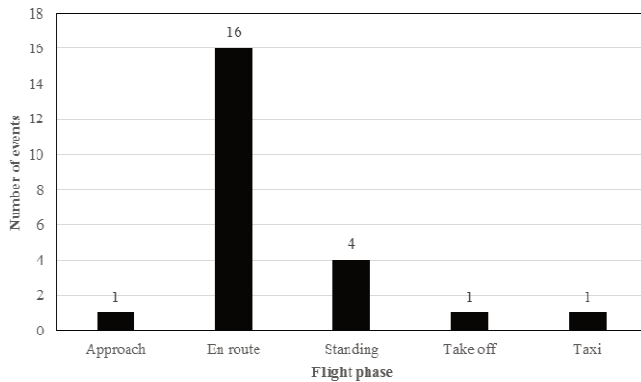
Between 2008-2016 there was 23 events caused by engine oil system. Figure 11 gives information during which aircraft maneuver a failure coded in the ATA 79 chapter took place within 2008-2016.

Fig. 11. Flight phases share when powerplant malfunction in the ATA 79 chapter took place

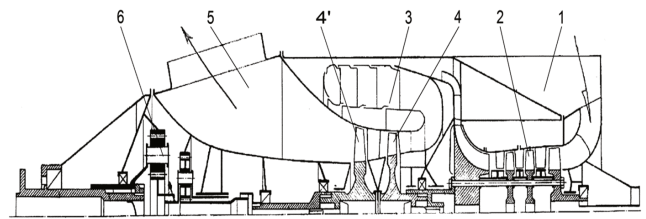
Figure 12 shows scheme of the contemporary utilized popular Pratt & Whitney PT6 turboprop engine with description of its main parts, covering the power range between 430 and 680 shaft kilowatts [8, 9].

Fig. 12. Design scheme of PT6 turboprop engine: 1 – air inlet, 2 – compressor, 3 – combustor chamber, 4 – compressor powered turbine, 4' – power turbine 5 – exhaust, 6 – reduction gearbox

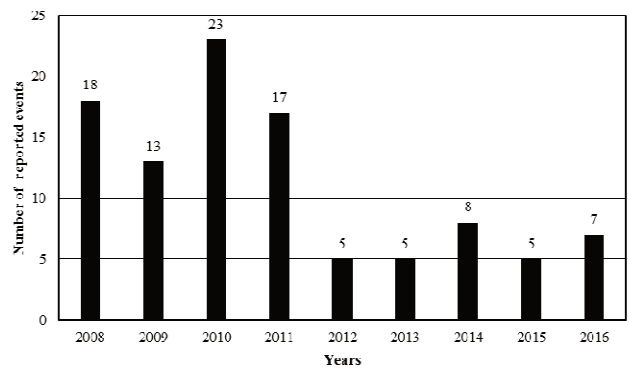
Figure 13 shows an annual number of reported aviation events caused by turboprop engines. Figure 14 shows changes of the coefficient $K_{1000\text{tprop}}$ during 2008-2016.

Fig. 13. Number of events caused by turboprop engines installed on Polish registered aircraft between 2008-2016

Above pictures are showing sudden decrease in number of events as well as coefficient $K_{1000\text{tprop}}$ from 2012 without turboprop aircraft fleet size changes. Reason for such level of safety increase is one of the operators aircraft fleet a

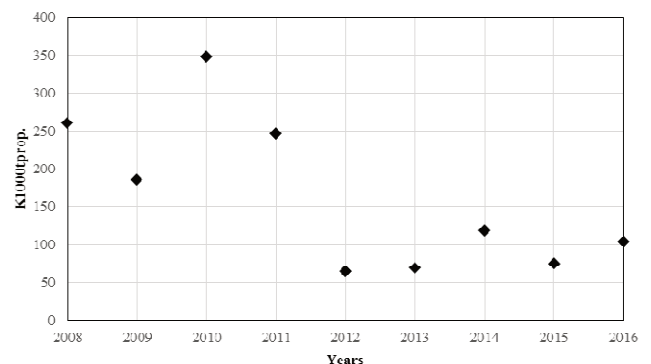
Fig. 14. Changes of the coefficient $K_{1000\text{tprop}}$

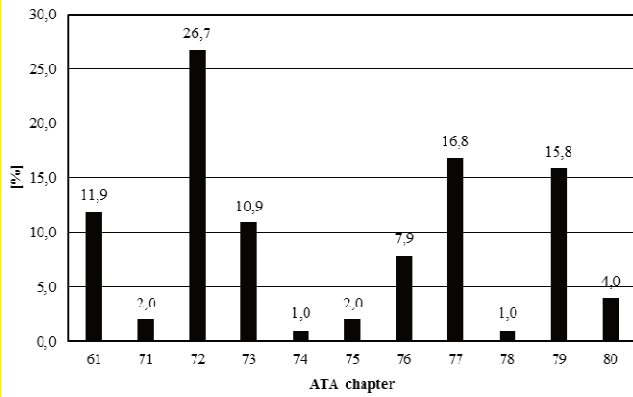
Figure 15 shows reported system defects frequency in percent assigned to the certain ATA chapter for the turbo-prop engines in the years 2008-2016. Figure 16 gives (in percent) information during which aircraft maneuver and how often reported event caused by turboprop engine took place within 2008-2016.

Fig. 15. Share of each powerplant system events coded in the ATA 100 chapter between 2008 and 2016

Figure 15 shows in percent “share” of the certain ATA chapter in the total volume of the turboprop engines reported events. It was assumed that the most frequently occurred event – ATA chapter 72 has occurrence probability level equal 5. Next, 77 and 79 level 4, 61, 73, 76 level 3, 80 level 2 and the remaining 71, 74, 75, 78, level 1. According to the methodology described in the Introduction

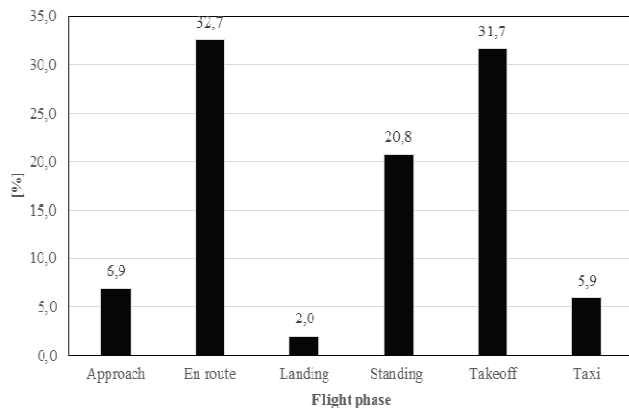
Fig. 16. Flight phases share when powerplant caused event took place

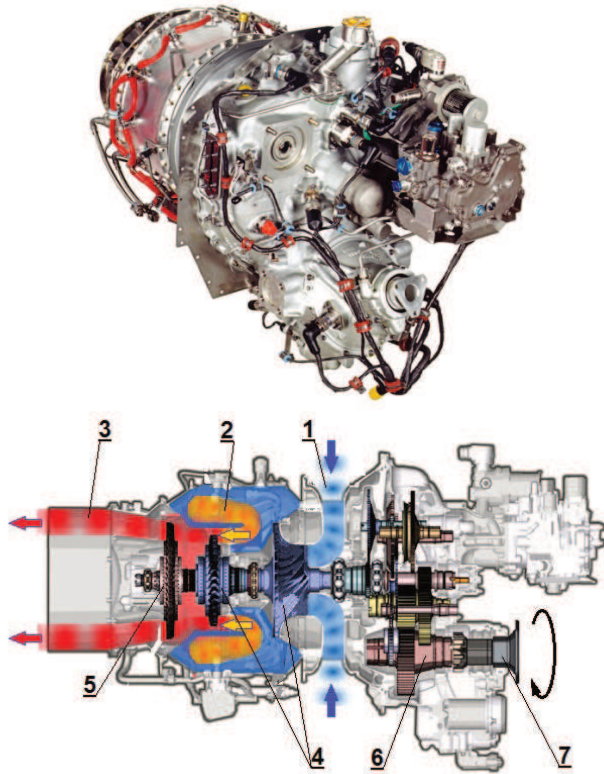
Fig. 17. View and cross-section of the PW 206 turboshaft engine: 1 – air inlet, 2 – combustor chamber, 2 – compressor, 3 – exhaust, 4 – radial compressor and turbine, 6 – reduction gearbox, 7 – shaft [17]

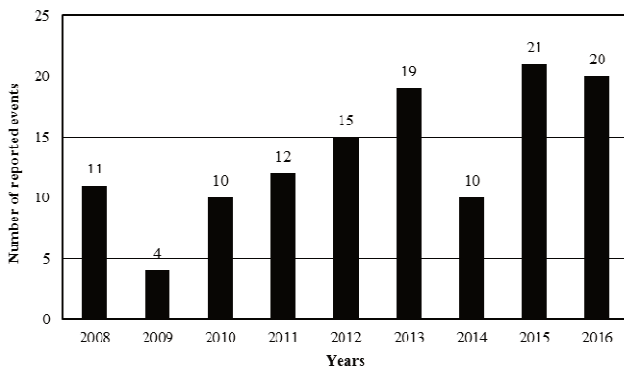
Fig. 18. Number of events caused by turboshaft engines installed on Polish registered aircraft between 2008-2016

With the constant number of helicopters, the number of events reported to the ECCAIRS database have increased since 2008 (Fig. 18), as a consequence also coefficient $K_{1000\text{ts shafts}}$ proportionally has increased (Fig. 19).

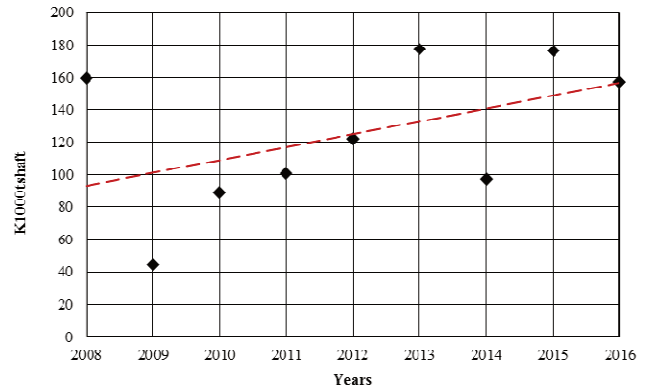
Fig. 19. Changes of the coefficient $K_{1000tshaft}$ and the trend line

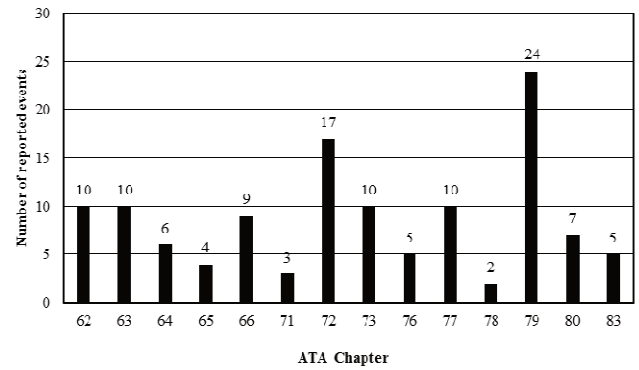
Fig. 20. Number of the turboshaft engine system events coded in ATA 100 chapter between 2008 and 2016

A more accurate analyzes of the events shows that most of them concerns engine oil system (ATA 79 chapter) and ATA 72 chapter. This order is preserved both in terms of number of events and percentage share (see Fig. 20 and 21).

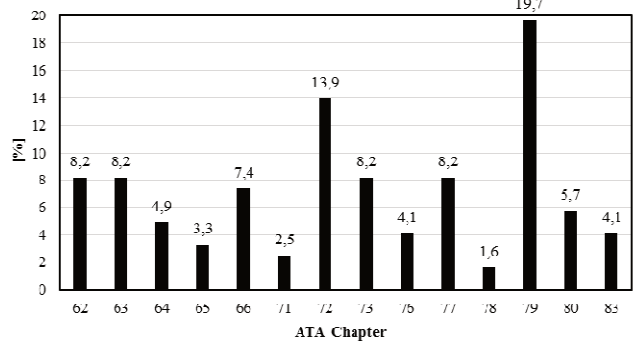
Fig. 21. Share of turboshaft engine system events coded in ATA 100 chapter between 2008 and 2016

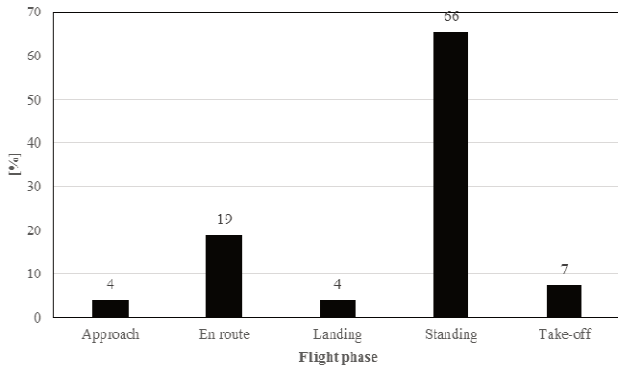
The positive thing is that as many as 2/3 of all turboshaft malfunctions were detected during routine maintenance checks and less than 1/5 during flight, which shows Fig. 22.

Fig. 22. Flight phases share when turboshaft engine malfunction took place

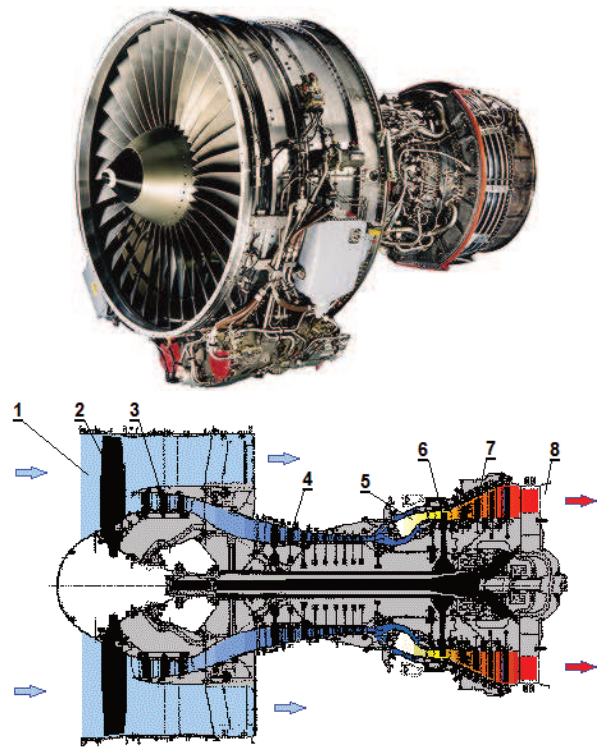
Currently there are 94 Polish registered aircraft powered by jet engines, 80 of them fall into MTOM > 5700 kg class [16]. Details are shown in the Tab. 15. Figure 23 presents representative of the most popular worldwide turbofan engine family CFM56.

Fig. 23. Basic features of modern turbofan engine [18]: 1 – engine inlet, 2 – fan, external duct, 3 – low pressure compressor internal duct, 4 – high pressure compressor air, 5 – combustion chamber, 6 – high pressure turbine, 7 – low pressure turbine, 8 – exhaust

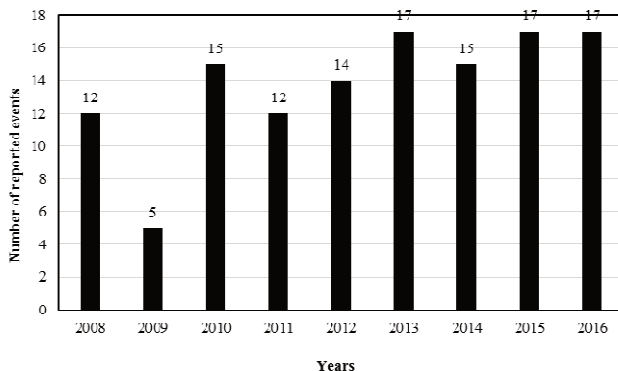
Number of reported events as well as factor $K_{1000jet}$ since 2011 have stabilized (Fig. 24 and 25).

Fig. 24. Number of events caused by turbojet engines installed on Polish registered aircraft between 2008-2016

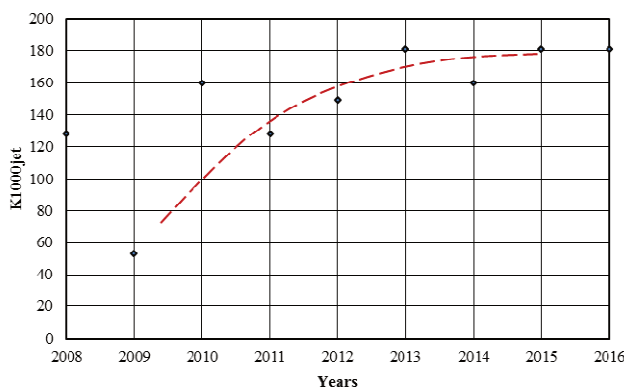
Fig. 25. Changes of the coefficient $K_{1000jet}$ and the trend line

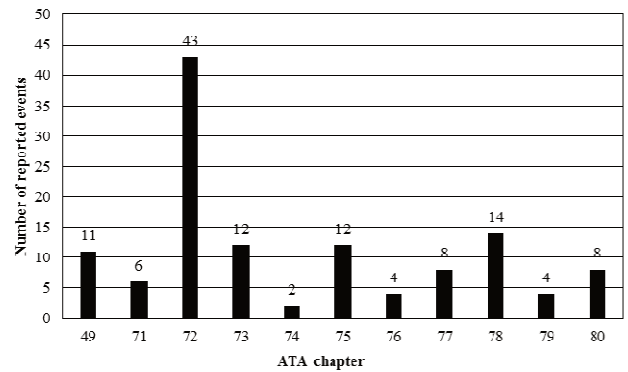
Figure 26 presents number of reported events in each ATA 100 chapter dedicated to powerplant systems. Fig. 27 shows reported system defects frequency in percent assigned to the certain ATA chapter for the turbojet engines in the years 2008-2016. Fig. 28 gives (in percent) information during which aircraft maneuver and how often reported event caused by turbojet engine took place between 2008-2016.

Fig. 26. Number of the turbojet engine system events coded by ATA 100 chapter between 2008 and 2016

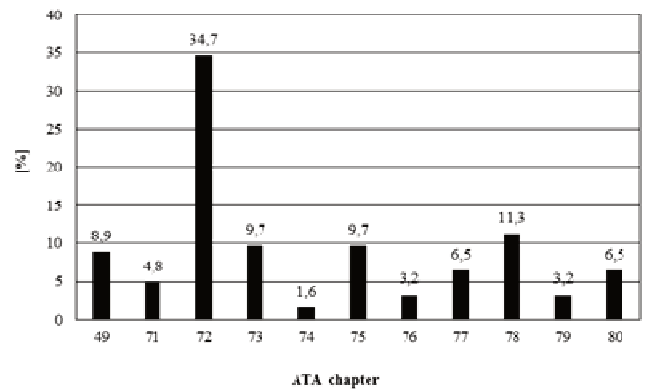
Fig. 27. Share of turbojet engine system events coded by ATA 100 chapter between 2008 and 2016

Figure 27 shows “share” of the certain ATA chapter in percent in the total volume of the turbojet engines reported events. It was assumed that the most frequently occurred event concerns engine design parts coded in ATA chapter 72, next are events in the ATA chapters 78, 75 and 73. The most serious consequences are caused by events related to the engine itself (chapter ATA 72). In 43 cases, 10 ended with aborted flight, 4 aborted takeoffs and 1 emergency landing. The reason was usually the sudden increase in engine vibration, compressor surge, also exhaust temperature limit exceedances, and thrust differences between engines causing the aircraft drift during takeoff. Borescope inspections performed during routine maintenance detected damage to the fan blades and compressor blades caused by foreign objects (FOD).

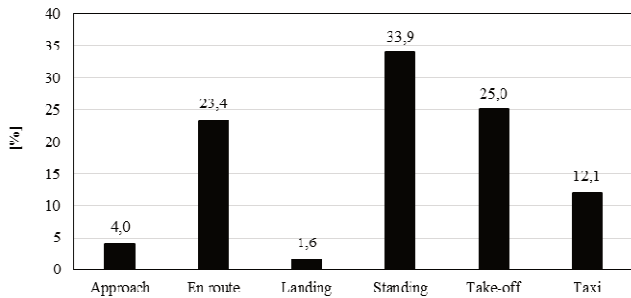
Fig. 28. Flight phase share when turbojet engine malfunction took place

It has to be taken into consideration for those involved in the SMS that more than 60% of the reported events have occurred during different aircraft flight phases (Fig. 28). Some organizational projects has to be undertaken in order to increase failures detectability level during maintenance.
