SEOK-WOO KO¹, HYEONWOO PARK², IL YOO³, HANSOO KIM²,
 JOONHO LEE^{2*}, BYOUNGCHUL HWANG^{1*}

IN-SITU OBSERVATION OF HIGH-TEMPERATURE FRACTURE BEHAVIOUR OF 347 STAINLESS STEEL SUBJECTED TO SIMULATED WELDING PROCESS

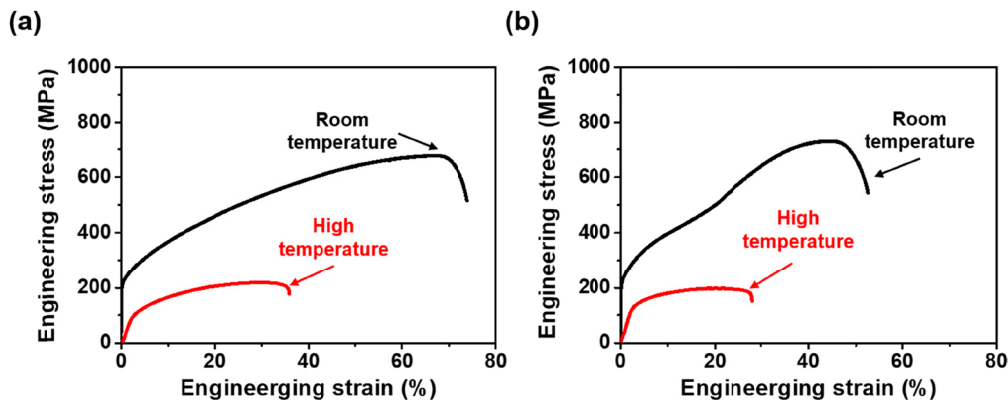
Fig. 2. Engineering stress-strain curves of the (a) solution- and (b) aging-treated specimens. Tensile tests were conducted at room temperature and high temperature (800°C) for the 347 stainless steel

Fig. 2 presents the room-temperature and high-temperature engineering stress-strain curves of the 347 stainless steel. The aging-treated specimen had a higher strength and lower elongation than the solution-treated specimen. The higher strength of the aging-treated specimen results from the precipitation hardening of fine secondary NbC carbides. The $M_{23}C_6$ carbides at the grain boundaries would act as stress concentration sites and thus lead to the lower elongation of the aging-treated specimen [12,13]. High-temperature tensile test results revealed that all the specimens exhibited lower tensile strength and lower elongation at high temperatures than at room temperature, probably due to the easiness of dislocation climb and grain boundary embrittlement at high temperatures [14]. The elongation of the aging-treated specimen at high temperatures was 10% lower than that of the solution-treated specimen. Langdon et al. reported that the increase of vacancy diffusion in the Cr-depleted zone encourages

grain boundary sliding [15]. Therefore, the formation of $M_{23}C_6$ carbides at the grain boundaries could cause Cr-depleted zones, and thereby leads to the lower elongation of the aging-treated specimen.
