CONCEPT OF COMPUTER-AIDED ASSESSMENT OF THE TECHNICAL CONDITION OF OPERATED GAS TURBINE VANES

The article presents a multi-stage algorithm for automatic (without any human, user – diagnostician intervention) detection of vanes-blades (technical objects) and their surfaces on a digital image, combined with color analysis, aimed at determining the technical condition of the tested turbine elements. The images recorded with the use of a camera, containing previously dismantled from the turbine operated stator vanes, were used as the exemplary analysis material. The paper presents the algorithm for the detection of the vanes' airfoil surfaces with the impact of the applied techniques and methods of image processing and analysis on the final result (software localization of the vane's trailing and leading edge). Then, the obtained image data, including the structural changes of both the vane's coating and material (metallographic testing) were correlated with the surface colour scheme (colour segmentation based on the YCbrCr colour space model). Thanks to this approach, areas on the surface of the blade were distinguished, characteristic for proper, overheated and transient condition.

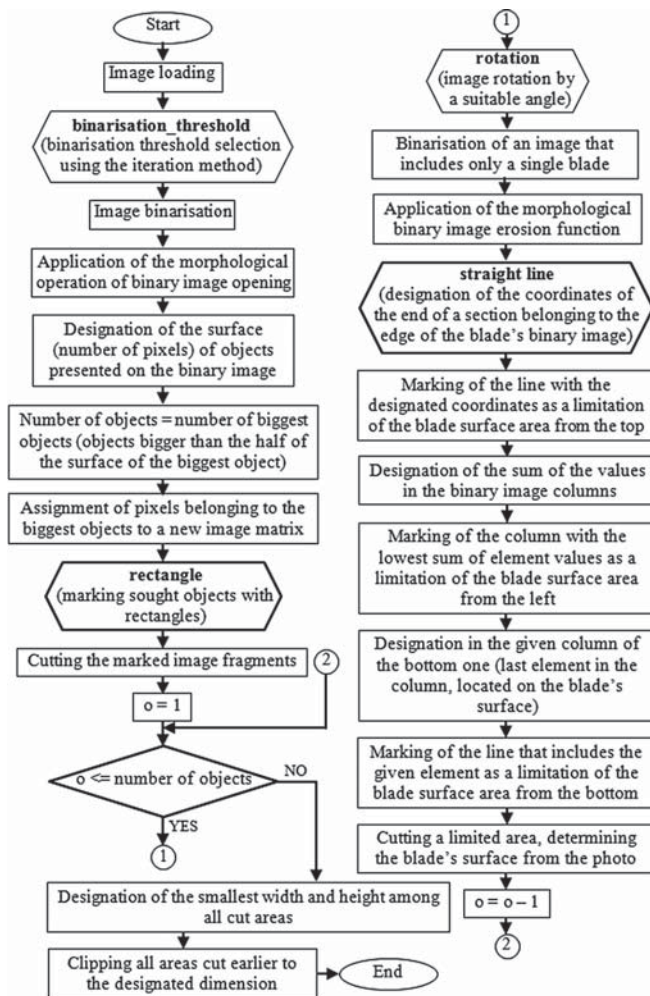
Fig. 2. Block diagram of the execution of subsequent steps of image processing and analysis – detection of vanes and their surface on a digital image

This part of the paper will present subsequent steps of executing the automatic object (vanes – Fig. 3a) detection and positioning of the detected vane leaf surfaces based on images presenting optionally placed vanes with various technical condition. The execution of this task involves no human (user – diagnostician) intervention. The block diagram of execution of subsequent stages of the selected image processing and analysis techniques and methods is presented in Fig. 2.

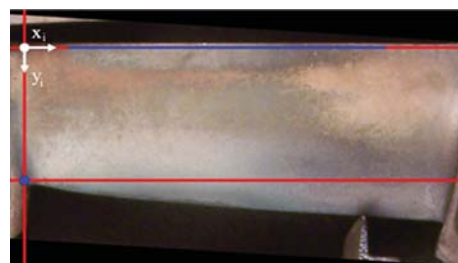
Fig. 7. Lines limiting the vane surfaces – sought (rectangular) area for further colour analysis

After changing the vanes' configuration and rotation, we obtained images on which the vanes are positioned in an identical way. Then, while maintaining only the vane surface pixels (without the background pixels), it was necessary to cut the rectangles with the largest area possible from the images. Due to the fact that all fraction points were to be located within the area of the vane surfaces, we conducted an image binarisation with the threshold selected using the iteration method. Then, we used the morphological erosion method (with a square structural element with a 20 pixel size, thereby "reducing" the vane's surface) on the binary image. This operation allowed for further application of the gradient (Sobel's) operators and Hough's transform in order to designate the coordinates of two points belonging to the top (position of the edge on the photo) vane edge (blue section in Fig. 7).

Thus, we were able to designate the straight line limiting the area later cut from the image for further analysis from the top (top red straight line in Fig. 7). The applied steps of

This was also the reason for the calculation for the binary image of the sum in the image matrix columns (the vane area is white in the binary image – it has the value “1” in the image matrix), by selecting the column with the lowest sum value, we designated the position on the vane’s length on which it has the smallest width. Thus, we obtained the straight line that limits the sought area from the left (red straight line on the left in Fig. 7). The bottom limitation of the sought image (bottom red straight line in Fig. 7) was obtained by locating in the earlier designated column of the last one, i.e. last column point belonging to the vane surface (from the top of the photo, blue point in Fig. 7).
