# EVALUATION OF IMPACT DAMAGE IN COMPOSITE STRUCTURES USING ULTRASONIC TESTING

Angelika Wronkowicz-Katunin<sup>1\*</sup>, Krzysztof Dragan<sup>2</sup>

<sup>1</sup> *Silesian University of Technology, Institute of Fundamentals of Machinery Design, Konarskiego 18A, 44-100 Gliwice, Poland*

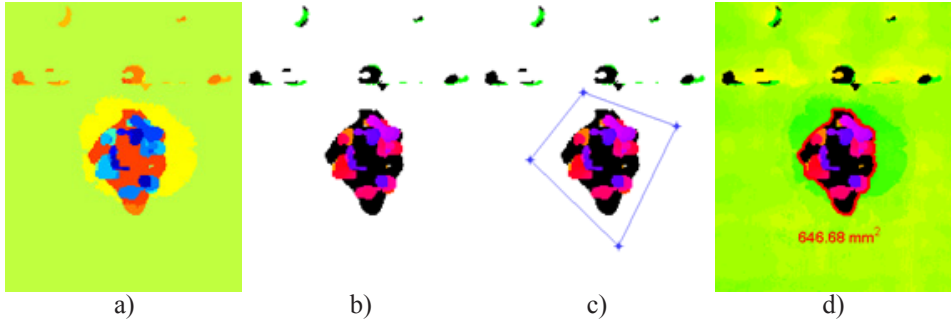
Fig. 5. Selected algorithm steps: image after segmentation (a), image after segments removal (b), ROI selection (c), input C-Scan with the BVID contour (d)

In order to calculate the total area surfaces of the resulting internal damage, an algorithm based on image processing and the analysis methods was elaborated. Selected steps of this algorithm prepared for the BVID evaluation, for the specimen case *K-15*, are presented in Fig. 5. The consecutive steps are detailed below. Firstly, the raw C-Scan is segmented using a developed MBP-based algorithm presented in [16]. The resulting image for the exemplary case is presented in Fig. 5(a). The aim of this step is to reduce data, which allows for further effective separation of the regions of interest (ROIs), i.e. damage, from the background. Then, the segments presenting undamaged regions are indicated to be removed from the image, i.e. assigned to zeros. This indication is reached by the interactive selection of one pixel point per one segment that is to be removed. The remaining regions (see Fig. 5(b)) indicate the presence of BVID but also the presence of a manufacturing flaw. For this reason, the next step is to select a final ROI by drawing a polygon around the damage location identified. This step

is interactive and relies on indicating the points of the polygon around the ROI (Fig. 5(c)). After that, the pixels outside the ROI are removed. The resulting image after this step is binarized by the assignment of ‘‘ones’’ to the non-zero pixels in order to extract the ROI contour and calculate its surface area. To enable visual verification if the BVID region was extracted properly, the boundaries of the final ROI are displayed on the input C-Scan (Fig. 5(d)).
