# Assessment of Factors Contributing to the Risks of Cargo Liquefaction Accident in Bulk Carriers (A Qualitative Approach)

**ABSTRACT:** Liquidation of cargo in bulk carrier has been identifying as a major hazard affecting the bulk carrier shipping and has resulted to several loss of lives. This study assesses the liquidation problem in bulk carrier shipping, it also discusses the mechanisms by which cargo liquefaction occurs in bulk carrier and the factors influencing the risks of occurrence, based on a qualitative approach. Based on the findings and survey, the unsafe storage condition, poor compliance with the testing and certification of cargoes, poor loading plan, have been identify as some of the root casual factors influencing the risk of liquidation problem in bulk carrier. This study will contribute to increasing the awareness and understanding of the problem of cargo liquefaction and will facilitate the development of regulations that reflects the realities of this problem and assist in the development of future recommendations for mitigation plans against the liquidation problem in bulk carrier.

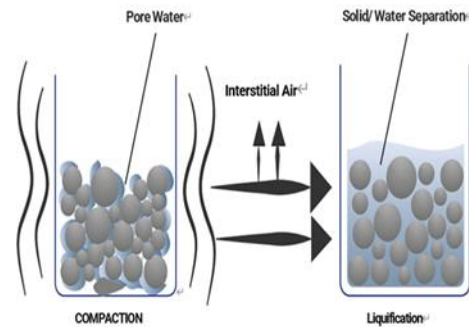
Figure 1. Compaction and subsequent liquefaction

Liquefaction is a phenomenon in which a soil-like material cargos are abruptly transformed from a solid dry state to an almost fluid state. As larger particles generally cannot retain much water and will settle together with greater voids space between them, while smaller particles will retain more water because of their greater contact and increased surface, so during the voyage of such cargo in an open seaway, particularly during heavy weather condition, these cargos are often subject to agitation due to the vibration of the engine, ship's rolling, and pitching impacts and the resultant effect will force the rearrangement of the cargo particle as they are being subjected to significant stresses.

The resulting effect is the compaction of the inter-granular spaces, and the removal of interstitial air, and this will lead to an increasing pores water pressure, thereby forcing the cargo solid particles to be separated from its moisture content as (Fig 4). The cargoes with high moisture content lose its shear strength due to the loose of direct contact between their particles and they become prone to sliding, particularly when the cargo is shallow and subject to large heel angles. These conditions will make the cargo material to behave like a liquid and in the

resulting viscous fluid state cargo may flow to one side of the ship with a roll but not completely returning with a roll to the other way [1]. Liquefaction often starts in a small portion of the cargo and rapidly spreading throughout the entire cargo, resulting in a sudden shifting of the entire mass and the ship may be affected, progressively reaching a heavy list and loss of control, which could result in the vessel capsizing and sinking in the worst-case scenario due to lack of stability.

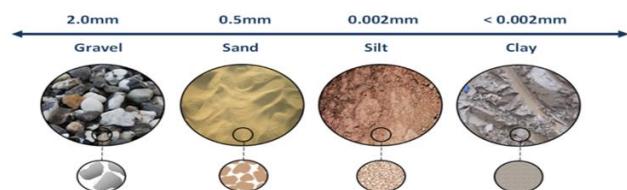
Figure 2. Variation in particle sizes of ores

The granular cargo materials are often consisting of varying particle sizes and may contain water within them, which were accumulated during mining process of the cargo or during storing them on grounds that are exposed to weather while awaiting loading. These cargo materials have the characteristic of cohesion, and may liquefy during voyage, even if they are cohesive and trimmed levelly. Most of the popular cargo materials involve in this incident are briefly outline below.
