# Stockholm Agreement Analysis for Ro-Ro Passenger Ships Navigating in the North European Waters and the Baltic Sea

M. Szymoński

*Polish Naval Academy, Gdynia, Poland*

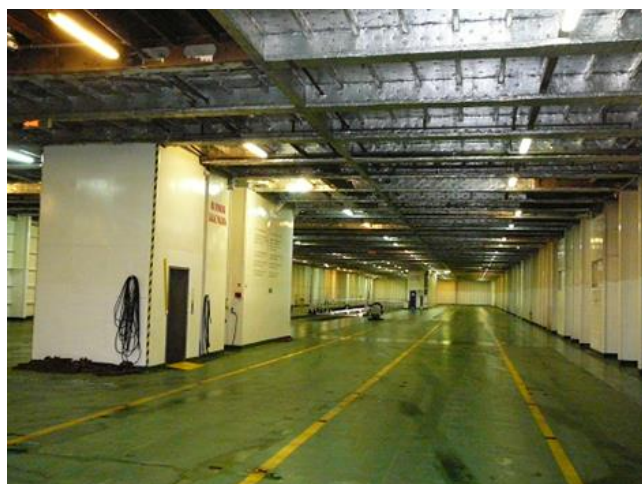
Figure 1. The open cargo deck of Polish Ro – Ro/ Passenger ship: M/F "Gryf" [photo by author]

These new regulations are based on a wide range of related design parameters, such as the number, positioning and local optimization of transverse bulkheads, the presence and position of longitudinal bulkheads below the main vehicle deck, the presence of side casings, and the height of the main deck and double bottom. In addition, the effects of water on deck and of operational parameters as draught, center of gravity and trim, has to be taken into consideration. The open un-subdivided vehicle deck space of presented Ro-Ro/ Passenger ship, is shown in Figure 1.

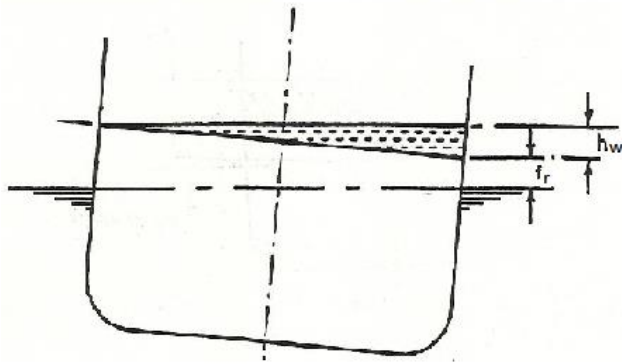
Figure 2. The residual freeboard definition. [2, 4]

The water is assumed to enter the Ro-Ro vehicle deck via a damaged "critical opening" and accumulated on deck. It is required that Ro-Ro/Passenger ship, in addition to complying with the full requirements of SOLAS'90, further complies with part of regulations of SOLAS with the defined water on deck. The height of water on deck (hw) is dependent on the residual freeboard after the damage (fr), and is measured in way of the damage. The residual freeboard (fr) is defined as the minimum distance between the damaged Ro-Ro vehicle deck and the final waterline, as it was shown in Figure 2.

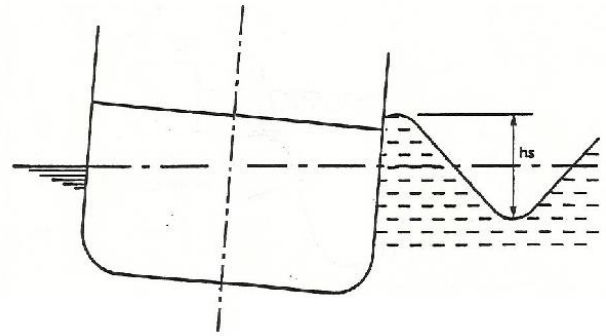
Figure 3. The height of water on deck ( $hw$ ) calculations, with the relation to a significant wave height ( $hs$ ). [2, 4]

It is clear, that the residual freeboard of damaged ship has a significant effect on amount of water to be cumulated on Ro-Ro deck. The maximum residual freeboard to be taken into account was agreed as 2.0 meters.

If the residual freeboard  $\geq 2.0$  meters, then the height of water on deck  $hw = 0.0$  meters.

If the residual freeboard  $\leq 2.0$  meters, then the height of water on deck  $hw = 0.5$  meters.

For example, if residual freeboard is equal  $fr = 1.25$  meters and the height of significant wave:  $hs = 3.5$  meters, the height of water expected on deck:  $hw = 0.5$  meters.

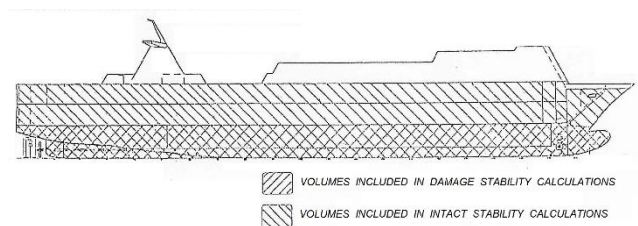
Figure 4. Reference for volumes included in Ro - Ro / Passenger ship as buoyancy for stability. [1, 4]

The general arrangement of the analyzed ship is shown in Figures 4 & 5.

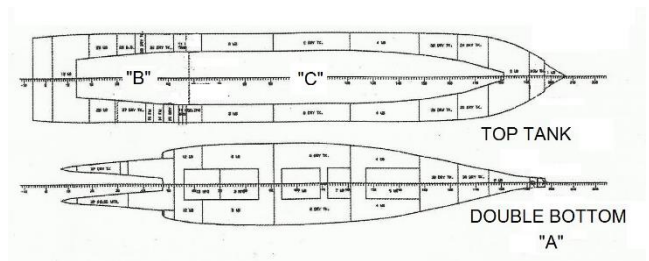
Figure 5. The general arrangement of volumes included in damage stability calculations. [1, 4]

In Figure 5: A – The double bottom with Ballast Tanks, Fuel Tanks, and Dry Tanks; B – Engine room; C - Cargo space in lower deck and the wing tanks.

The volumes "A", "B", "C" are included in damage calculations.

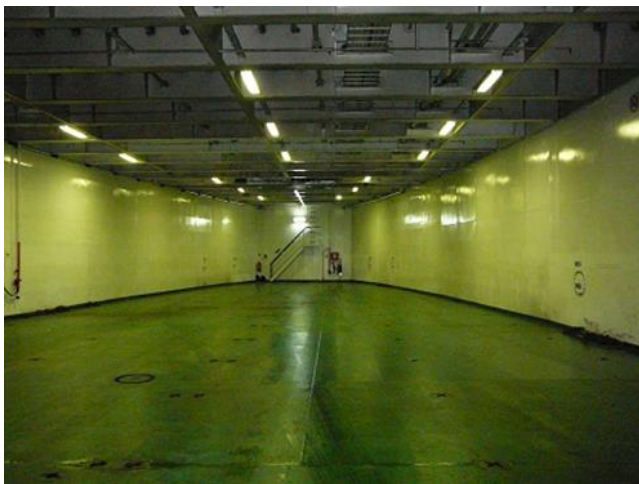
Figure 6. The open cargo space "C" below the main deck, located on " Top Tank", and surrounded by the wing tanks. [photo by author]

Such penetration can fill up the engine room "B" or cargo space "C" , which is shown in Figure 6.

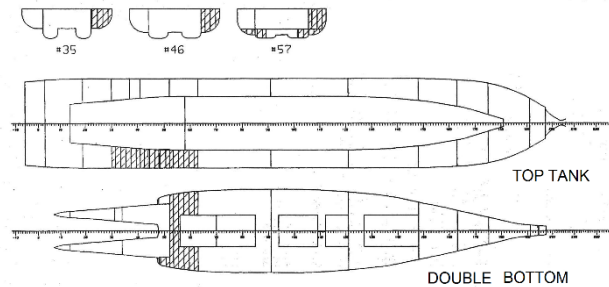
Figure 7. The Minor penetration of starboard side compartments. [ 7 , 9 ]

This Case is presented in Figure 7.

5.1.1 The intact conditions for the ship in maximum DWT state, are as follows: mean draught: 5.75 meters, no trim, the intact Metacentric height:  $GM_0 = 1.53$  meters.

The damaged compartments	Permeability [%]
27 Dry tank	0.95
Tanks 22, 23, 24, 35	0.95
15 FW tank	0.95
14 + 30 FW tanks	0.95
Dry tank	0.95
WB tank	0.95
11 SB Heeling tank	0.95

Extent of damage is as follows: Damage between frames: 30 – 63, Penetration: inboard 4.80 meters, Flooded volume: 6 767.1 m<sup>3</sup> .

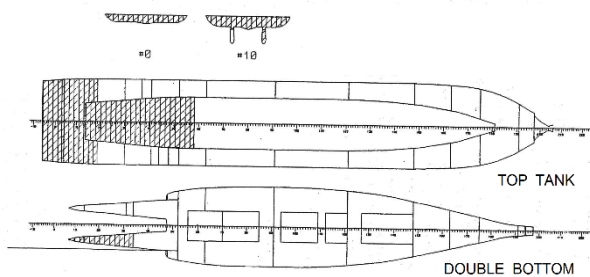
Figure 8. The damage case of Major penetration. [1, 4]

This case is presented in Figure 8.

5.2.1 *The intact ship's conditions in state of maximum DWT are: the mean draught of 5.75 meters, and the intact Metacentric height  $GMO = 1.53$  meters.*

Damaged compartments	Permeability [%]
13 WB tank	0.95
38 SB Dry tank	0.95
Engine room	0.85
37 SB bilge water	0.95
Steering gear room	0.85

Extent of damage is as follows: damage between frames: 6 – 58. Penetration: inboard 4.80 meters, flooded volume: 6 767.1 m<sup>3</sup>.

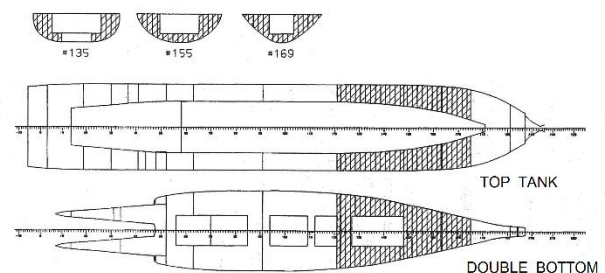
Figure 9. The case of Major penetration in fore part of the ship. [1, 4]

This case is presented in Figure 9

5.3.1 *Intact condition for the fully loaded ship are as follows: Mean draught = 5.75 meters, intact Metacentric height  $GMO = 1.53$  meters*

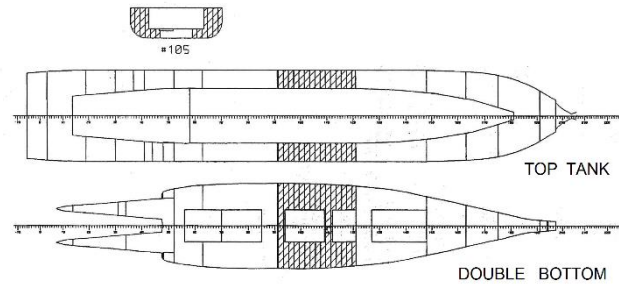
Figure 10. The case of penetration into the midship's compartments. [1, 4]

5.4 *The case of penetration in midship, below the main cargo deck This case is presented in figure 10*

5.4.1 *Intact condition for the ship state of maximum DWT are as follows: Mean draught = 5.75 meters, intact Metacentric height  $GMO = 1.53$  meters*
