The behaviour of R.C. beams patch-repaired and strengthened with CFRP strips subjected to impact loading

Abstract. This paper presents an experimental investigation of the structural behaviour of reinforced concrete (R.C.) beams, patch-repaired with a cementitious grout and strengthened with carbon fibre reinforced polymer (CFRP) strips subjected to impact loading. The results of this study show that strengthening patch-repaired R.C. beams subjected to impact loading using CFRP plates, restores the load-carrying capacity of the beams. The strengthened beams exhibited ductile behaviour with no debonding between the patch repair and the substrate concrete. The primary failure mode of the strengthened beams was intermediate crack (I.C.) debonding. In addition, the beams with longer patch length exhibited higher flexural strength.

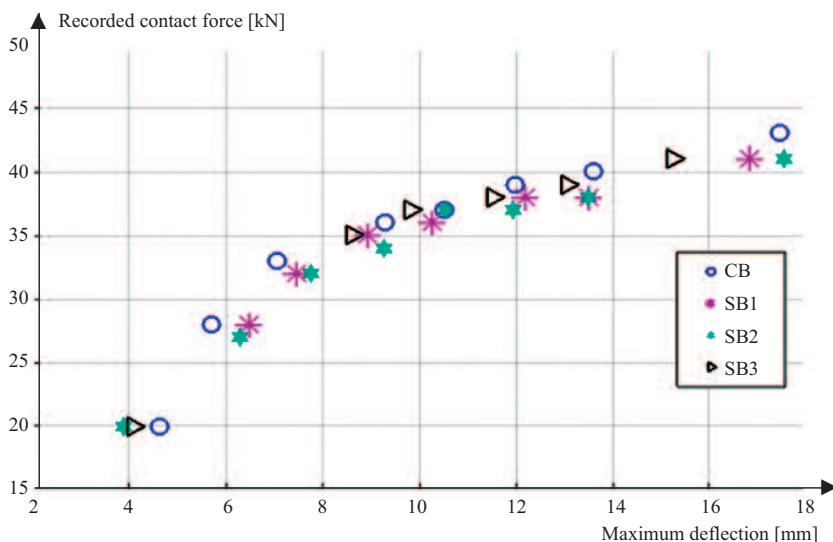
Fig. 2. Recorded contact force vs maximum deflection for each drop height

Contact forces. The contact forces were captured using a load cell transducer. The recorded contact force loading history combined both maximum contact forces and rebound forces. However, it should be noted that this study focused on the maximum values of contact forces. Figure 2 shows the contact force variation with displacements for each drop height, with lower displacements representing lower drop heights.

Generally, there is a small difference between the control beam (C.B.) and the damaged beams. Thus, different layers composing patch-repaired and CFRP-strengthened R.C. beam worked together and behaved almost as a monolithic specimen. In addition, the degradation of stiffness due to consecutive drop tests was almost the same, despite the type of the beam under test. The 14% reduction of cross-sectional area from main reinforcing steel bars was adequately compensated with the used CFRP materials.

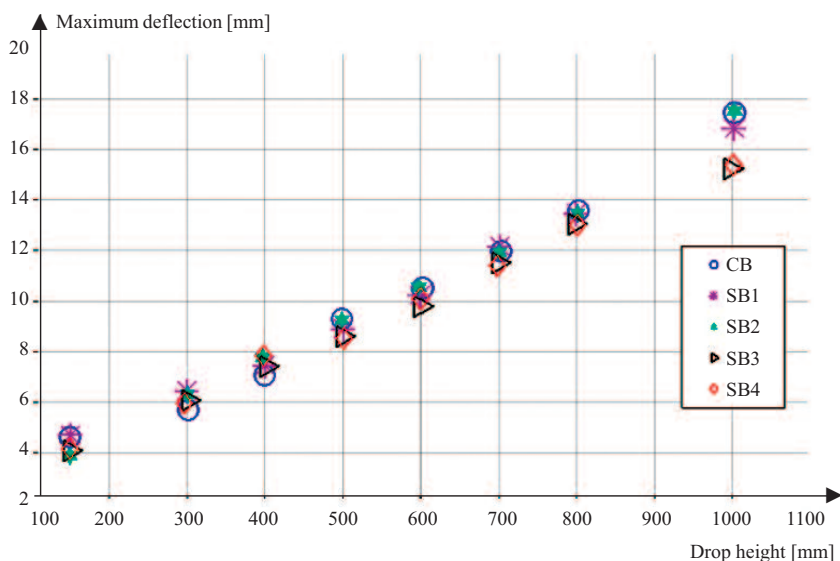
Fig. 3. Maximum deflection vs drop height

Deflections. Figure 3 shows the variation of maximum deflection with drop height. The maximum deflection results from the control beam (C.B.) 450 mm damage (SB1), 800 mm damage length (SB2) were practically the same, whereas maximum deflections for 1300 and 1800 mm damage lengths were slight. The reduced steel bars and the intentionally damaged concrete area were compensated accordingly through patch repairs and CFRP strengthening applications.
