Ergonomics Hazards Analysis of Linemen's Power Line Fixing Work in China

This study used qualitative and quantitative methods, such as OWAS (Ovako working posture analysis system) and behavior observation, to analyze musculoskeletal disorder (MSD) risk factors of power line fixing work in China. Video-based sampling was used to record and analyze the frequency and posture of on-pole activities. Those key subtasks showed ergonomics characteristics of on-pole fixing tasks. Insulator-fixing was the longest subtask (33% of total working time). Bar-installing was the second longest (26% of total working time). It was evident that bar-installing and insulator-fixing were full of hazardous risks. The action categories of the 2 subtasks were higher than of the other ones. The 2 subtasks were also time-consuming, difficult and induced MSDs. Assistant linemen faced more hazardous factors than chief linemen.

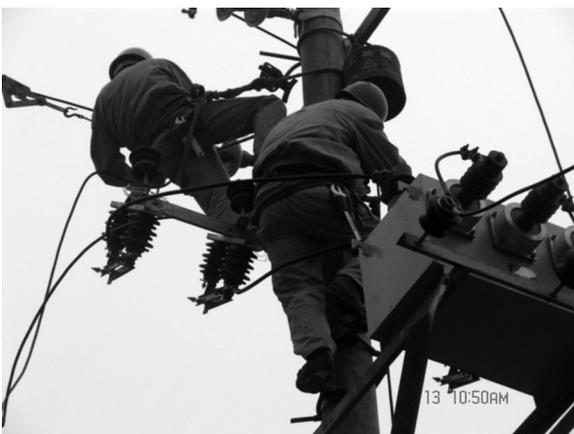
Figure 1. Left lineman’s code: 33142, AC4; right lineman’s code: 24131, AC2. Notes. AC—action category.

In this study, it was very important to do field investigation on power line fixing and to search for relevant data such as work flow, work duration, action frequency, etc. The working process was recorded. The working scenes from the video were intercepted every 30 s. Then, the neck, hands, back and thighs of linemen and exerted force were separately coded according to the working postures. Hazardous risks were estimated with a coding system referring to the postural risk estimation method proposed by Graham and Nicola [12]. The data were analyzed with SPSS version 11.5, the significance was <.05. Five video samples were used to analyze the working process. Every video sample was ~2 h long. Figures 1–2 illustrate examples of coding.

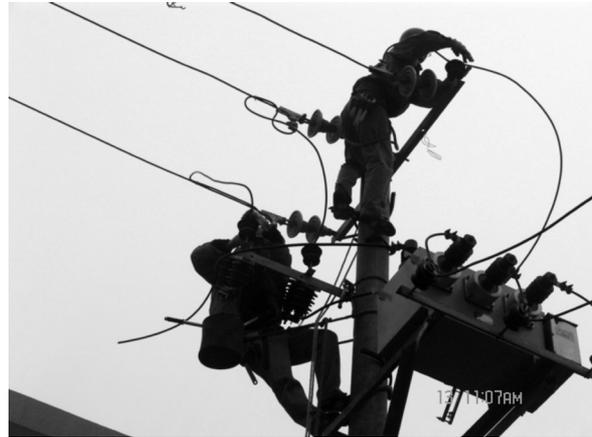
Figure 2. Left lineman’s code: 43352, AC4; right lineman’s code 12221, AC2. Notes. AC—action category.

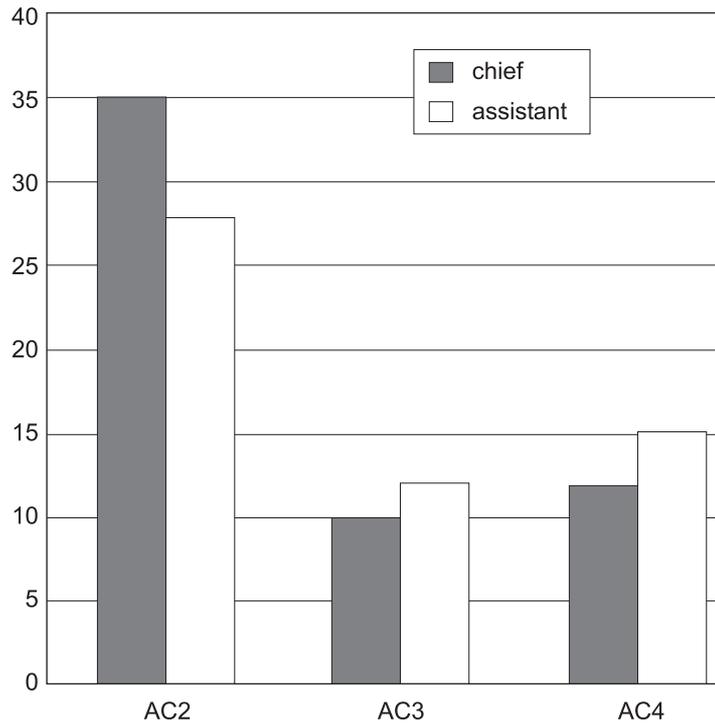
Figure 3. Comparison of frequency percentages of chief and assistant linemen’s action categories (ACs).

Moreover, Figure 3 depicts a comparison of proportions for AC2, AC3 and AC4. Although there was no significant difference of un-neutral posture percentages between chief and assistant linemen, the frequencies of AC3 and AC4 of the assistant lineman were higher than the chief’s. This showed that the assistant faced more hazardous exposures than the chief.
