MATERIAL ULTRASONIC ATTENUATION INFLUENCE ON CONVENTIONAL ULTRASONIC NON-DESTRUCTIVE COPPER ALLOY CAST TESTING

Keywords: Ultrasonic testing, ultrasonic attenuation, copper alloy casting, centrifugal casting

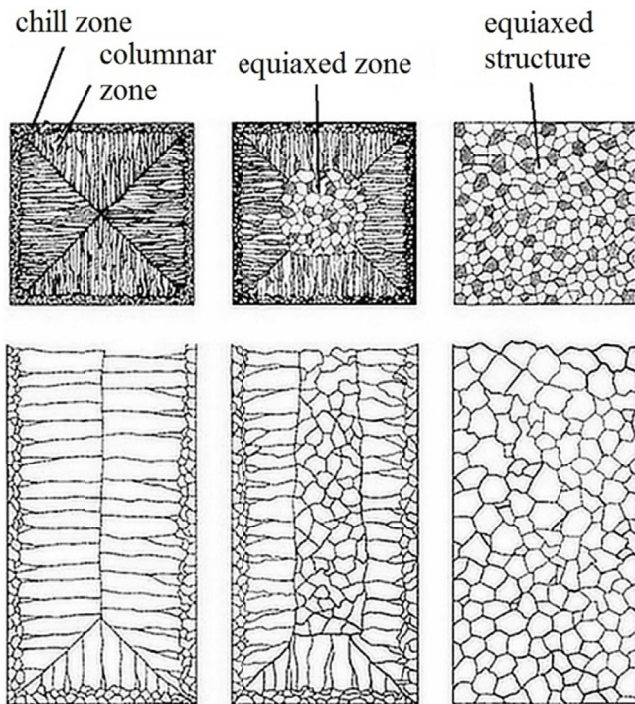
Fig. 1. Schematic illustration of three cast structures of metal: a) pure metal, b) solid-solution alloys, c) structure obtained by using nucleating agents [1]

Ultrasonic testing of castings is difficult because castings have usually a large anisotropic structure grain. The heterogeneous anisotropic cross-sectional structure of a casting is caused by a different cooling conditions during solidification of the casting in the mold (Fig. 1) [4,7,9].

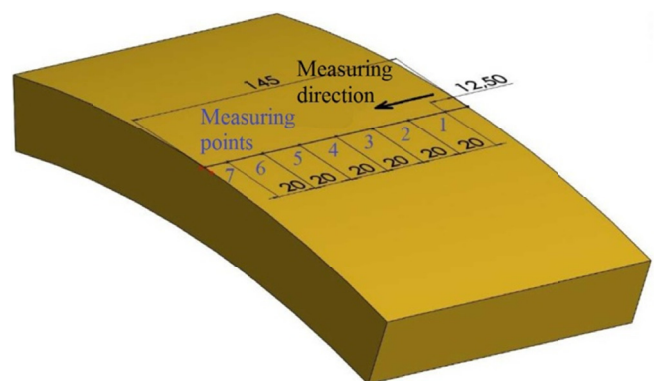
Fig. 2. Scheme of measuring direction and probe position for experiment

The probe with a frequency of 5.00 MHz has a type designation SM-A551, 3.50 MHz probe has designation A550S-SM, probe with frequency 2.25 MHz has designation C606 and probe with frequency 1.00 MHz has designation C603. The experiment was conducted on the outer surface of the ring in the seven points. The measurement line was positioned parallel to the axis of the ring. The measurement scheme is illustrated on Fig. 2.

Probe and system calibration was performed directly at the test object in the place with the lowest attenuation (in point No. 1), which was on the edge of the casting. Calibration was performed based on the position of the first and second end echo on the screen flaw of defectoscope Olympus OmniScan MX2 using the setting wedge delay and velocity [4,11].

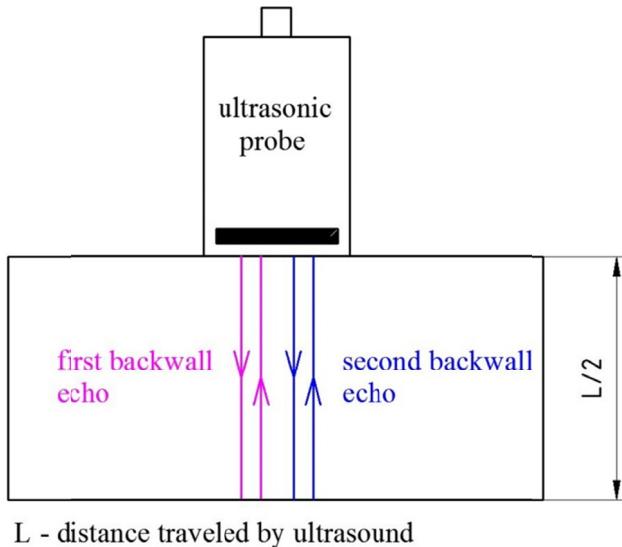
Fig. 3. The principle of attenuation determining

The principle of attenuation measurement by direct contact ultrasonic probe (longitudinal wave attenuation) is established to measure the acoustic energy difference of the first and second

backwall echo in dB. This value is divided by the actual distance traveled by ultrasound in mm. The result is the attenuation value of material for a given frequency in the units $\text{dB}\cdot\text{mm}^{-1}$. Thus, the attenuation is ultrasound energy loss per unit of length (Fig. 3).

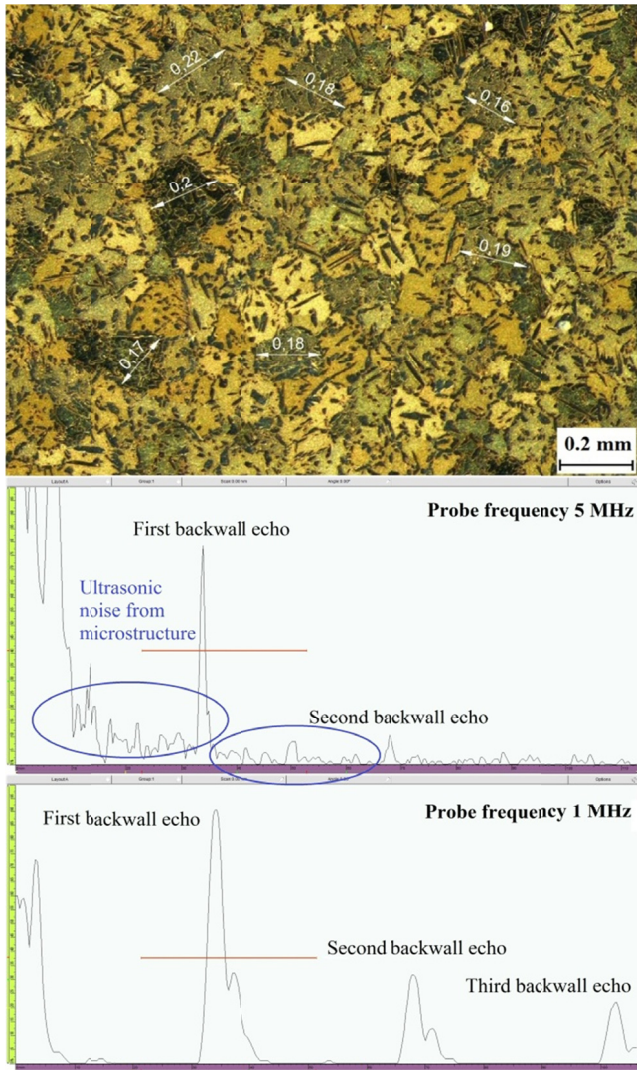
Fig. 4. Brass microstructure in point No. 1 (top), 5 MHz echogram (middle) and 1.00 MHz echogram (bottom)

Microstructure photo in point 1 with echoes obtained with 5.00 MHz and 1.00 MHz probes is on Fig. 4. The average grain size in point 1 is 0.19 mm. This grain size causes a significant attenuation at the 5 MHz frequency. Significant attenuation is visible on the echogram as the ultrasonic signal noise from microstructure located between the transmitting pulse and the backwall echoes. Only two echoes are present on an echogram at a 5.00 MHz frequency. The attenuation noise from microstructure is not visible when using a 1 MHz frequency probe, which is due to a lower attenuation due to a lower frequency. Three backwall echoes are on echogram.

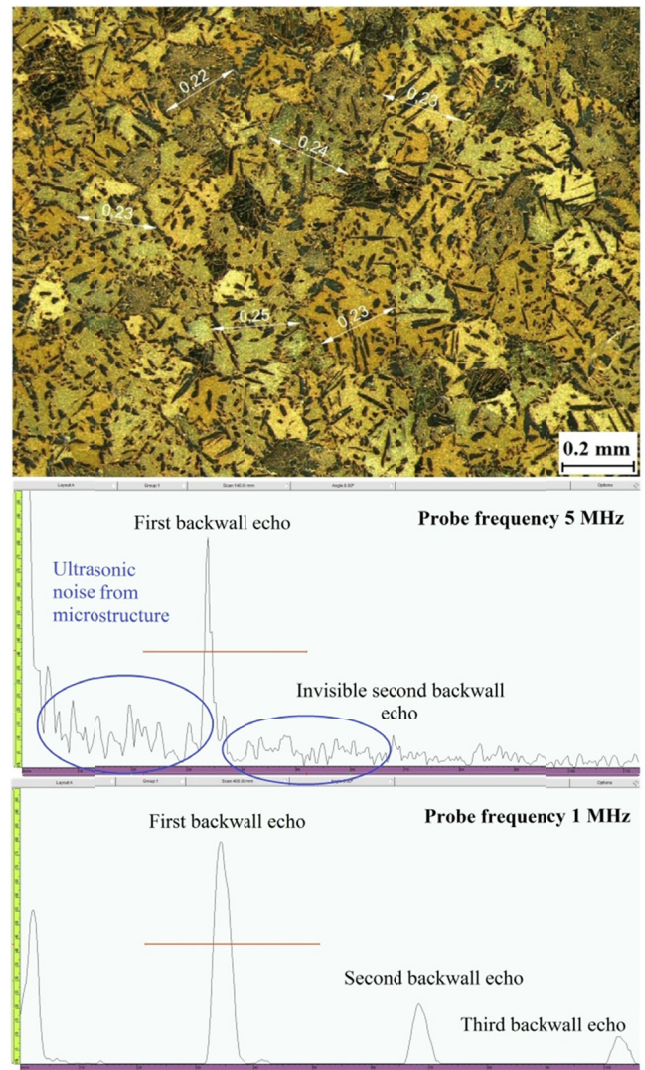
Fig. 5. Brass microstructure in point No. 2 (top), 5 MHz echogram (middle) and 1.00 MHz echogram (bottom)

The average grain size in point 2 is 0.24 mm. The increasing grain size is caused by increasing attenuation at the 5 MHz frequency. The increasing ultrasonic signal noise from microstructure is visible on the echogram located between the transmitting pulse and the backwall echoes again. Only one backwall echo is present on an echogram at a 5.00 MHz frequency, second backwall echo is invisible, due to high attenuation. The 1.00 MHz echogram is without visible attenuation from microstructure.

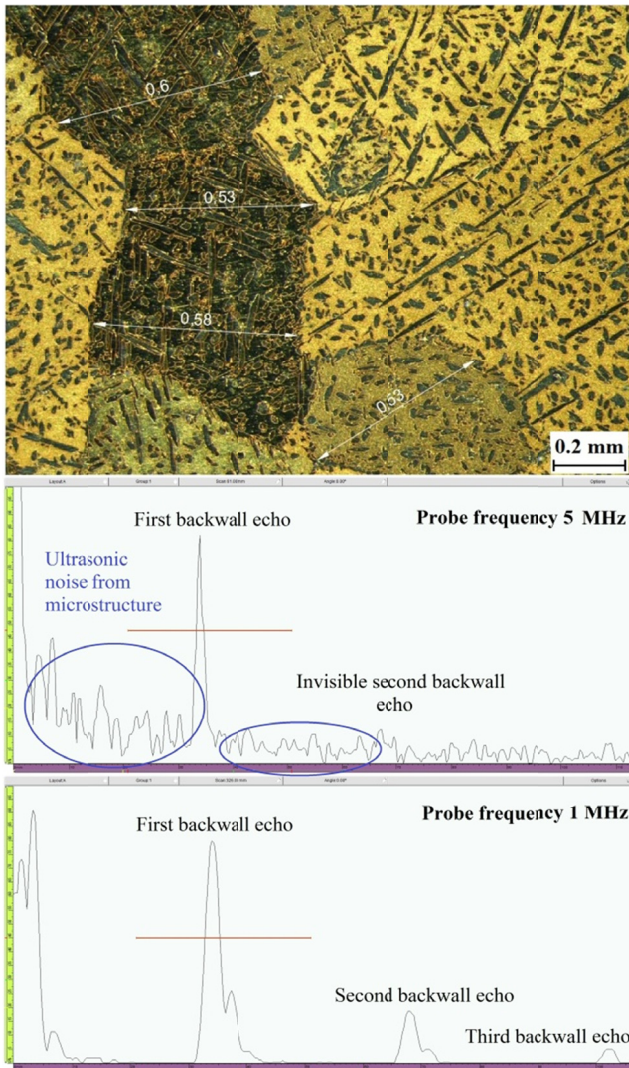
Fig. 6. Brass microstructure in point No. 3 (top), 5 MHz echogram (middle) and 1.00 MHz echogram (bottom)

The average grain size in point 3 is 0.56 mm. Ultrasonic noise echoes have already reached half the height of the backwall echo in 5.00 MHz probe frequency echogram. High ultrasonic noise from microstructure (up to 30% full height screen - FSH)

will cause the defect echoes to be merged with noise echo and defect will not be indicated in this case. The 1.00 MHz echogram is clear with only three backwall echoes.

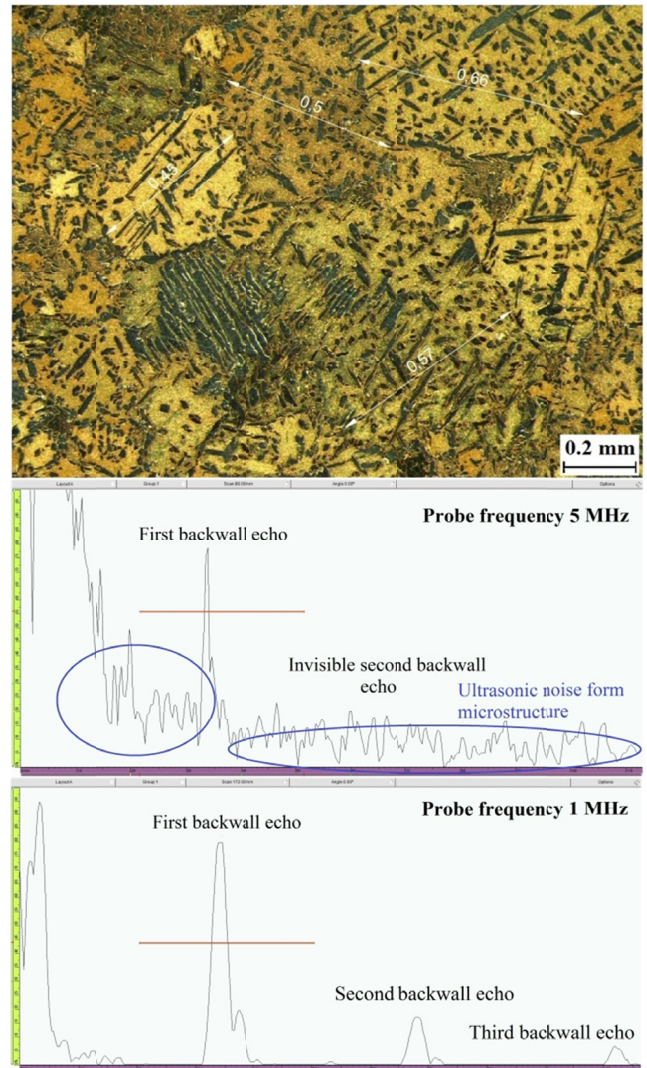
Fig. 7. Brass microstructure in point No. 1 (top), 5 MHz echogram (middle) and 1.00 MHz echogram (bottom)

The average grain size in point 4 is 0.62 mm. The 5.00 MHz probe cannot be used for this grain size because the high noise level is presented on the echogram. It is possible to use max. 2.25 MHz for ultrasonic testing of castings of this grain size. The 1.00 MHz echogram is on Fig. 7. Echogram is without noise from microstructure with three distinct backwall echoes.

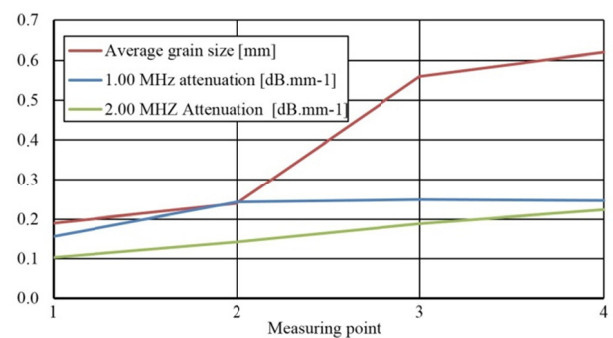
Fig. 8. The dependence of the attenuation on the grain size

The results of attenuation measurements and microstructure evaluation confirmed that increasing grain size increases ultrasound attenuation, which is directly proportional to the used probe frequency. The dependence of the attenuation on the grain size is on Fig. 8.
