EXPERIMENTAL DETERMINATION OF THE SYNERGISTIC COMPONENTS OF TRIBOCORROSIVE WEAR OF Ni-Cu-Mo-AUSFERRITIC DUCTILE IRON

The paper presents results of a two-stage study on the tribocorrosive wear of ADI alloy cast iron containing Ni and Cu. In the first stage of the wear tests with use test rig type pin-on-plate, there were determined the parameters of the process of tribocorrosion of the ADI cast iron in 3.5% NaCl solution. In the second stage, the tests were carried out on a test rig simulating real operating conditions of chain wheels used in armoured face conveyors. The purpose of this study was to demonstrate the impact of the combined action of corrosive agents (water and NaCl) and quartz abrasive on the wear of the wheels tested. As part of the test, the abrasive wear in the presence of the abrasive material alone and in the presence of a mixture of the abrasive material, water and NaCl was determined. The microstructure and the hardness of the surface layer as a function of the distance from the surface were also determined. During the study it has been found that regardless of the type of test there is a synergy between the effects of corrosion and friction which led to an in

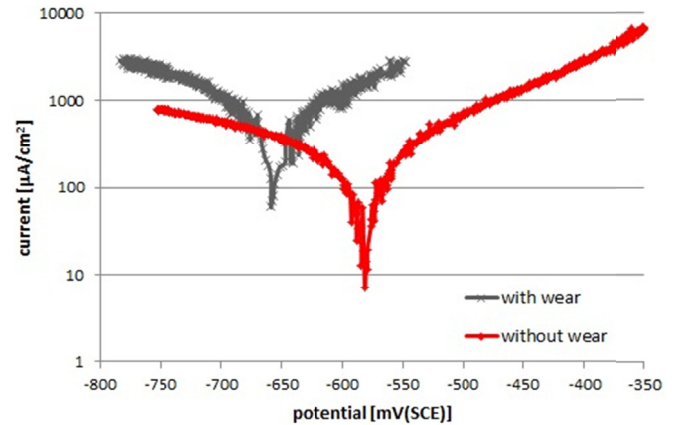
Fig. 8. ADI polarization curves in 3.5% NaCl solution (2 mV/s)

These methods were applied for static conditions (sample immersed in electrolyte) and during the wear test (counter-sample is sliding against the surface of the sample in the presence of electrolyte). The results obtained are shown in Fig. 8. The plots of the polarization curves do not indicate the occurrence of an

area of passivation [32,33]. A distinct decrease in the corrosion potential proves that the ADI corrodes in 3.5% NaCl solution. Fig. 9 illustrates an intensification of the corrosive impacts in frictional conditions [34,35]. Based on the polarization curves, the corrosion potential E_{cor} and the corrosion current density (I_{cor}) were determined using the method of Tafel equations. The results of the analyses are presented in Table 4. Using the Faraday equation for the corrosion current density, the rate of corrosion was also determined. When friction occurs, the corrosion current density (loss of material) increases threefold.

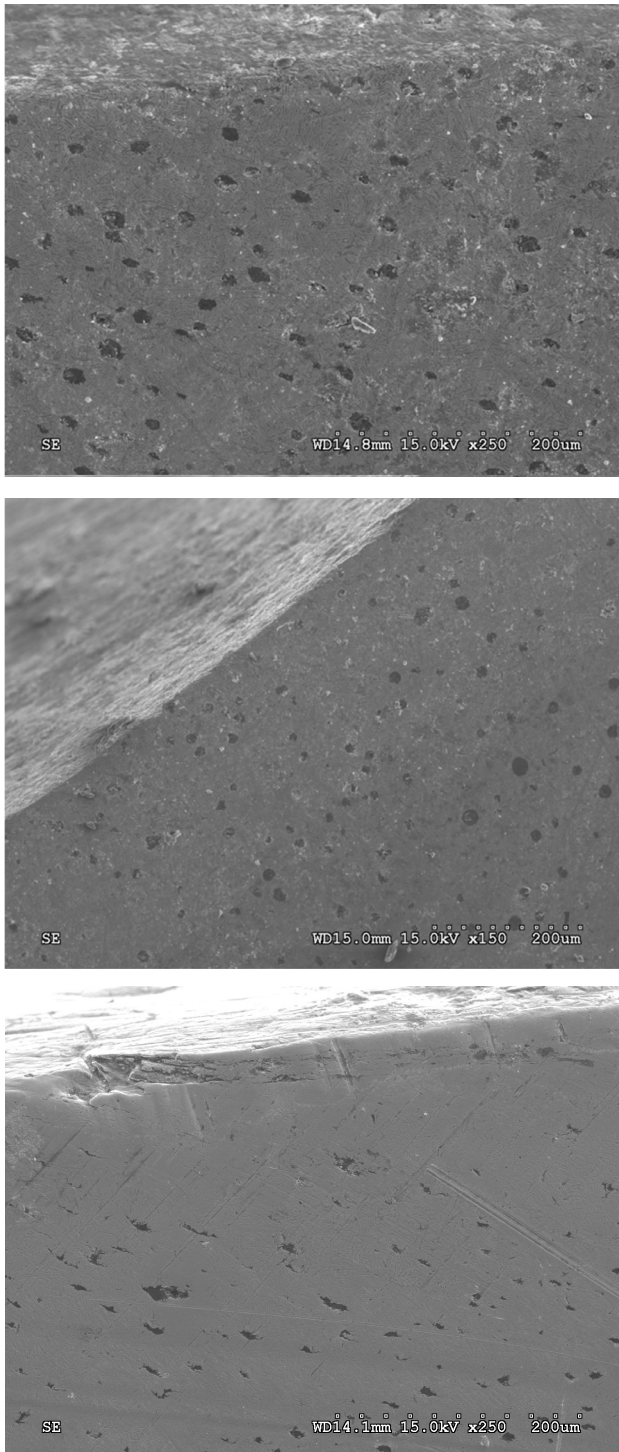
Fig. 13. The microstructure in an area of $0 \div 1$ mm under the surface subject to wear in abrasive conditions; lower figure show microstructure of ADI_360, medium figure and upper figure shows microstructure of ADI_360_COR

Fig. 12 shows the microstructure of ADI_360_COR chain wheel approx. 2 mm under the surface subjected to abrasive wear. The microstructure of the matrix is composed of upper ausferrite with a content of residual austenite at a level of approx. 40%. The graphite maintained its spherical shape, no deformation caused by the abrasive or by the pressure of the chain was found. Fig. 13 shows shallow cavities oriented askew in relation to the surface, caused by the action of the abrasive. At the surface the graphite was oriented almost in parallel to the surface, but in the near-surface zone it is characterized by an elongated shape, a complete lack of sphericity and the orientation at an angle of approx. 45 degrees in relation to the surface. A characteristic arrangement of the deformed graphite inclusions is associated with a non-rectilinear sliding movement of the chain in the area of mating with the chain wheel. The zone of the deformed graphite is located in the area of 0-0.2 mm under the surface of wear. The deformations of the graphite in the near-surface zone are shown in more detail in Fig. 14.

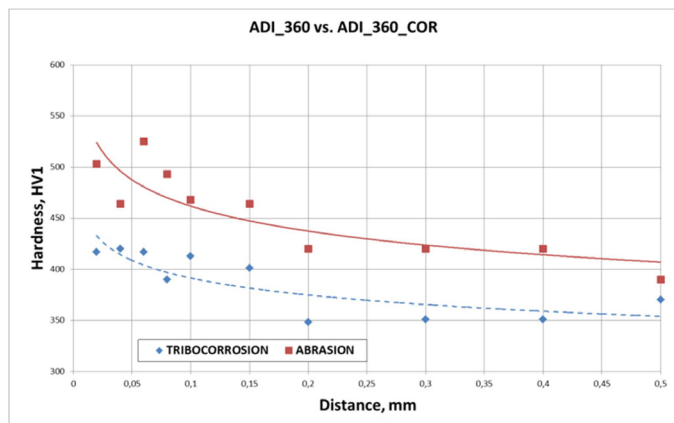
Fig. 16. The hardness HV0.1 of ADI_360 in an area of approx. 0.1 mm under the surface subject to wear in tribocorrosive conditions

A characteristic feature for the structures shown in Fig. 15 is an apparent lack of graphite deformations. The spherical shape of the graphite was maintained even in the immediate vicinity of the cutting caused by the action of quartz grains. This may suggest a smaller energy intensity of the microcutting process in the near-surface layer in conditions of the combined effect of abrasive and corrosive factors. The easier penetration of the surface layer by abrasive grains might be caused by an intensive formation of oxide layers in corrosive conditions on newly exposed surfaces and by a less intensive process of the transition of the residual austenite into martensite. This process depends to a significant degree on the value of the tension in the contact layer. A reduction in the intensity of the TRIP process is proved by a reduction in the hardness of the near-surface layer after a period of operation (Fig. 16).
