COMPARISON OF COMPOSITE LAMINATES MACHINING METHODS AND ITS INFLUENCE ON PROCESS TEMPERATURE AND EDGE QUALITY

Robert Jaskiewicz

Lukasiewicz Research Network – Institute of Aviation,
Center for Composite Technologies,
Al. Krakowska 110/114, 02-256 Warsaw, Poland
robert.jaskiewicz@ilot.edu.pl

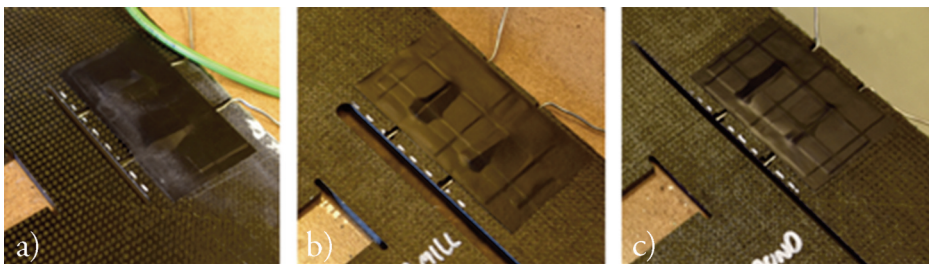
Figure 4. Grooves machined next to thermocouples using three tools: a) Tool 1, b) Tool 2, c) Tool 3 [author's materials]

The temperature readers used for the test were not equipped with registration functions, therefore the whole test was filmed and the temperature charts were done on the basis of the film. Temperature values have been read once per second. Figure 4 shows grooves machined next to thermocouples using three tools.

According to the data in table 2, tool no 1 had to make 11 passes to cut the panel with the thickness of 5,3 mm. Feed for tools no 1 and no 2 was the same – 18 mm/s. Tool nr 2 is only suitable for side milling, therefore the entrance to the panel using this tool was made from its edge. The machining using diamond saw (tool no 3) causes additional incisions. Because of that the groove formed with the saw is longer. Saw feed was ten times slower – 1,6 mm/s.

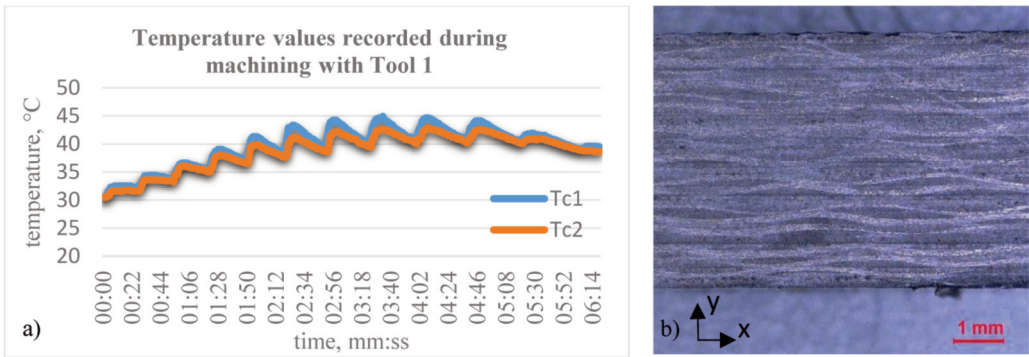
Figure 5. Tool no1 test results: a) temperature vs. time graph, b) machined surface under microscopic magnification [author's materials]

In the temperature chart from tool no. 1 test, all mill passes are clearly visible. Every passage caused an increase of temperature. Thermocouple no 1 reacted first because it was located closer to the beginning of path. Max temperature recorded during first test was 44,1°C on Tc1. Max difference between the sensors indications was 3,3°C. One of the reasons for this difference could be a difference in the thermocouples contact with measured wall. The highest values were recorded during passages no 7 and 8. Then the tool was in the middle of panels depth, so the closest to the end of the thermocouples. In the figure 5b there are no visible defects. However traces of separate tool passes are visible. Whole machining took about 6 min, but it is possible to shorten it. The return movements and the setting of the pass depth were set manually and can be programmed.

Graphs of recorded temperatures depending on the time are shown in the figures 5, 6 and 7. Figures also shows microscopic pictures of surfaces made by each tool.

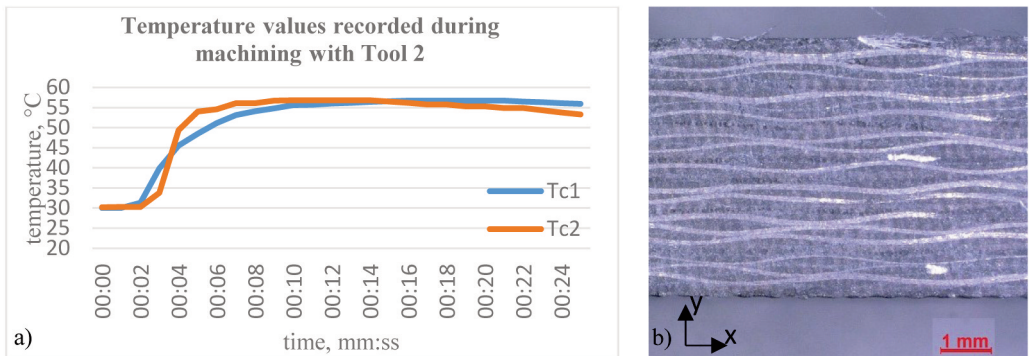
Figure 6. Tool no2 test results: a) temperature vs. time graph, b) machined surface under microscopic magnification [author's materials]

The tool no 2 has cut the panel in one pass, therefore, one rapid increase of temperature can be observed in fig. 6a. The whole process lasted less than half minute. Max temperature recorded during second test was 56,8°C on Tc2. Tc1 max was 56,7°C. It is 12,6°C more than during test with tool no 1. Feed of the tool was the same as during first test – 18 mm/s. Whole machining took about 20 seconds. In the figure 6b there are no visible defects, however there are some vertical traces visible. In the further part of the article these defects will be shown on the contour of the surface.

On the profile in the x-direction in the figure 9, there are clearly visible traces after using Tool no 2. The same marks were visible on microscopic view shown in the figure 6b. The roughness in the x-direction was 6,01 μm , and 3,49 μm in the y-direction.

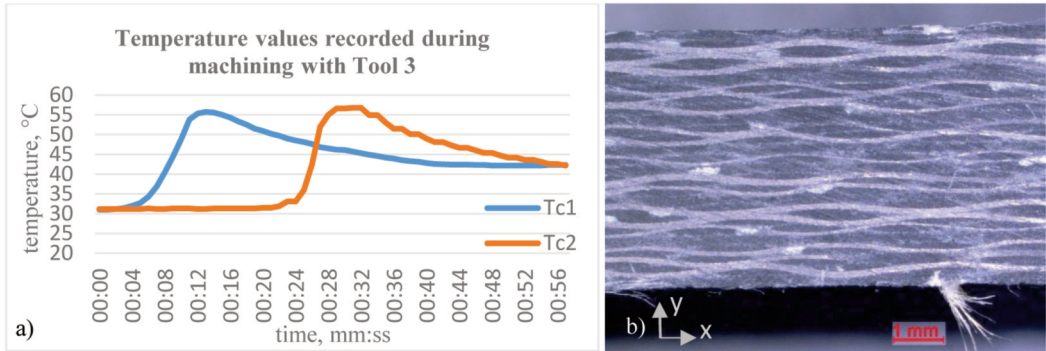
Figure 7. Tool no 3 test results: a) temperature vs. time graph, b) machined surface under microscopic magnification [author's materials]

The use of the saw required a reduction of feed to 1,6 mm/s. It is ten times slower than both cutters, but saw the same as tool no 2 can cut the panel in one pass. It is one rapid increase of temperature visible in the figure 7a. Due to the reduced speed, the diagrams from the thermocouples moved away from each other. Max temperature recorded during test no 3 was 56,8°C on Tc2. It is exactly the same temperature as max temperature during test with tool no 2. In the figure 7b there are visible diagonal traces after using saw. There are also some shred visible on the bottom surface.

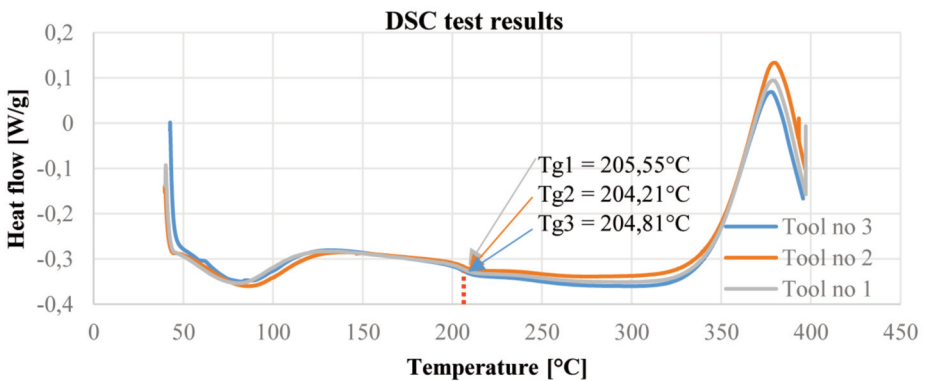
Figure 11. DSC results chart [author’s materials]

From the surface edges machined by 3 tools, DSC samples were made. This is one of the methods to determine glass transition temperature of the material. The difference in the glass transition temperature of the samples could mean that during the machining some change occurred in the material. DSC results are shown in the Figure 11.

The recorded heat flow patterns from all samples are very similar. The recorded changes are too small to clearly define the glass transition temperature, but an attempt was made to indicate them. The glass transition temperature of the sample machined with Tool no 1 was estimated at 205,55°C, with Tool no 2 was 204,21°C, and with Tool no 3 was 204,81°C. Results of test did not indicate any changes during machining.
