EWA SZALINSKA¹, KAJETAN D'OBYRN¹

LONG-TERM CHANGES IN SURFACE AND GROUNDWATER QUALITY IN THE AREA OF A MUNICIPAL LANDFILL (BARYCZ, POLAND)

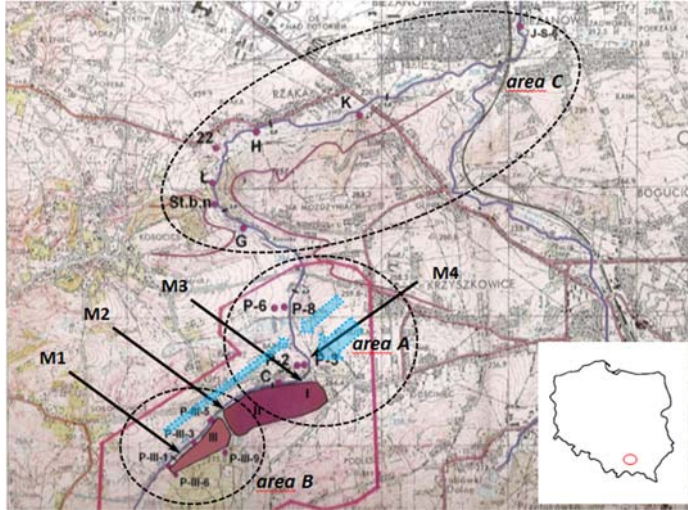
Fig. 1. Localization of the surface (M1–M4) and groundwater (area A–C) sampling sites in the Barycz landfill area (ca. 1:40 000). Arrows represent presumed directions of the groundwater flow (size of the arrow depicts probability of the influence)

The Barycz municipal landfill (southern Poland) was opened for use in 1974 at a former salt mining area, belonging to the Wieliczka Salt Mine. Establishment of this facility was a part of a post-mining reclamation plan, which today covers 36.5 ha, and is divided into three stages (Fig. 1). Stage I of the original dumping site had no environmental safeguards, i.e., the landfill base had no drainage system and was not sealed by any natural or artificial liners. This stage was later reclaimed by the end of 1992 by covering with layers of clay and soil, and sown with grass. Degassing chambers for this part of the landfill were built between 1992 and 1997. Stage II, opened in the late 1980s, which has been surrounded by a system of drainage ditches, and the landfill bowl was equipped with a surface drainage system. Leachate was collected into a leak-tight reservoir and regularly transferred to a waste water treatment plant. Parallel to the reclamation of stage II (2005), the expansion of the landfill site into stage III was designed in compliance with all the UE standards and has a life expectancy until 2018. Stage III has been equipped with an artificial two-layer insulation and a leachate collecting system to prevent any adverse impacts on surface and groundwaters.

The surface water monitoring sampling consists of 4 sampling sites localized on the Malinówka creek, upstream, midstream, and downstream (2 sites) from the landfill (Fig. 1, sites M1–M4). This system focuses on the status of the stream and it is supposed to enable a comparison between present levels of contamination downstream from the landfill from the background quality upstream of the facility. Samples have been collected 4 times per year (March, June, September, and November) by the Voivodship Inspectorate for Environmental Protection at Cracow, Poland (WIOŚ). The selection of

Currently, the groundwater monitoring system in the landfill area consists of 11 piezometers, sampled also four times per year by the WIOŚ. Piezometers C, P-2, P-3, P-6, and P-8, localized in the neighborhood of the landfill (Fig. 1, area A) hold the longest data record (1997–2011), while piezometers P-III-1, P-III-3, P-III-5, P-III-6, P-III-9 (Fig. 1, area B) were added to the monitoring network in 2005, after the opening of stage III. For the piezometers localized at the greatest distance from the landfill (G, S, Ł, 22, H, K, and S-6; Fig. 1, area C) the sampling effort was suspended in 2002. Survey effort within the entire monitoring system is focused on priority groundwater contaminants typical of landfill impact. This includes: major ion balance and minor chemical composition (inorganic and organic contaminants, including heavy metals).

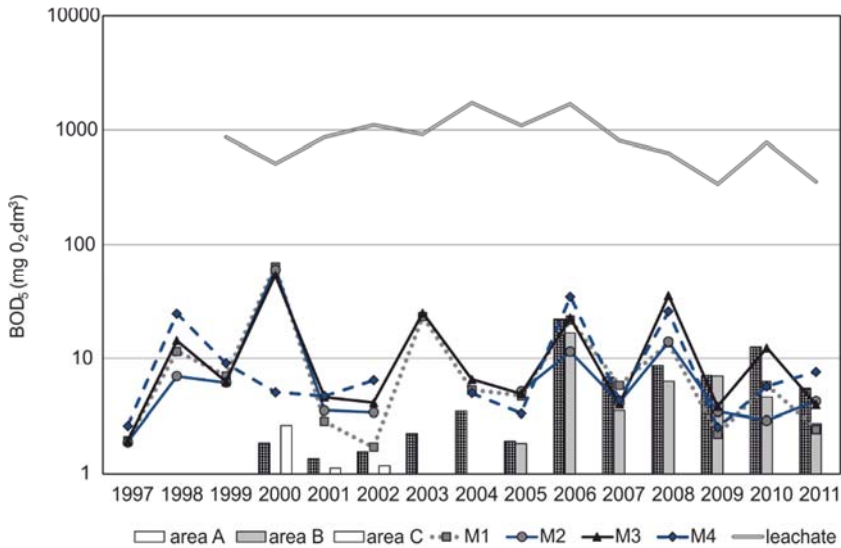
Fig. 2. Temporal distribution of average BOD₅ in groundwater (areas A–C), surface water (M1–M4), and leachate

Parameters usually discussed in the case of landfill impacts on the aquatic environment (i.e., BOD₅, NH₄⁺-N, TOC) indeed demonstrated elevated values at the Malinówka creek sampling sites, especially at site M3 localized directly downstream from the facility. This trend has been previously reported in the area [9, 15]. Average concentrations of BOD₅ detected in a site upstream from the landfill (M1) were not significantly, or even noticeably lower from the values observed at sites M2 and M3 (Fig. 2).

As for groundwater samples, noticeably high concentrations of all parameters were detected in area A, especially in piezometers localized close to the landfill (C, P-2, P-3). The average values for areas B and C were substantially lower in the respective time periods, as presented by BOD_5 and NH_4^+-N (Figs. 2 and 3). This demonstrates that the direct impact of the landfill on the groundwater is limited to the direct proximity of the facility (area A). It should also be noted that the average concentrations of the investigated parameters for area A were significantly lower than the values measured in leachate (Kruskal–Wallis, $p < 0.05$). As for the relationship with the parameters in the Malinówka creek sampling sites, no significant differences have been observed due to data variability, though the average values were at a similar level, as for sites M3 and M4.

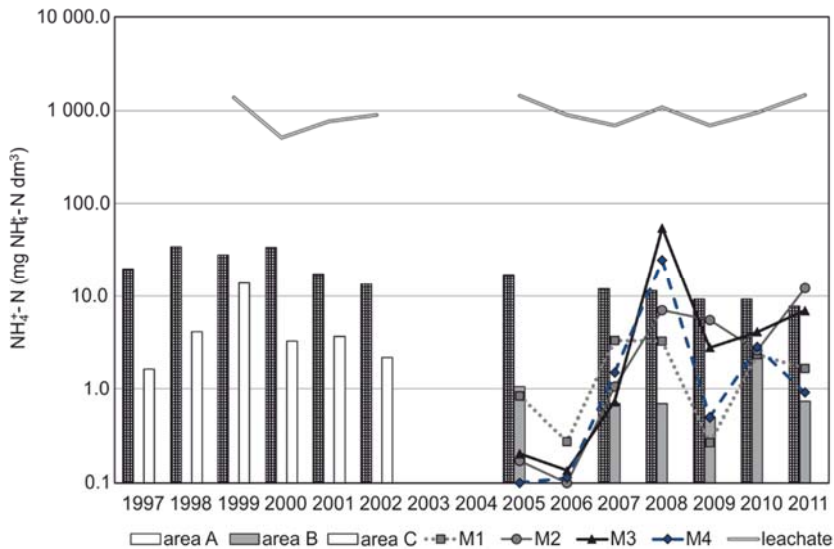
Fig. 3. Temporal distribution of average NH₄⁺-N concentration in groundwater (areas A–C), surface water (M1–M4), and leachate

A similar trend was observed for NH₄⁺-N values in 2005–2007 (Fig. 3). This indicates that the Malinówka creek, upstream from the landfill, carries contamination originating from the upper part of the catchment, which is likely due to the surface runoff source which contributes to the overall contamination level of this creek. As for the site

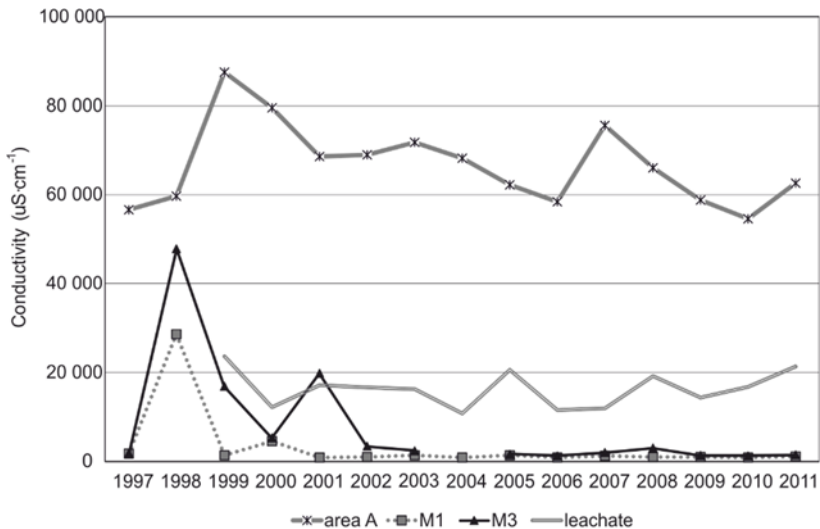
Fig. 4. Temporal distribution of average conductivity values in groundwater (area A), surface water (M1 and M3), and leachate

Despite the presence of the landfill and the noticeable surface runoff impact, the most distinctive issue for the aquatic environment in this area is the chloride contamination. Since, chloride measurements have been suspended during the monitoring effort, the subsequent discussion is based on conductivity distribution. Conductivity observed in the leachates was within, or only slightly above, the limits presented for various landfills [1, 2], and noticeably higher than the values noted in the Malinówka creek samples (Fig. 4). The average level of conductivity of the surface waters exceeded the EU guideline values established for surface water ($309 \mu\text{S}\cdot\text{cm}^{-1}$ for class II, watercourse type 12, [16]), especially in 1998 and 2001. However, it should also be noted that after these two events, the conductivity in surface water decreased and remained at the guideline levels (except for 2008). An extremely high conductivity was observed in groundwater samples collected in area A, with an average value of $66\,523 \pm 65\,297 \mu\text{S}\cdot\text{cm}^{-1}$. The reason behind such extreme salinity of the samples collected from the piezometers in area A is clearly the localization of the landfill. As mentioned before, the Barycz landfill occupies the former salt mine area, mainly natural hollows and depressions resulting from surface subsidence commonly occurring due to the mining of salt [17, 18]. The weight of the deposited waste load causes an extrusion of brine filling the caverns left after rock salt excavation, which due to the permeability of formations, comes into contact with the aquifer (the presumed groundwater flow directions are presented in Fig. 1). Since, brine flow outside the deposit boundaries is not very likely, due to the presence of poorly permeable and impermeable formations in the landfill neighborhood, the conductivity of groundwater in areas B and C were expected to be at a much lower level. Indeed, the average conductivity in these areas was similar to that observed in the Malinówka creek, and below the EU guidelines values established for ground water ($3000 \mu\text{S}\cdot\text{cm}^{-1}$ for class V [19]). The graphic presentation of conductivity measurements in all the media (Fig. 4) also displays an intermittent character of brine extrusions which are visibly reflected in changes of conductivity in all the investigated media. An explicit separation of the chlorides impact from the landfill and the brine is not possible, especially since the two first stages of the landfill were built without sealing the landfill base. The entire dataset shows however, that the chloride contamination has been declining since discontinuation of the salt excavation.
