Agnieszka TUBIS¹, Mateusz RYDLEWSKI¹, Marcin BUDZYŃSKI²
¹Wrocław University of Science and Technology (Politechnika Wrocławska)
²Gdańsk University of Technology (Politechnika Gdańska)

SAFETY AND FUNCTIONALITY ASSESSMENT OF TRAM LOOPS IN WROCLAW

Abstract: *The article presents the implementation of the ISFTL method proposed by the authors consisting in an indicator assessment of the safety and functionality of tram loops. Five tram loops located in Wrocław were analyzed. Each of these loops has different characteristics. The components of each assessment are described in detail and further directions for improving the proposed assessment are indicated.*

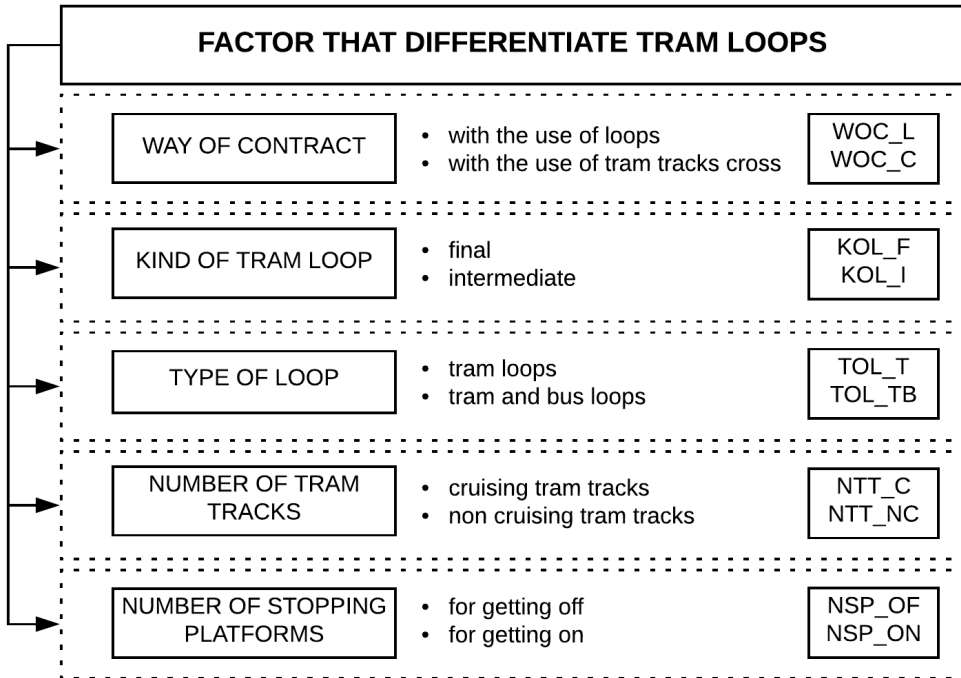
Fig. 4. Factor that differentiates tram loops

The field study was conducted in December 2019. In tab 1. are presenting the most important parameters of the analyzed tram loops taken into account during the analysis and detailed information describing the factors differentiating the tram loops (fig. 4). As an additional parameter - NL - the number of lines served on a given loop as of 31.12.2019 was also given.

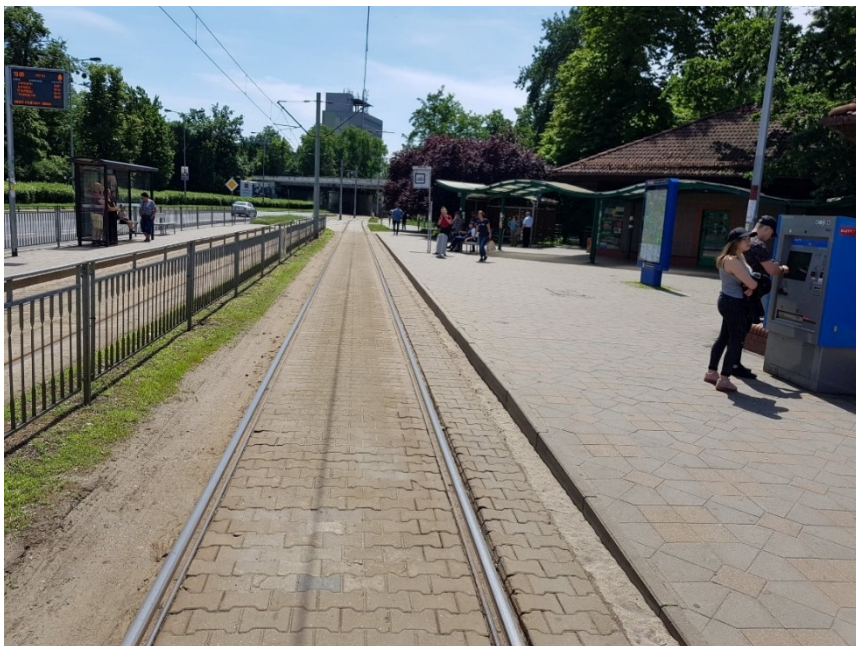
Fig. 6. Tram platform stops located in Krzyki tram loop in Wrocław (Poland)

The measurements carried out allowed for the conclusion that the Krzyki loop (fig. 6) has a low level of safety compliance. The first aspect is the condition of the pavement surface, which is not adequate. There are individual defects and unevenness. In the case of the separation of transport traces (ST), no pedestrian crossing through the tram track was identified and there was a clear problem in separating pedestrian and cyclist streams. The entire length of the stop leads as a road to the bicycle parking lot which can lead to dangerous situations in the cyclist-pedestrian relationship. The technical condition of the track is assessed as satisfactory. In terms of the functionality of the loop, the evaluation result is satisfactory.

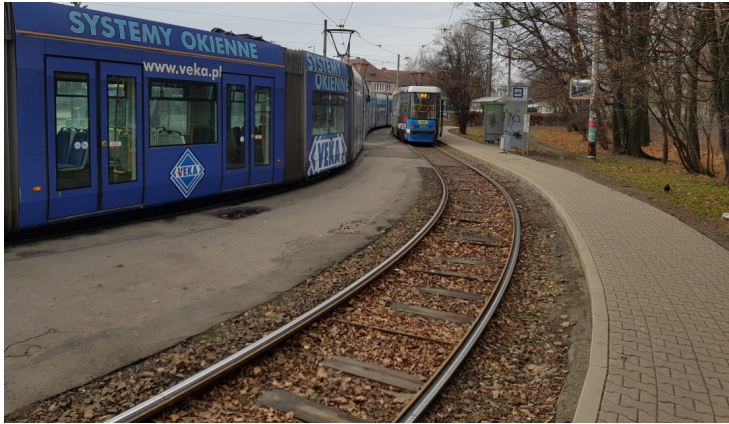
Fig. 7. Tram platform stops located in Sępolno tram loop in Wrocław (Poland)

The Sępolno loop (fig. 7) has the lowest values of ISTL and IFTL indicators. Both in the case of the safety and functionality assessment, the conducted tests showed a very bad condition of both parameters, classifying the loops at the unacceptable level in both areas of the assessment. During the audit carried out at the loop it was observed that the condition of the tram track is in poor condition. The surface of pedestrian and bicycle routes is in very poor technical condition, the pavements are uneven and have cavities. In the loop area, there are no pedestrian crossings and pavements separated from the tram track. There is also a lack of bicycle traffic separation. The Sępolno loop meets all requirements only in terms of accessibility to different forms of transport and visibility of tram trains in the area of the loop. In the case of functional indicator parameters, there is a lack of adaptation of bus platforms and infrastructure. There are no shelters, benches and dynamic passenger information boards on the loop. Platforms are not adapted for the disabled. The platform for passengers who getting on is too short. And the number of platforms for passenger who getting on is not adapted to the number of tram lines which serving loops.

The results indicate that the Sępólno loop is an example where it is necessary to carry out repair and modernization works aimed at improving the safety of users and the functionality of the facility. Analyzes indicate a significant risk of adverse events, including those threatening the health and life of users. One loop that has obtained the maximum indicator value (only in terms of security) is the Klecina loop.

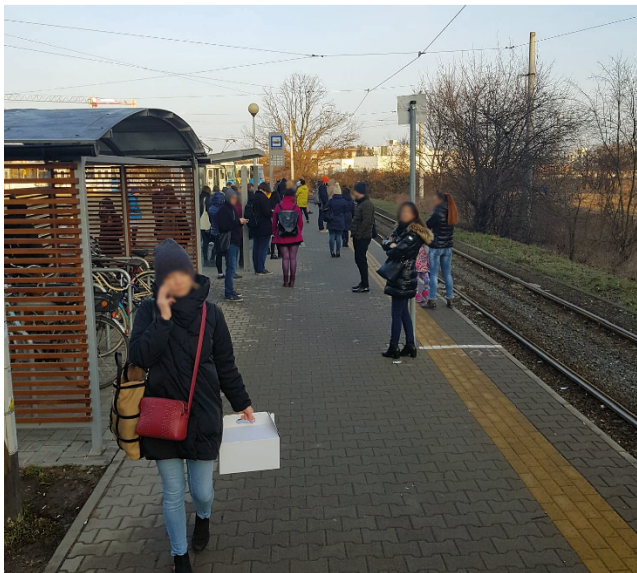
Fig. 8. Tram platform stop for getting on located in Klecina tram loop in Wrocław (Poland)

The Klecina loop (fig. 8.) is an example of a tram loop where the direction change takes place differently than on typical loops. As a standard, tramway traffic on the loop runs counter-clockwise and stops are located on the outside of the tram track. In the case of the Klecina loop, the tram traffic is clockwise and the stops are located inside the loop. The awarded point values depend on the selected parameters for: accessibility to different forms of transport (AD) - no P&R parking, the distance from the city bike station is about 80 m, bus stops located at the street adjacent to the loop at a short distance from the stop; type of stop infrastructure and facilities (TI) - no dynamic passenger information boards, service outlets and the ticket machine is located outside the tram loop.
