EFFECT OF PROCESS PARAMETERS ON MICROSTRUCTURE AND MECHANICAL PROPERTIES OF RFSSW LAP JOINTS OF THIN AL7075-T6 SHEETS

Keywords: refill friction stir welding, lap joining, aerostructures, aluminum alloy, alclad

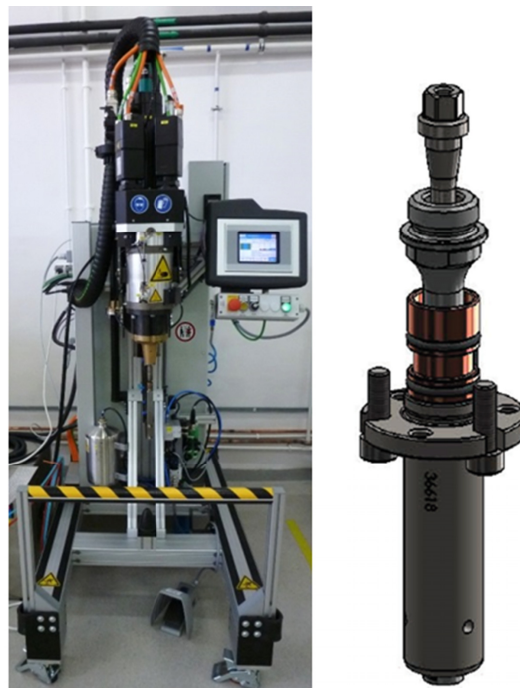
Harms & Wende RPS100 welding machine was used during the research. Tested joints were created by using tool, which allows to weld parts thinner than 4 mm. The diameter of the spot welds was ~9 mm. Specimens were welded from the side of upper (thicker) sheet metal. RPS100 and a RFSSW tool are shown in Figure 1.

Fig. 1. RPS100 welding machine (left) and RFSSW tool (right)

The thicknesses of welded metal sheets were: 1.6 mm and 0.8 mm for upper and lower sheet respectively. Shape and dimensions of specimens were adopted according to AWS D17.2 standard. Typical lap joint welded by RFSSW method is shown in Figure 2.

Fig. 2. Two aluminum sheets welded by RFSSW method

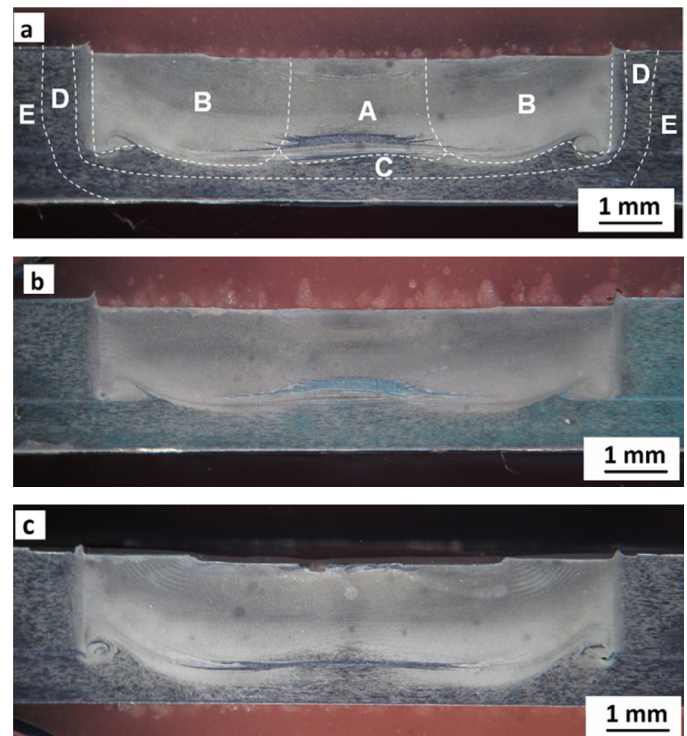
Figures 3÷5 present macro- and microstructure of selected RFSSW joints. There are some characteristic zones in RFSSW welds, as shown in Figure 3: internal and external mixing zone, formed respectively by the pin and the shoulder (A and B), thermomechanical affected zone (C), heat affected zone (D) and base material (E). Very detailed characteristic of specified zones in RFSSW welds can be found in available literature, among others [4÷7]. Some structural defects described in further part of this paper were also marked in selected figures (Fig. 4a, 5a).

Friction welding of sheets covered with alclad is challenging issue as presence of this protective layer limits possibilities of obtaining homogenous microstructure in weld area. Figures 3 a-c present microstructure of joints welded by a tool rotating with a speed of 2000 rpm. On the bottom of welds bonding ligament may be observed (layer of alclad closed within RFSSW joints, usually thicker in a central part of a weld). Bonding ligament's shape depends on RFSSW process parameters. For lower rotational speed bonding ligament is localized in a central part of a weld, whereas for high rotational speed bonding ligament extends almost the entire width of the weld. Similar dependence was observed in a case of tool plunge depth. With the increase in the tool plunge depth, alclad located on the surfaces of joined sheets is moved towards the bottom of the weld (Fig. 3). The increase in the tool plunge depth caused that bonding ligament

Fig. 3. Macrostructure of selected RFSSW joints welded at rotational speed of 2000 obr/min and different plunge depth of the tool: a – specimen 4P, b – specimen 5P, c – specimen 6P

retains the flat shape. Bonding ligament's shape is important issue, because as other researchers claim [4,8] such kind of failure may be a place, where crack can be easily propagated.

In case of joints welded with a rotational speed of 2000 rpm (specimens 4P, 5P, 6P) the boundary of sleeve impact zone was actually invisible. This means that mixing of a material was proper and weld was strongly joined with a parent material. These joints were destroyed by shearing and the beginning of breaking was localized at the end of the contact line (Fig. 6c) or by rupture of lower sheet also in a place, where contact lines end (Fig. 6d). These specimens were characterized by the best mechanical properties. The highest values of load were carried by specimen 5P, welded at rotational speed 2000 rpm and depth of tool penetration 1,7 mm.

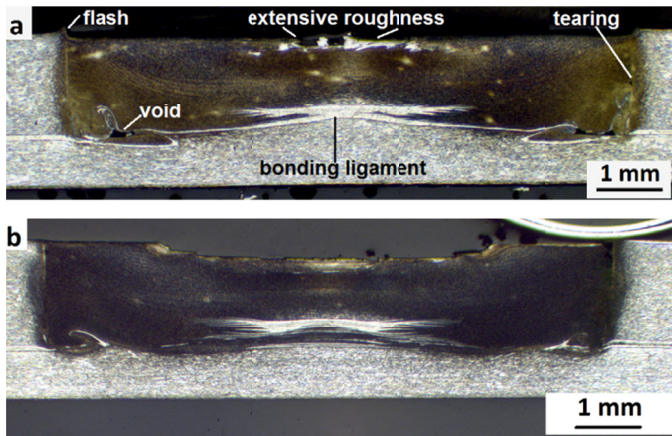
All specimens except for anodized one are characterized by lack of a notch. Notch- the groove around the spot weld- is

a typical geometrical failure appearing in RFSSW welds and is an effect of insufficient plasticization of material and insufficient filling of gap left by retreated sleeve in the last stage of welding process.

Fig. 4. Macrostructure of RFSSW joints of sheets with alclad – specimen 9P (a) and with anodic oxide layer – specimen 1A (b)

In order to investigate influence of anticorrosive layer on RFSSW process, some specimens were anodized, which resulted in thin oxide layer formation on the surface of an aluminum sheet. Subsequently specimens were welded using the same parameters as in case of specimen 9P (Tab. 3).

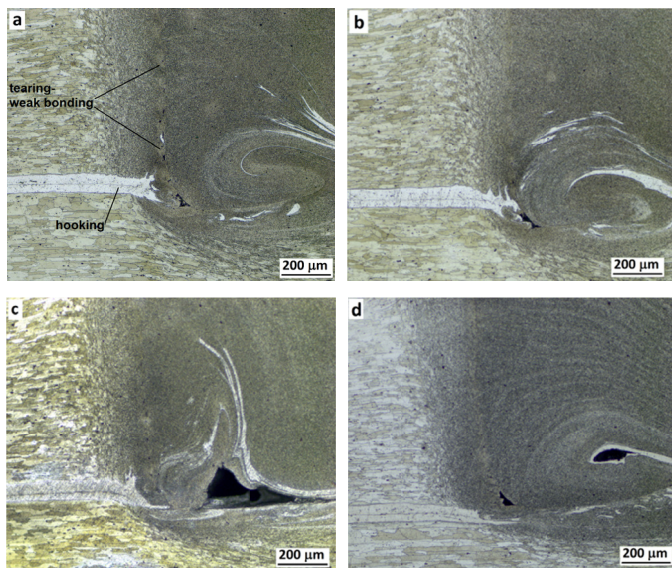
A characteristic feature of lap joints is contact line (thin oxide layer between joined sheets) deformation in a thermo-mechanical affected zone. In some cases this deformation extends even further to a mixing zone. This is a structural failure, which can initiate joint cracking, because the tip of the hook is susceptible to stress accumulation. In more than half of investigated specimens, the end of a contact line is localized near the boundary between thermomechanical deformation zone and outer recrystallization zone (Fig. 5). The configuration of the contact line in the form of a small hook directed downwardly was mainly observed for specimens welded at a rotational speed of 2000 rpm and a tool plunge depth of 1.8 mm and in the case of welded joints with the speed of 2500 rpm and a 1.6 mm tool plunge depth (Fig. 5 b-c).

Fig. 5. Defects in RFSSW joints-microstructure of cross-sections of specimens: a-3P, b-6P, c-7P, d-1A

also appears in the bottom of a weld in a sleeve impact zone (Fig. 5c, d). Then there is a significant probability that the destruction of the joint will come by separating of weld from the bottom plate at lower value of breaking force than expected. Such situation occurred in case of RFSSW specimens welded with the speed of 2500 rpm. Maximum size of voids was even more than 300 μm.

Small voids (also called as tearing) were observed along boundary of sleeve action area (i.e. Fig. 5a). This form of discontinuity occurred in welds, when material that fill space emptied by a retreating sleeve was not plasticized enough. This type of failure was observed in joints welded with a rotational speed of 1500 rpm where poor plasticity of metal is effect of low temperature in a weld. Small voids or clearly visible boundary along the zone of sleeve action occur also when anodized sheets were welded. Probably in this case, despite of using the high rotational speed, plasticization of material was insufficient to create a durable joint between the weld and the parent material. Anodized layer may be limitation in obtaining a sufficiently high temperature and plastic deformation of the welded material despite its slight thickness (of the order of several micrometers). Oxide layer is rather brittle and porous, which may promote the formation of microstructural inhomogeneity and the formation of discontinuities. There is lack of further information about influence of oxide layer on microstructure and properties of RFSSW welds. This mean, that this subject should be investigated broader. In case of welds, where joint between weld and

Contact line deformation mostly observed as hooking is very dangerous issue, especially in welds were some voids

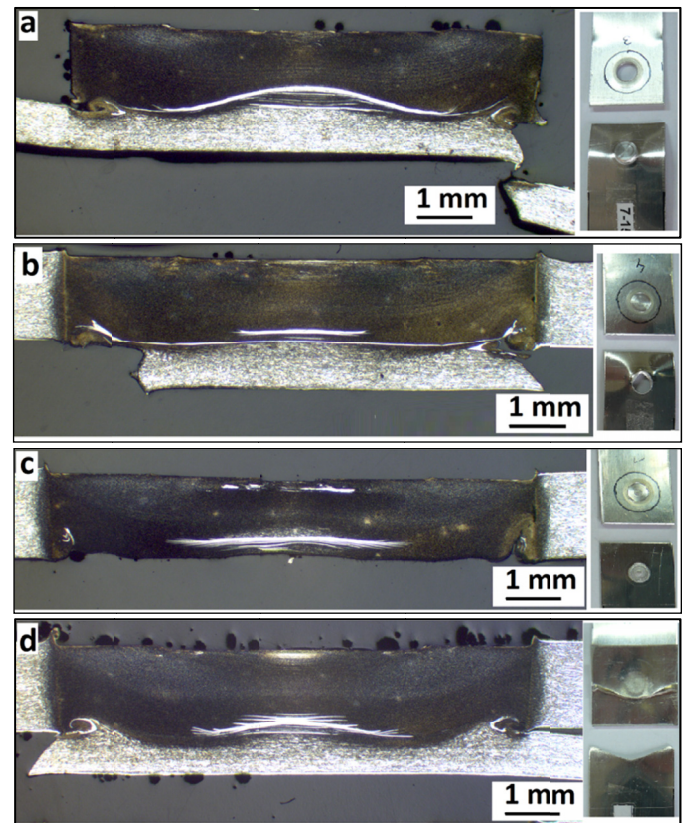
Fig. 6. Different types of failure mechanism in RFSSW joints: a) spot weld separation from upper sheet, b) spot weld separation from bottom sheet, c) shearing, d) bottom sheet breaking

parent material (along the area of sleeve action) is poor, weld is separated from the upper sheet during loading (Fig. 6a).

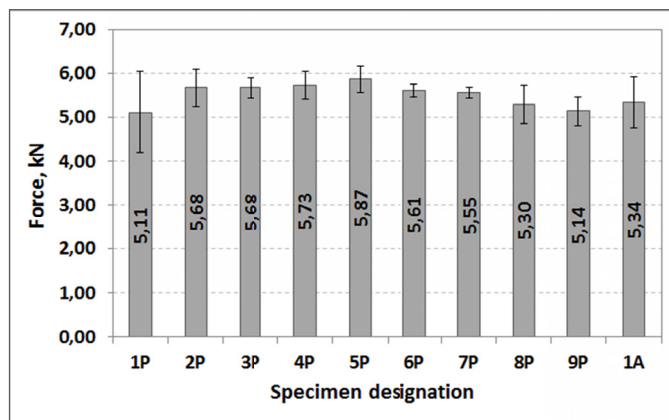
Fig. 7. Results of tensile strength tests of RFSSW joints

The rest of investigated joints broke at lower force values (Fig. 7), mainly because of relatively weak join between weld and parent material (specimens 1P, 2P, 3P, 1A) or presence of voids in the bottom of a weld (specimens 7P, 8P, 9P). No influence of bonding ligament was observed on joints' mechanical properties.

- Best mechanical performance of RFSSW welds were provided when rotational speed was equal to 2000 rpm and a depth of tool penetration of 1.6 mm or 1.7 mm (for a welding time of 2 seconds). These welds were characterized by a very good mixing of a material in a sleeve impact zone,
