The specifics of lighting of restoration objects (on the example of stave and stone church structures)

2. Solution of lighting of restoration objects (by the example of stone cathedrals)

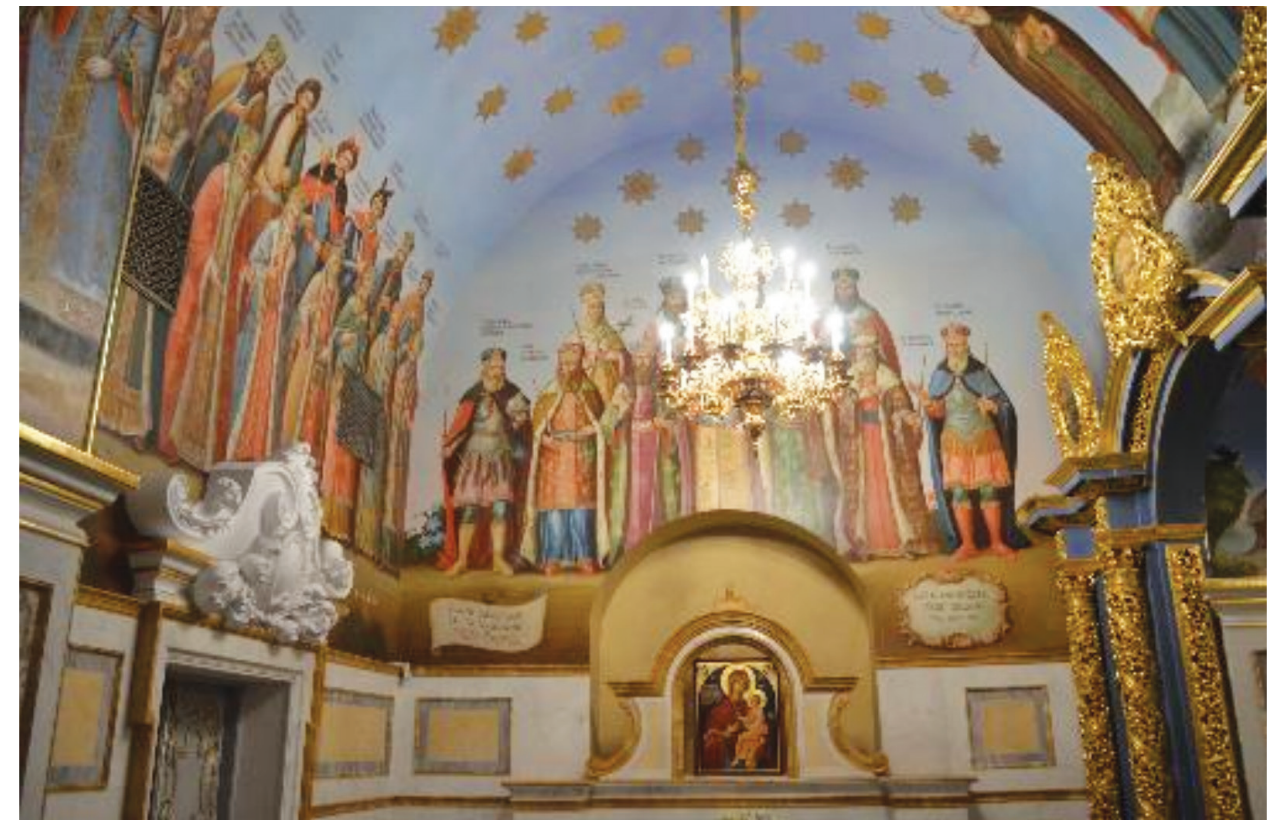
III. 3. Chandeliers in the church wardens' gallery. The photo from the funds of "Ukrrestavratsiya" corporation

Once the Dormition Cathedral was equipped with a large silver chandelier with 24 candles of the main dome, weighing over 100 kg, presented to Lavra by Kateryna II in 1784, which was not preserved, but later reproduced according to the archival photos (Fig. 2). Chandeliers in the church wardens' gallery were arranged in the same manner (Fig. 3). The total length of the Dormition Cathedral power supply network was 9,000 m.

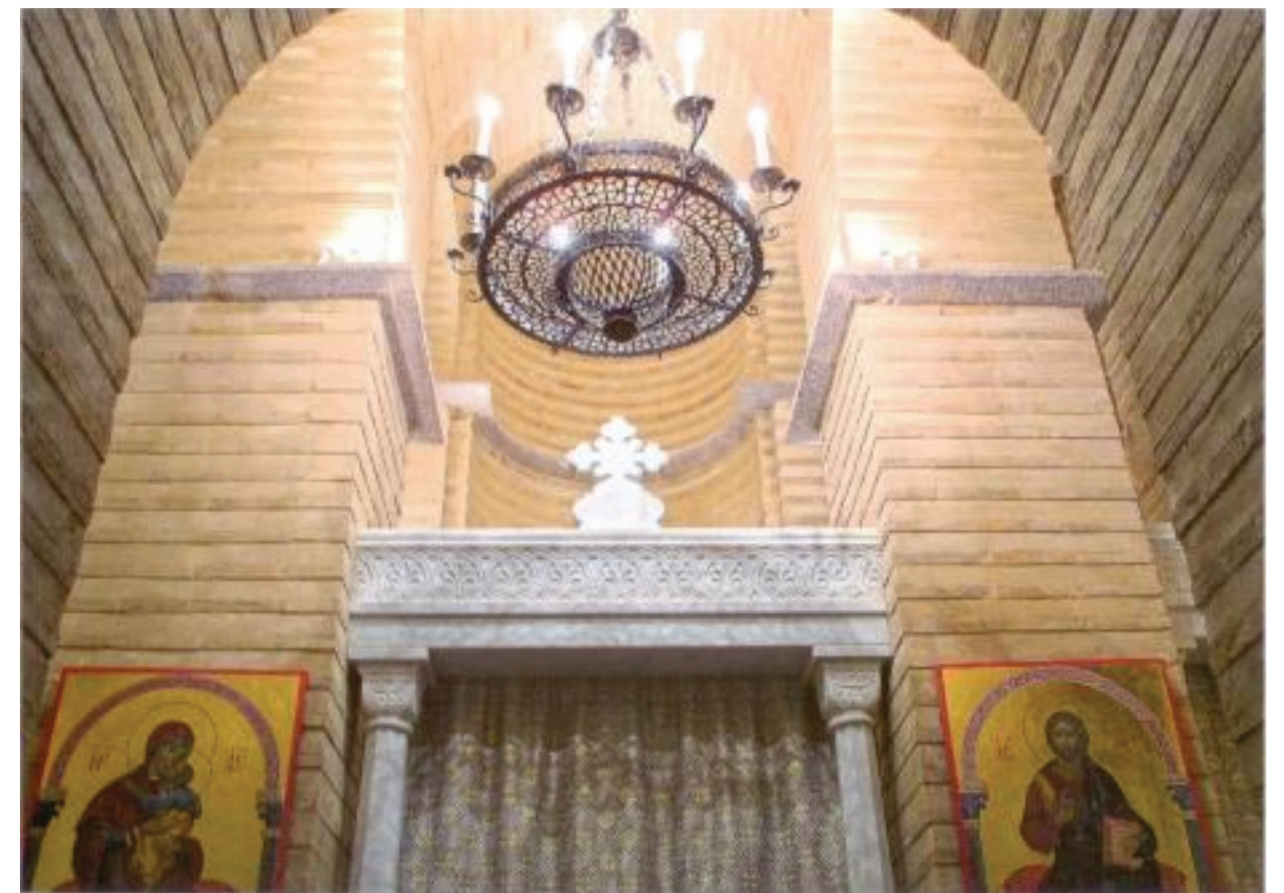
III. 4. Chandelier in the Church of St. John Prodomos interior. The photo from the funds of "Ukrrestavratsiya" corporation

The project of the Dormition Cathedral reconstruction provided for installation of lustres, lamp-brackets and other light fittings. The solution of the chandelier in the interior of the internal Church of St. John Prodomos was performed in Neo Russian style in accordance with the stylistics of church interior (Fig. 4).

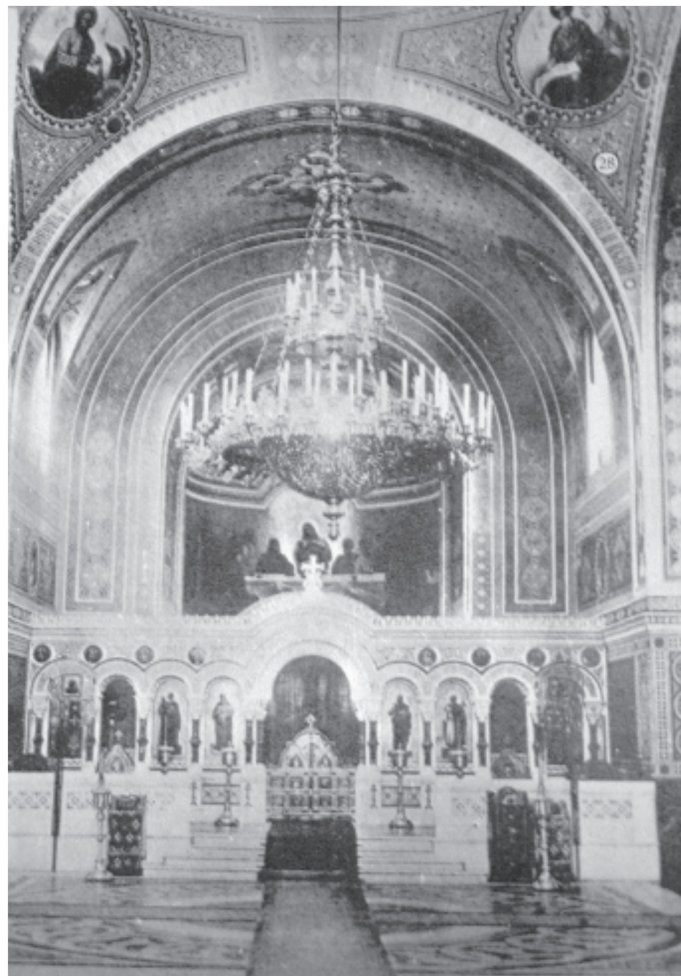
Ill. 5. Chandelier of the Saint Vladimir Cathedral. From the funds of "Ukrrestavratsiya" corporation

iconostases. As it can be seen from archival photographs, the adornment of the Saint Vladimir Cathedral was a large chandelier, which stylistically combined with pseudo-Byzantine interior and exterior stylistics (Fig. 5). Chandeliers similar in stylistics were located on the lower temple ceiling.

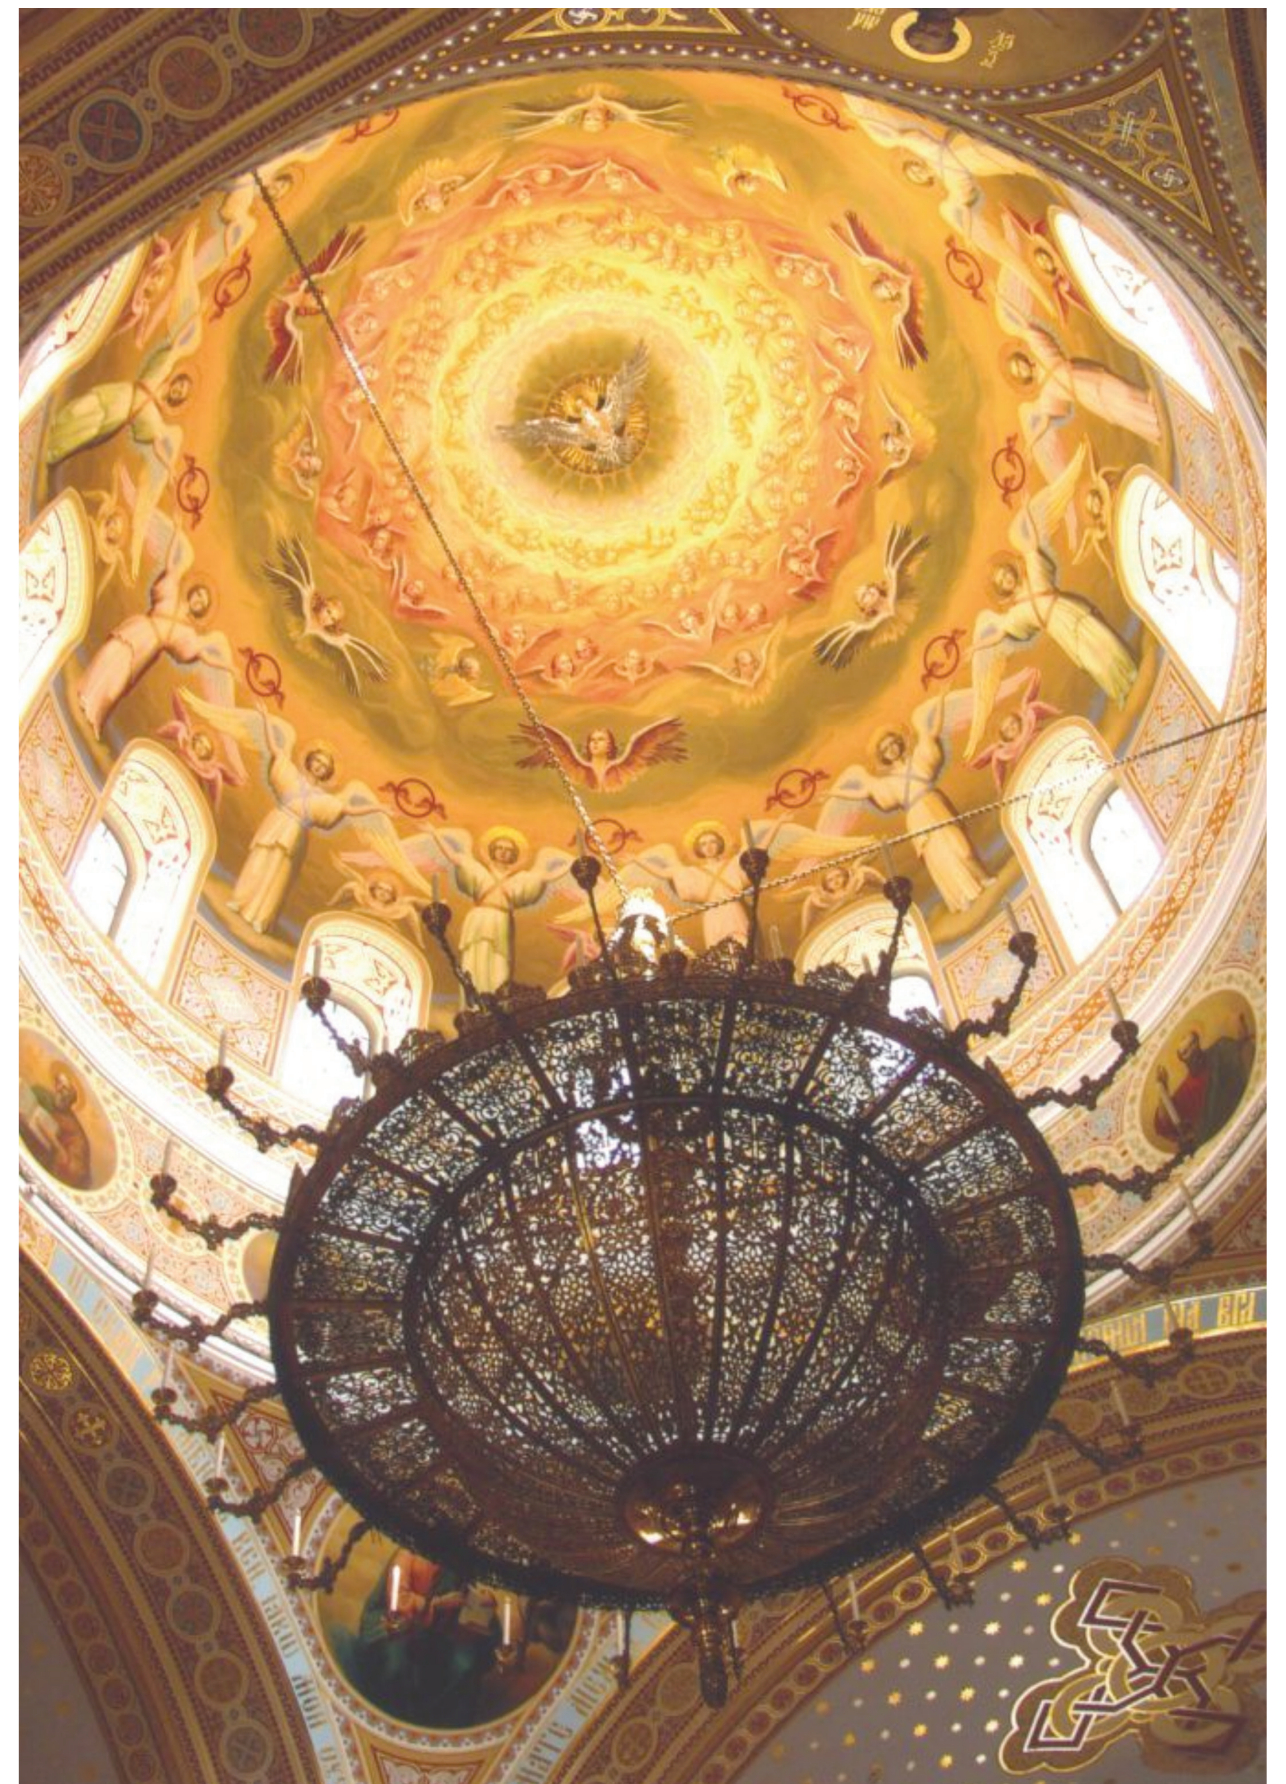
Ill. 6. Chandelier of the upper church. From the funds of "Ukrrestavratsiya" corporation

In the period from June to November 1999, comprehensive research was carried out for the condition of oil mural paintings in the lower church interior, research and report documentation was prepared and approved, the list of general construction works included electrical lighting of the interior, which changed the impression of the mural paintings. According to archival sources, special chandeliers were made for this church (Fig. 6).
