THE LOAD-BEARING CAPACITY OF TIMBER-GLASS COMPOSITE I-BEAMS MADE WITH POLYURETHANE ADHESIVES

Konrad RODACKI¹

Cracow University of Technology, Kraków, Poland

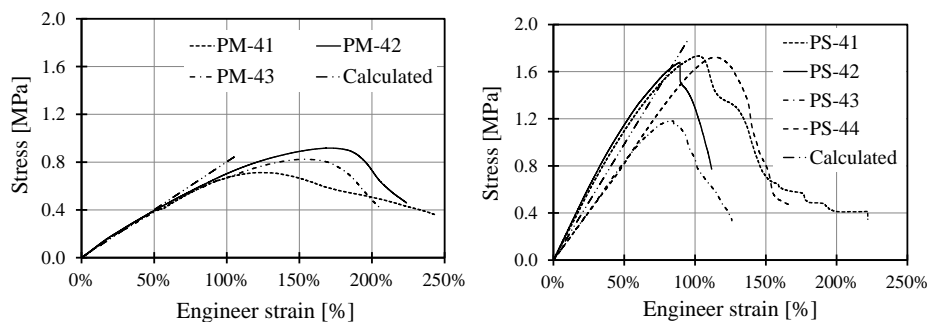
Fig. 11. Test results of double lap joint investigation for elements bonded with the Sika®PM polymer (left) and the Sika®PS polymer (right)

For the evaluated mean values of the shear modulus of the lap joints, the stress-strain curves for the adhesive layer were drafted and compared with the curves obtained during the investigation (Fig. 11). It can be observed that the stress-strain curves for the Sika®PM polymer are significantly similarity. In the case of the Sika®PS polymer, a slightly higher modulus deviation from the average value can be reported.
