Ergonomics Interventions at Badger Mining Corporation

In 2005, the National Institute for Occupational Safety and Health (NIOSH) and Badger Mining Corporation entered a partnership to implement ergonomics interventions, including a systematic process, to address exposure to risk factors that may result in musculoskeletal disorders or other types of injuries/illnesses. As a result of this partnership, an ergonomics process was integrated with the existing safety and health programme to promote an on-going application of ergonomics principles, and over 40 task-specific interventions were implemented during the first year of the process. This paper presents details of the process integration, and several examples of task-specific interventions that reduced exposure to risk factors.

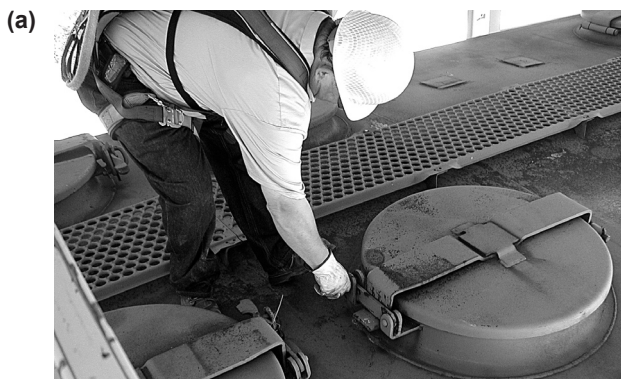
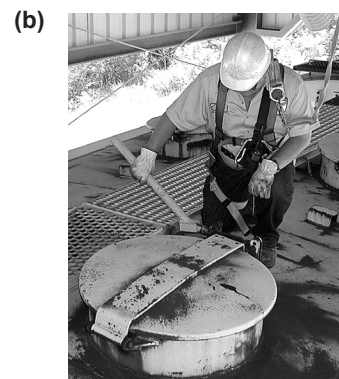
To open the rail car cover, the associate used his foot to release the latch while bending over to open the cover (Figure 6a). This task was

Figure 6. Rail cover latch released (a) manually and (b) with a hand tool.

Two hand tools were constructed by the maintenance team to unlatch different types of covers. The associate knelt on one knee as he placed the tool on the latch and then pushed down on the tool with his arm to release the latch. Once the latch was released, the cover was opened (Figure 6b). Although the associate was still exposed to an awkward posture, briefly kneeling on one knee probably resulted in less risk than the trunk flexion when the hand tool was not used. The material used to fabricate the two tools was available scrap material so the only cost associated with this intervention was for labor.
