Review Papers

Can Historic Interiors with Large Cubature be Turned Acoustically Correct?

The paper is a presentation of architectural interference in three historic interiors with large cubature leading to changes in their acoustic qualities. In two cases, the changes were beneficial to the functional qualities of the halls to satisfaction of the investors carrying out the renovation work. In the third instance, the architectural interference aimed at showing off the monumental valor of the interior resulted in significant degradation of its acoustics. To remedy the situation impairing the functional program of the facility, corrective measures are proposed neutral with respect to its historic character.

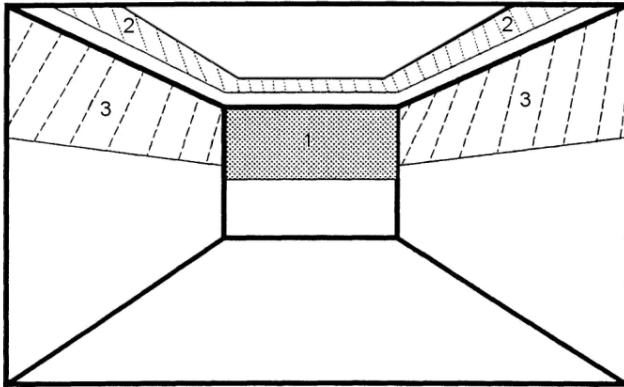
Fig. 3. The recommended sequence in which the sound-absorbing materials should be applied, in the order corresponding to increasing effect on the room acoustics: 1 – rear wall; 2 – ceiling portions bordering to walls, 3 – upper portions of side walls (KULOWSKI, 2011; FASOLD, WINKLER, 1976).

Historical character of the interior excluded the use of typical materials (such as mineral or glass wool lined with fabric), but it was possible to hang window curtains and additionally, cover the floor with fitted carpet in case of certain events. Presence of 11 large paintings unexpectedly turned out to be a favorable circumstance – they could be lined on the back side with a 50-mm thick layer of mineral wool with density of about 60 kg/m^3 . The canvas surfaces covered with a thick layer of oil paint, stretched on thick frames filled in with sound-absorbing materials, have formed a box-shaped acoustic structures absorbing effectively low-frequency sound components. Location of the paintings in upper portions of the walls was also a favorable circumstance (Fig. 3). Acoustic properties of the used materials are listed in Table 1.

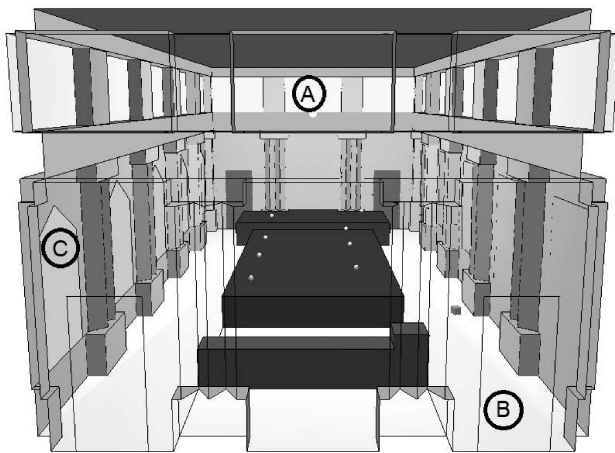
Fig. 4. The Assembly Hall model developed in CATT-Acoustic with arrangement of sound-absorbing materials listed in Table 1.

A graphical representation of the model used to simulate the hall in CATT-Acoustic programming environment is shown in Fig. 4. The model was developed with geometrical dimensions of the hall taken into account together with sound absorption and diffusion coefficients characterizing the existing finishing materials and furniture (4 long tables, a lectern, and 160 upholstered chairs). The model has been calibrated based on the measured reverberation time values.

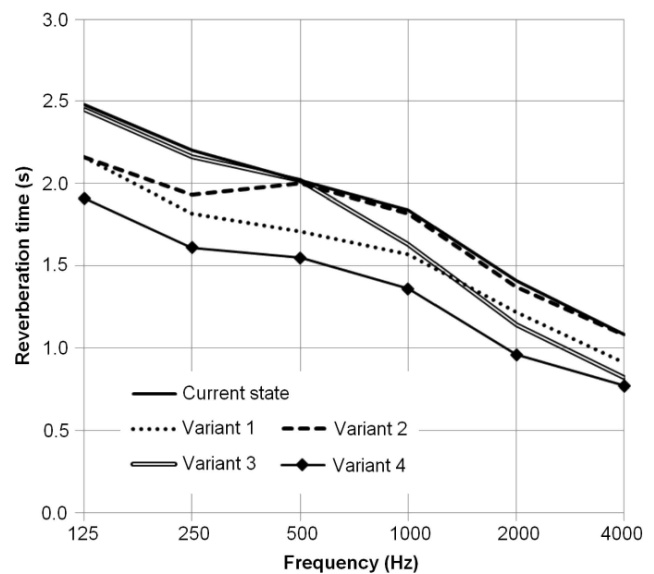
Fig. 5. Reverberation time frequency characteristics for the LUT Assembly Hall (unoccupied, computer simulation).

Simulation results closest to the design assumptions correspond to the use of all measures admissible in the hall in view of heritage conservation restrictions (cf. Table 2, Variant 4). The obtained value of $STI = 0.57$ corresponds to a good speech intelligibility (the reverberation time value for frequency 500–1000 Hz is 1.45 s). An interesting feature is the favorable behavior of the sound absorbing material used as lining under the paintings, thanks to which a significant reduction of the reverberation time in the low-frequency range has been obtained.

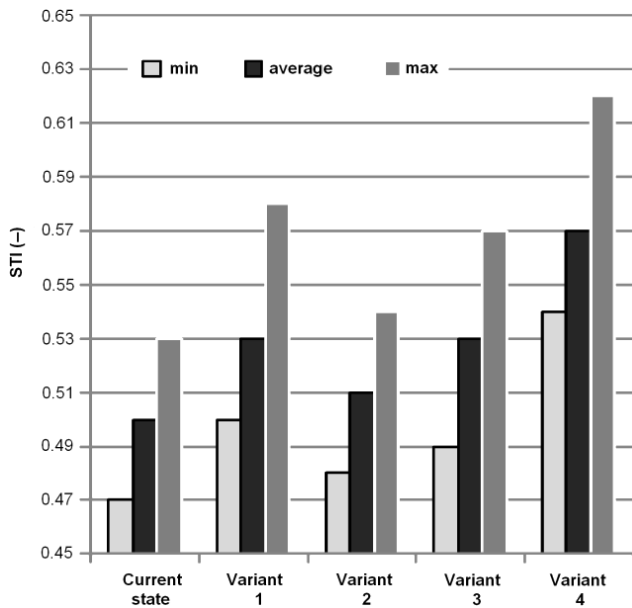
Fig. 6. The sound transmission index in the LUT Assembly Hall (unoccupied, computer simulation).

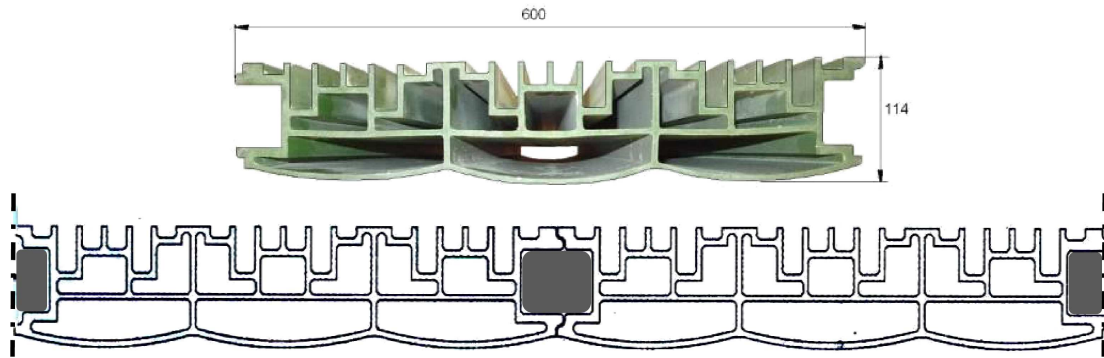
Fig. 9. A cross-section of the sound diffusers (dimensions in mm). The material and manufacturing process is protected as an industrial design (Community Designs Bulletin, 2012).

Schroeder diffusers are usually constructed by craftsmen in the course of interior finishing work or are offered in short series by specialized manufacturers. A solution concerning both the material and technological process used to fabricate the diffuser elements on an industrial scale has been patented in the European Union as an industrial design (Fig. 9). The diffuser has a form of a pressing continuously extruded out of a composite based on epoxy resin (EPD) filled with wood dust. The system is mounted on 60 mm × 60 mm posts inserted into holes provided in the diffuser’s structure.

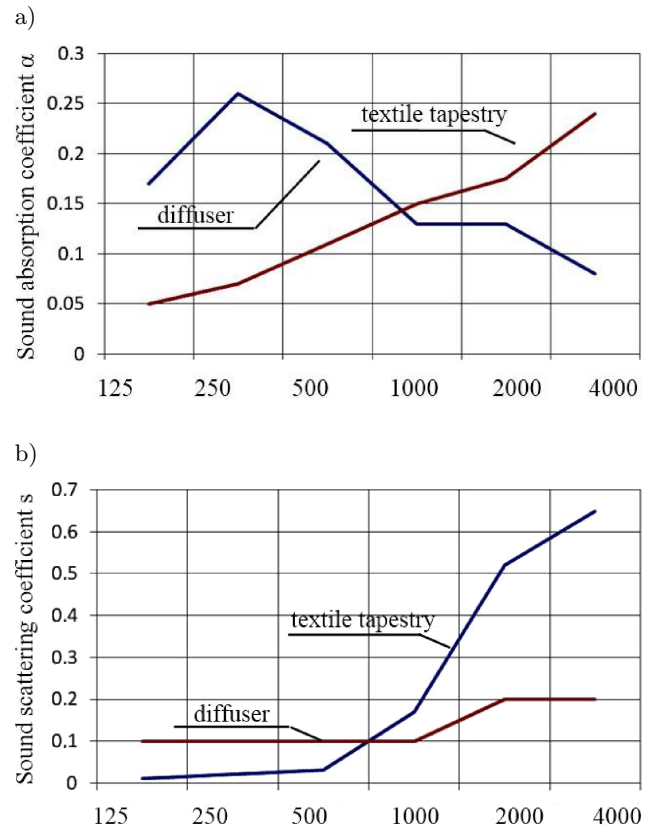
Fig. 11. Acoustic parameters of the textile tapestry and the diffuser of Fig. 9 used in computer simulation (octave resolution, frequency range 125–4000 Hz): a) sound absorption coefficient α , b) sound scattering coefficient s (KAMISIŃSKI *et al.*, 2012b).

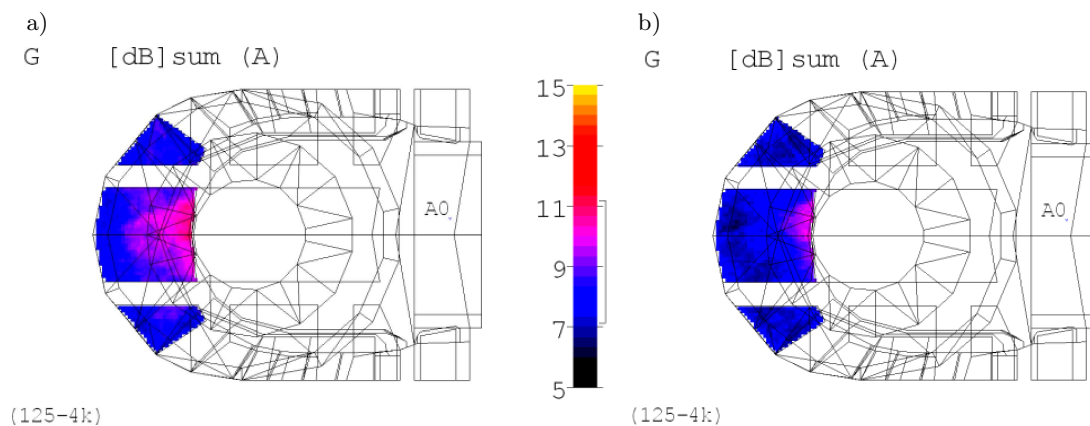
Fig. 12. The forecasted distribution of G values in the underbalcony area for the rear wall covered with: a) textile tapestry, b) sound diffuser.

smooth and hard rear wall with a sound scattering structure, distribution of the parameter became significantly more even (Fig. 12). The effect is particularly prominent for frequencies above 1 kHz, as in this very range, the sound absorption introduced by the diffuser is lower, while the scattering effect is stronger (Fig. 11). Even more favorable is the forecasted change in the clarity factor C_{80} (Fig. 13). This is especially

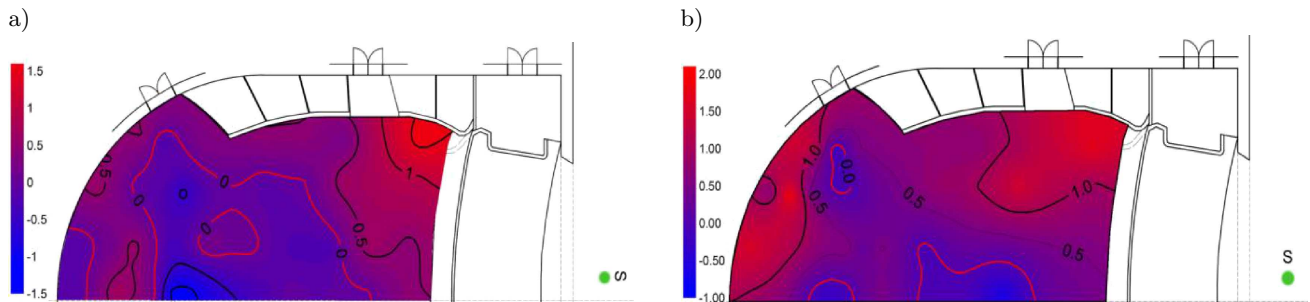
Fig. 14. The effect of mounting the diffusers on the sound strength G in octave bands: (a) 0.5–1 kHz and (b) 4 kHz.

A characteristic feature worth noticing is a similarity of the sound strength distribution patterns in the 4 kHz octave band, observed for the first 80 ms and for

the whole impulse response decay period (cf. Fig. 15a and 14b, respectively). This means that the impression of sound strength in the auditorium and the parameter G corresponding to sensation related to this quantity is created in the initial stage of formation of the impulse response. The observation is consistent with the generally accepted regularity concerning enhanced response of the human ear to early high-energy sound reflections.

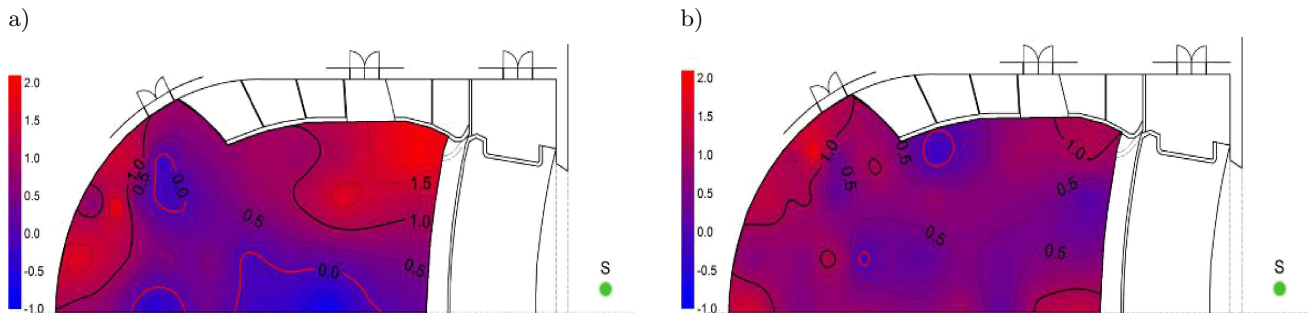
Fig. 15. The effect of mounting the diffusers on the sound strength G : a) $G_{80 \text{ ms}, 4k}$ and b) $G_{\text{Late}, 4k}$.

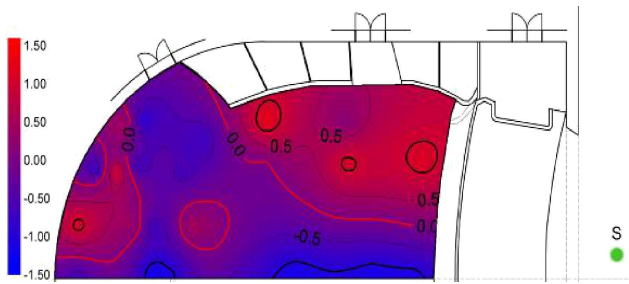
Fig. 16. The effect of mounting the diffusers on the sound clarity $C_{80, 4k}$.

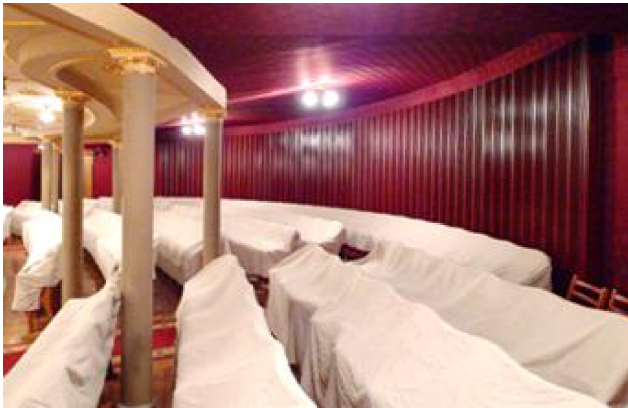
Fig. 17. The underbalcony space in the Lviv Opera House after mounting the sound diffusers.

surements covered the whole stalls. The measurements were taken in the unoccupied hall. From among all parameters that were examined, the sound strength G was the one which demonstrated the most noticeable effect related to mounting the diffuser on the rear wall. The increase was particularly high in the medium ($G_{0.5-1 \text{ kHz}}$) and high ($G_{4 \text{ kHz}}$) frequency regime in the whole area of stalls (Fig. 14). The other parameters noticeably improved in the underbalcony cavity and in the areas close to proscenium, at the expense of a slight reduction of their values in the auditorium center (Figs. 15 and 16). A view of the underbalcony cavity with the diffusers installed on the rear wall is presented in Fig. 17.

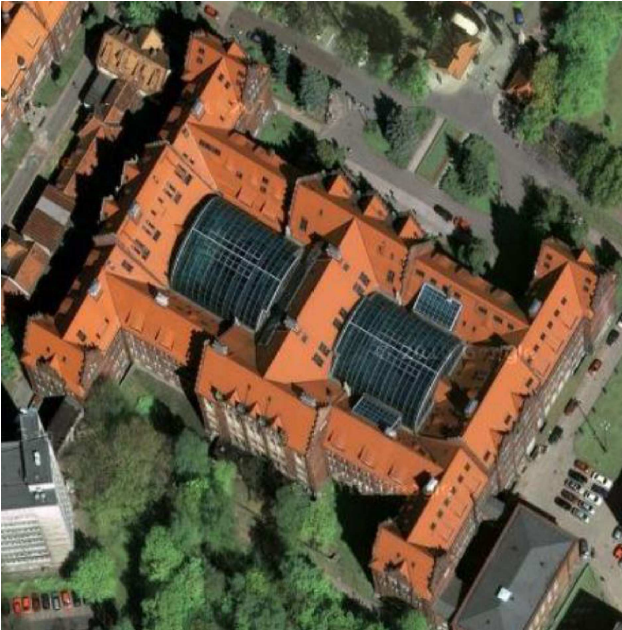
Fig. 18. Glazing roofs over Gdańsk University of Technology's main building courtyards (Google maps, 2015).

The courtyards remained open-air spaces until 2004 when glazed roofs were installed over both of them. The load-bearing structure is based on arched steel trusses with the span reaching about 22.5 m. The roof shell is made of double-pane insulation glass units with voids filled with argon. The outer panes made of tempered glass are 10-mm and 8-mm thick, while the inner pane is a 2 × 4 mm glass laminate with plastic film glued between the layers (Figs. 18–20).

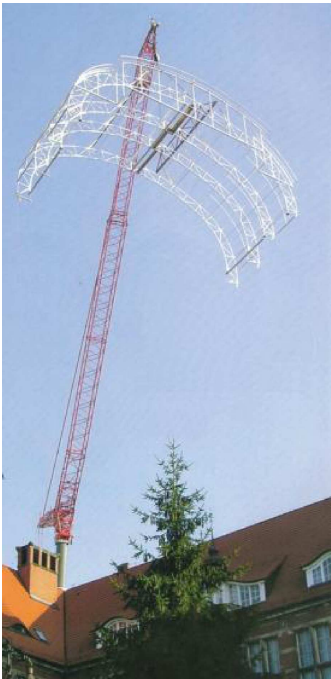
Fig. 19. Transferring glazed roof framework from the assembly site onto the Hevelius Courtyard (CYWIŃSKI, 2012).

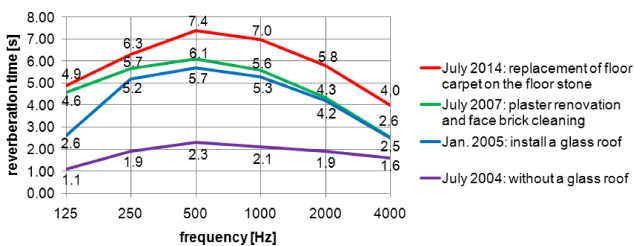
Fig. 23. The Fahrenheit Courtyard reverberation time after successive renovation stages.

The original acoustics of the courtyards was characterized with a short reverberation time (cf. Fig. 23, the lowest curve). The original acoustics of the courtyards was distinguished with a short reverberation time and high degree of sound diffusion. This followed from diversified structure of the brick elevation with significantly resolved stone decorations and resulted in good speech intelligibility. Such characteristics was favorable from the point of view of the functional program of the courtyards despite exposition of the space to the elements.

als are intended mainly for outdoor applications, such repairs result in further deterioration of acoustic conditions prevailing in the courtyards. For instant, the recent stage of renovation included laying a stone floor (Fig. 22) which was the cause of further increase of the reverberation time, as the stone, alike the glass used for the roofing, is a material reflecting virtually the whole of incident acoustic energy. After subsequent work stages, the reverberation time increased gradually and from the initial 2.5 s, it increased up to the current 7.5 s, whereas the value recommended for the official functional program of the interiors should not exceed 2.0–2.5 s (Fig. 23).

where $T_0 \approx 7.0$ s is the currently observed reverberation time (cf. Fig. 23), and ΔA is the acoustic absorptivity increase relating to application of the foil, value of which can be calculated as
