ANALYSIS OF THE ACCURACY OF RECONSTRUCTION OF THE GEOMETRY DRIVING WHEEL OF GEAR PUMP WITH APPLICATION OF CATIA SYSTEM

Summary

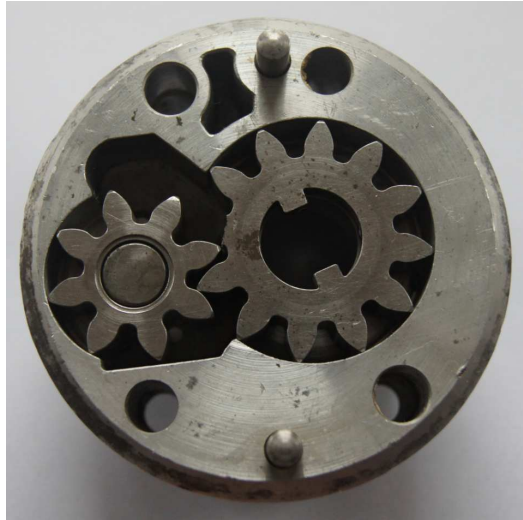
Fig. 1. Positive - displacement gear pump

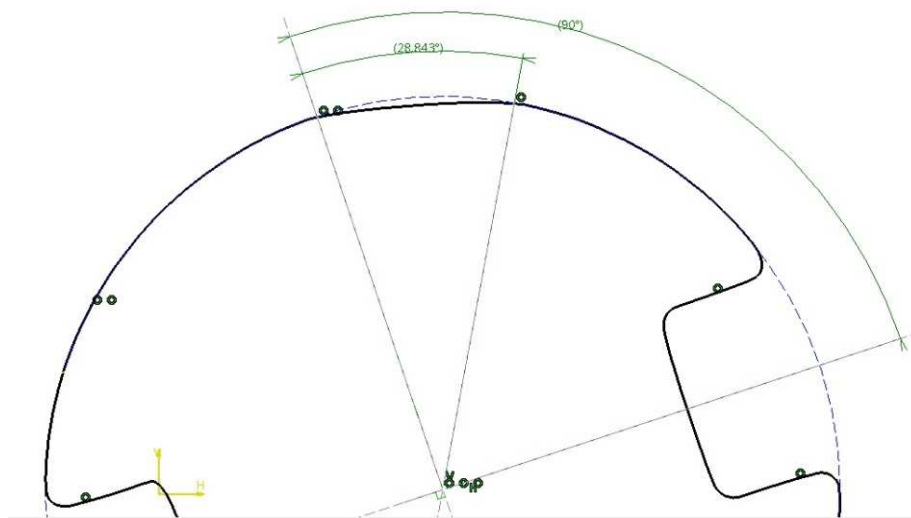
Fig. 8. Distortion in profile of internal gear hole

Figure 8 shows deviation of profile of internal gear hole which was made from sections in research model (solid line), from theoretical (dotted line). This kind of hole distortion by its nature may be the result of measurement inaccuracies or approximation curves during creating sections.

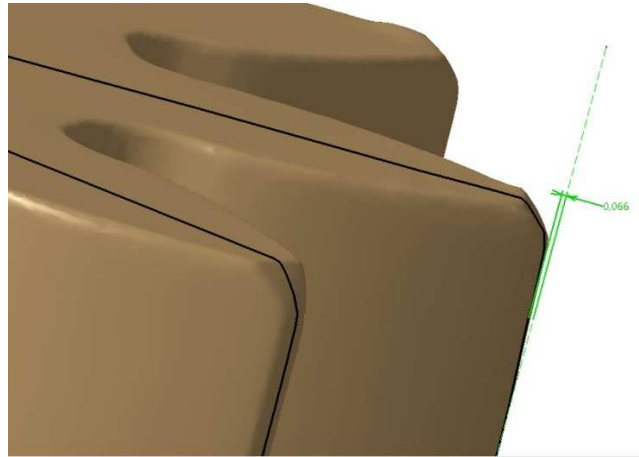
Fig. 9. Distortion of tooth surface as wiping (0,066 mm)

Figure 9 shows tooth surface distortion as wipe in thickness of 0.066 mm on the side of one tooth from the vertices. This type of distortion (such as wiping) on the tooth surface for individual character may be (similarly as the above internal hole damage), the result of measurement inaccuracies or approximation curves during creating sections.
